#### Little Doward Camp Ganarew Parish SO 3597 1597

Herefordshire Archaeology Report No.229 HSM 45003

## Little Doward Camp Ganarew

## Herefordshire Archaeology Report No.229

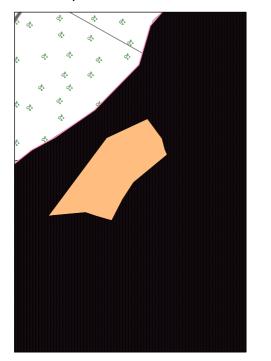
Figures 4 and 5: The map on the left (figure 4) shows the area where brash left by recent felling operations impeded visibility during the survey and the map on the right (figure 5) shows the areas where past ploughing or scarification have disturbed the surface smoothing out any archaeological features.

Modern forestry planting has over most of the site been done by hand planting and therefore below ground survival will be good. The exception to this is in the areas that have been subject to pre-planting ground disturbance (shown in figure 5) prior to tree planting. The density of features in these areas is much less than in the remainder of the survey area and those features that do occur have been reduced in scale and spread. In these areas survival and condition is poor.

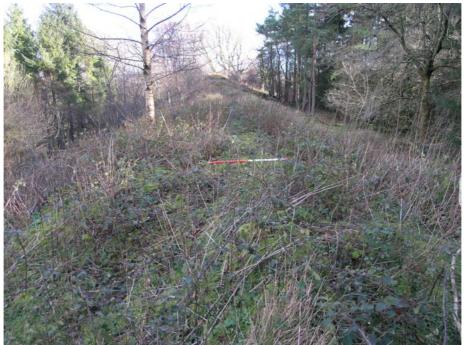
The main enclosure is 6 hectares and is defined by a rampart that encloses the whole area apart from the link area between it and annex 1. On the south side, the rampart is composed of a single bank with no ditch as the steep slope is sufficient to function as a defensive ditch. Following the rampart in a clockwise direction, the bank is supplemented by a ditch and counterscarp bank from SO 5374 1601 on its west side. This configuration of the rampart continues on the west and north sides to where it joins with annex 1. The rampart circuit has been modified by the development of the 19<sup>th</sup> century designed landscape associated with Wyastone Leys. In particular the bank of the southern rampart has been much reduced in height and levelled to form the promenade described by Rev Webb in the 19<sup>th</sup> century and the material from the bank has been pushed into the interior of the hillfort. Sections of the rampart ditch on the west of the monument appear over-deepened (HSM 45172); an activity that may have occurred in the 19th century at the same time as the structure, interpreted as a parkland hermitage (HSM 45128) was built into the counterscarp bank. The rampart system on the north side has been substantially remodelled by the parkland development, with the construction of carriage rides and paths obscuring the rampart ditch and counterscarp. A carriage ride cuts through the rampart in the northeast side of the main enclosure and it is only east from SO 5400 1610 that a true impression of the scale of the rampart system can be perceived with survival of the rampart bank, ditch and counterscarp.

Figure 6: Section of main enclosure rampart looking east.

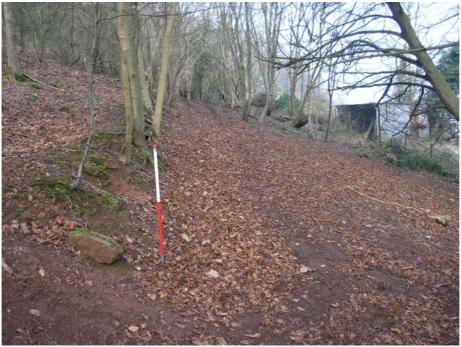
Within the medieval period the study area would have become an area of common land. A 1m high and 2m wide bank (HSM 45087) is aligned east-west in the northeast corner of the study area and probably represents the former boundary of the common (figure 7), which now lies within the stone wall boundary of the later deerpark. Outside the bank is a 4m wide track (HSM 45088) that runs parallel to the common boundary. This track continues under the deer park wall (HSM 45175) of the parkland confirming this as an access track prior to the development of the parkland in the 19<sup>th</sup> century.

Figure 7: Bank (HSM 45087) defining the former extent of the common.

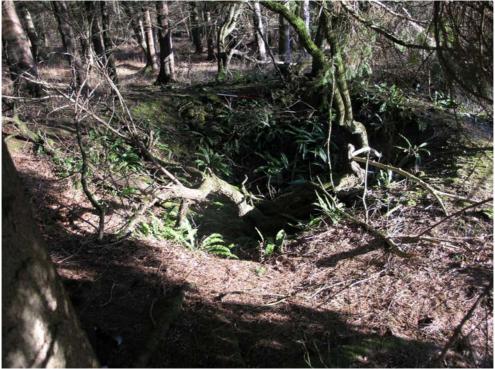
Figure 8: Mine shaft (HSM 45043) in the south of the main hillfort enclosure.

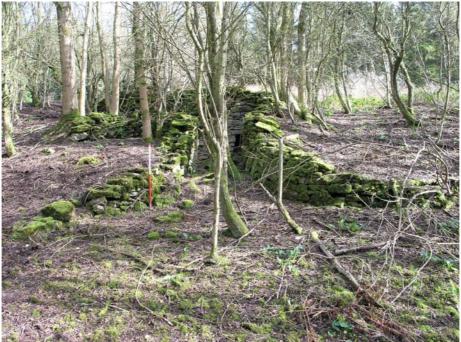
Figure 10: The hermitage structure (HSM 45128)

Also of note is the condition of parkland structures. All are in declining condition and in the case of the tunnel and hermitage in imminent danger of loss through further collapse. These two features are considered to be in poor condition and require attention to secure their continued survival.

- Trees within the "hermitage", its entrance or within 2m of its external walls should be felled. Structural roots of trees tend to extend up to 2m from the main trunk and therefore felling trees within this distance reduces the risk of damage from structural roots. Care should be taken not to damage the structure during felling work. The stumps left on the walls should not be treated with an herbicide as this may cause collapse of the structure due to decay of the root system, but all other stumps should be treated to prevent re-growth.

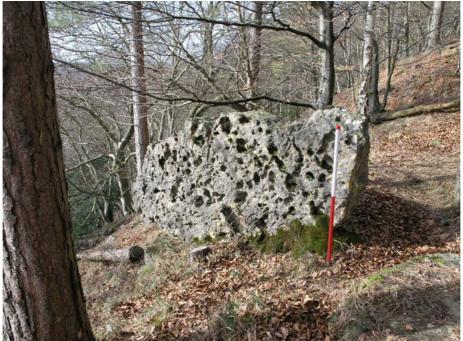
Figure 11: One of the weathered limestone boulders that have been placed throughout the landscape.

Around the designed landscape are a number of placed boulders (figure 11). These placed boulders are often either locally sourced water worn limestone or quartz conglomerate, both of which have distinctive decorative appeal. The main group of placed boulders is in the north area of the main enclosure (HSM 45027). Other boulders are a part of other interest features such as the cutting on the north rampart, the tunnel or the stone bench. There are also some single boulders set throughout the area (HSM 45037 and 45123).

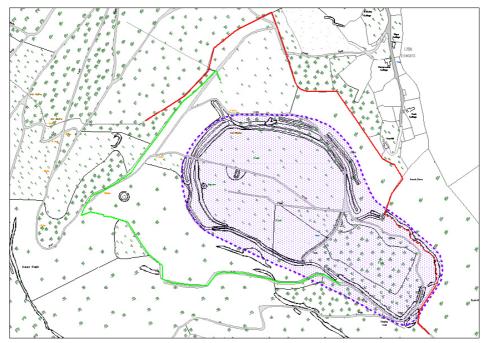
The other created features are two boundary walls. One wall (HSM 45175) forms the main boundary of the designed landscape and is a deer park wall constructed of roughly coursed local limestone to a height of 2m. The wall (figure 12) enters the west of the survey area at SO 5366 1613 and forms the northern limit of the survey area to SO 5420 1572 where it descends the slope from the southeast corner of annex 1 towards the River Wye. The other wall is of variable height and nature and appears to define the pleasure grounds that the hillfort formed as part of the designed landscape. At its northern end (HSM 45140) it comprises a dry stone wall, 0.75m high, and this continues as a more ruinous structure on the west edge of annex 1. It then continues as a earthen bank (HSM 45111) to SO 5354 1596 where it turns to the west and forms the southern edge of a parkland path (HSM 45110). At SO 5363 1596 the boundary is defined by an outcrop of limestone, which is supplemented by dry stone walling (figure 9) to maintain a consistent height of 1m. The wall the continues as a dry stone wall up to 1.5m high to where it terminates as a 0.5m high wall at SO 5403 1582.

Figure 12: Parkland boundaries – The red line represents the deer park wall (dashed where the cliffs of the annex for the wall. The green line represents the second parkland wall.

- The two parkland boundaries (HSM 45175 and HSM 45140) and the base of the iron tower (HSM 30089) are subject to damage and decay through the development of trees on and adjacent to the structure. Root penetration is the main cause of damage, but subsequent uprooting of the trees by wind action and the percussive impact of overhanging branches are additional causes of damage. Trees and scrub should be removed from the iron tower base and stumps treated. Trees on the parkland boundaries should be felled if assessment indicates they are likely to result in the collapse of wall sections. Other trees should be coppiced, reduced in height or thinned to reduce the risk of uprooting in high winds. Branches adjacent to the structure that may periodically hit the wall should be removed.

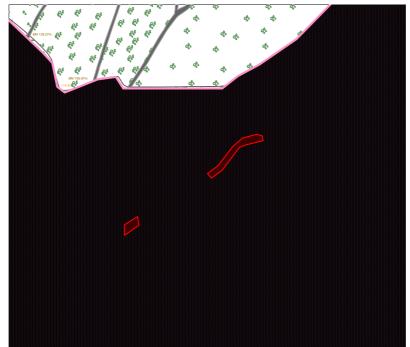
Figure 14: Brash mats must be located at the areas marked in red to protect underlying archaeology.
