A Conservation Management Plan for “Leintwardine Roman Station of Bravinium” (Branogenium), Leintwardine, Herefordshire

Scheduled Monument No 1005522
Historic Environment Record No 549

June 2014

Herefordshire Archaeology Report No. 341

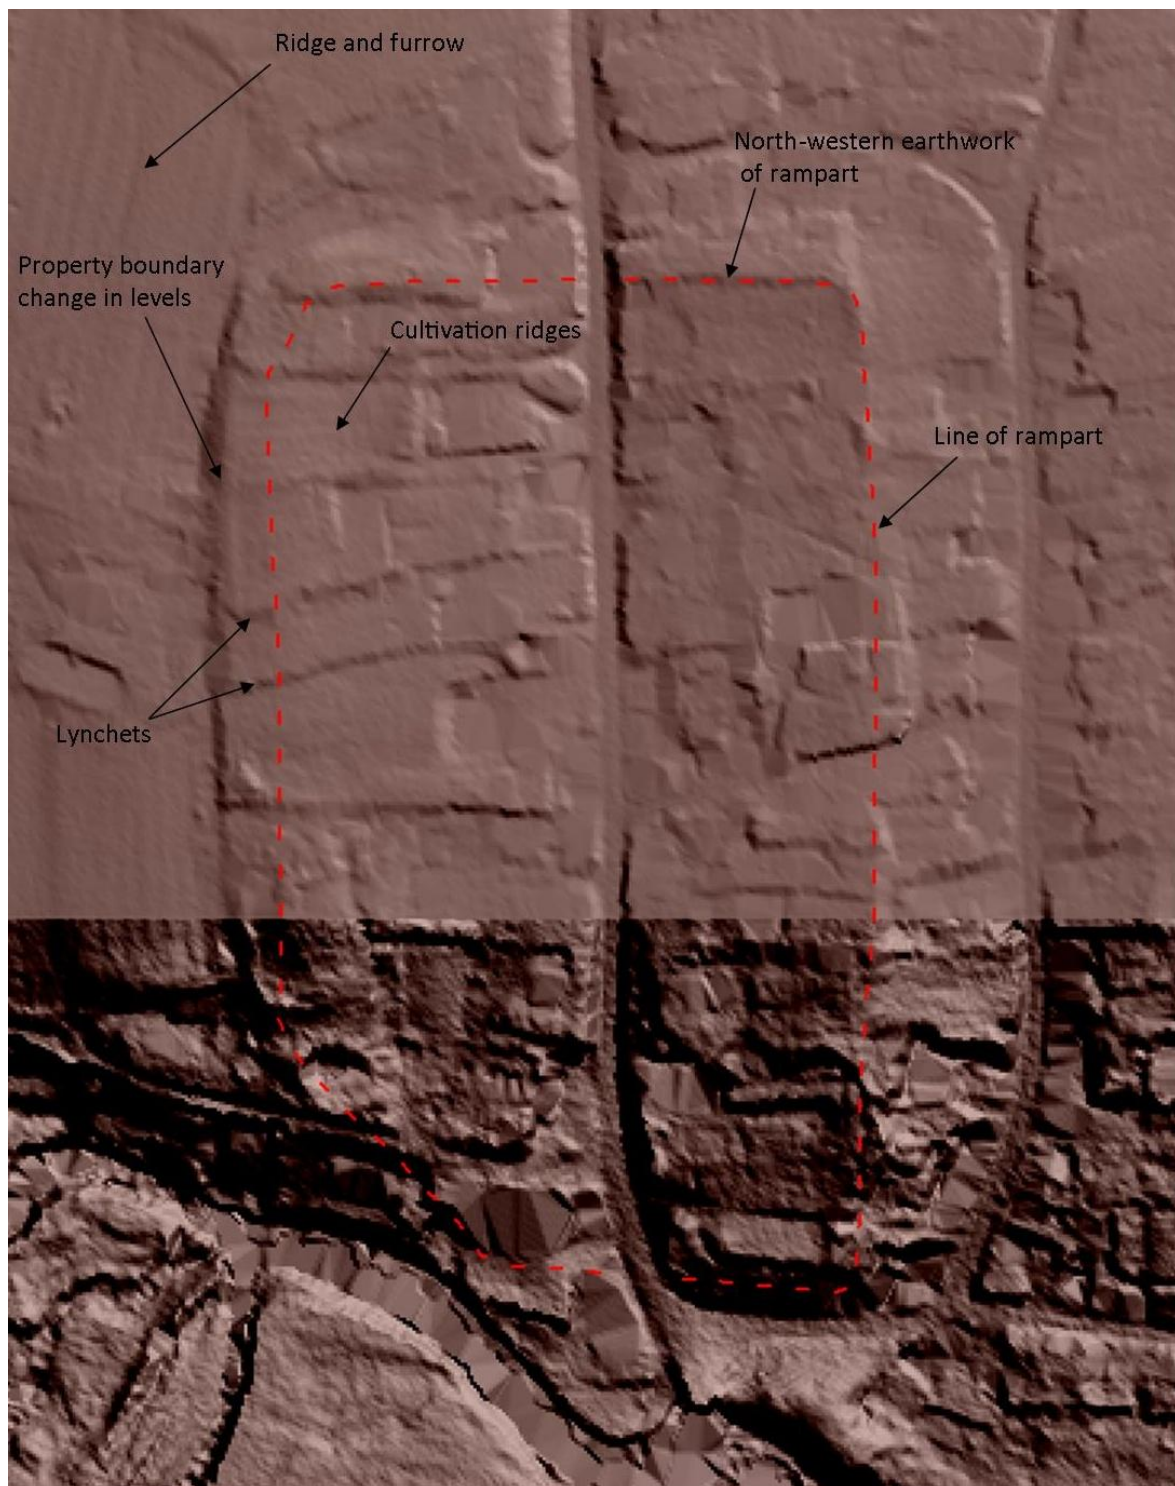
Figure 6: Lidar Image of Leintwardine. (© Environment Agency) Lidar (from “light detection and ranging”) is a remote sensing technique which utilises lasers to obtain a digital model of the earth’s surface. A laser beam is fired from an aircraft usually at 1m or 2m intervals, a number of signals may be returned from trees and other vegetation cover but the last is from the ground surface below or other solid surfaces. By using only the last signal the vegetation cover can be filtered out, buildings can also be removed to produce a model of the ground surface only. This can then be manipulated and lit from any direction to enhance the detail and visibility of the earthworks. The southern part of the Leintwardine image above is recorded at a lower resolution and the data is therefore coarser.

2.22 Today the most visible stretch of rampart survives in the north-eastern corner of the enclosure. It is also clearly visible on the Lidar image (figure 6). A length of around 50m is apparent as an earthwork about 1.5m high including the corner itself and from there around 25m running west and the same running south. In the former direction it fades out at the eastern boundary of properties on High Street and in the latter direction there is an apparent break where an established field gate between Yardley Farm and one of its fields exists. Beyond this to the south it appears to be visible again under the churchyard wall and within the churchyard itself. It is acknowledged that some of this feature may have been produced by excess soil from grave digging being deposited along this boundary over the centuries but the wall is undoubtedly on the original line of the rampart. The land use here does however have implications for the survival of buried archaeological deposits which are no doubt heavily disturbed, even close to the churchyard wall, by numerous graves. Bull reports that when graves have been dug to a depth of 8 feet “two layers of ashes and charcoal intermixed with tiles, broken pottery, bronze articles and coins, have been passed through” (Bull, op cit pp253) these deposits are more likely to relate to internal deposits and features but the report does indicate the likely depth of disturbance within the churchyard generally.
