Evaluation Excavations at Lower Brockhampton, Bromyard, Herefordshire

Herefordshire Archaeology Report No. 298

**NGR: SO 6874 5590
EHE 1905**

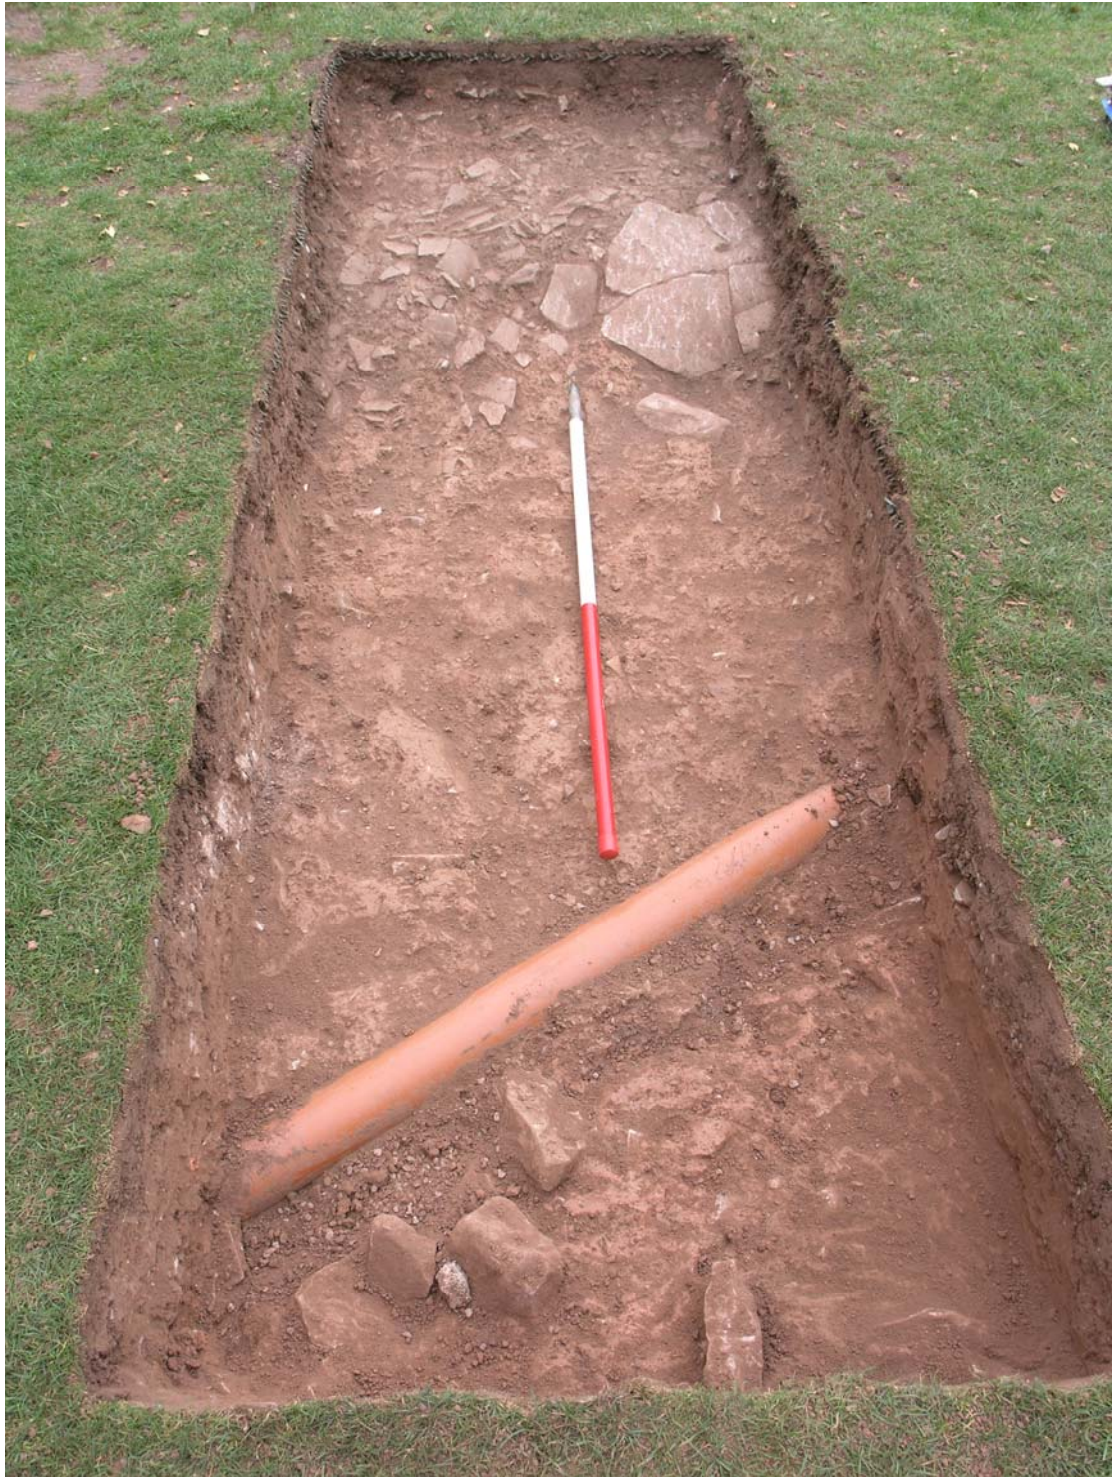
Plate 1: General view of Trench 1 upon completion of the excavation.

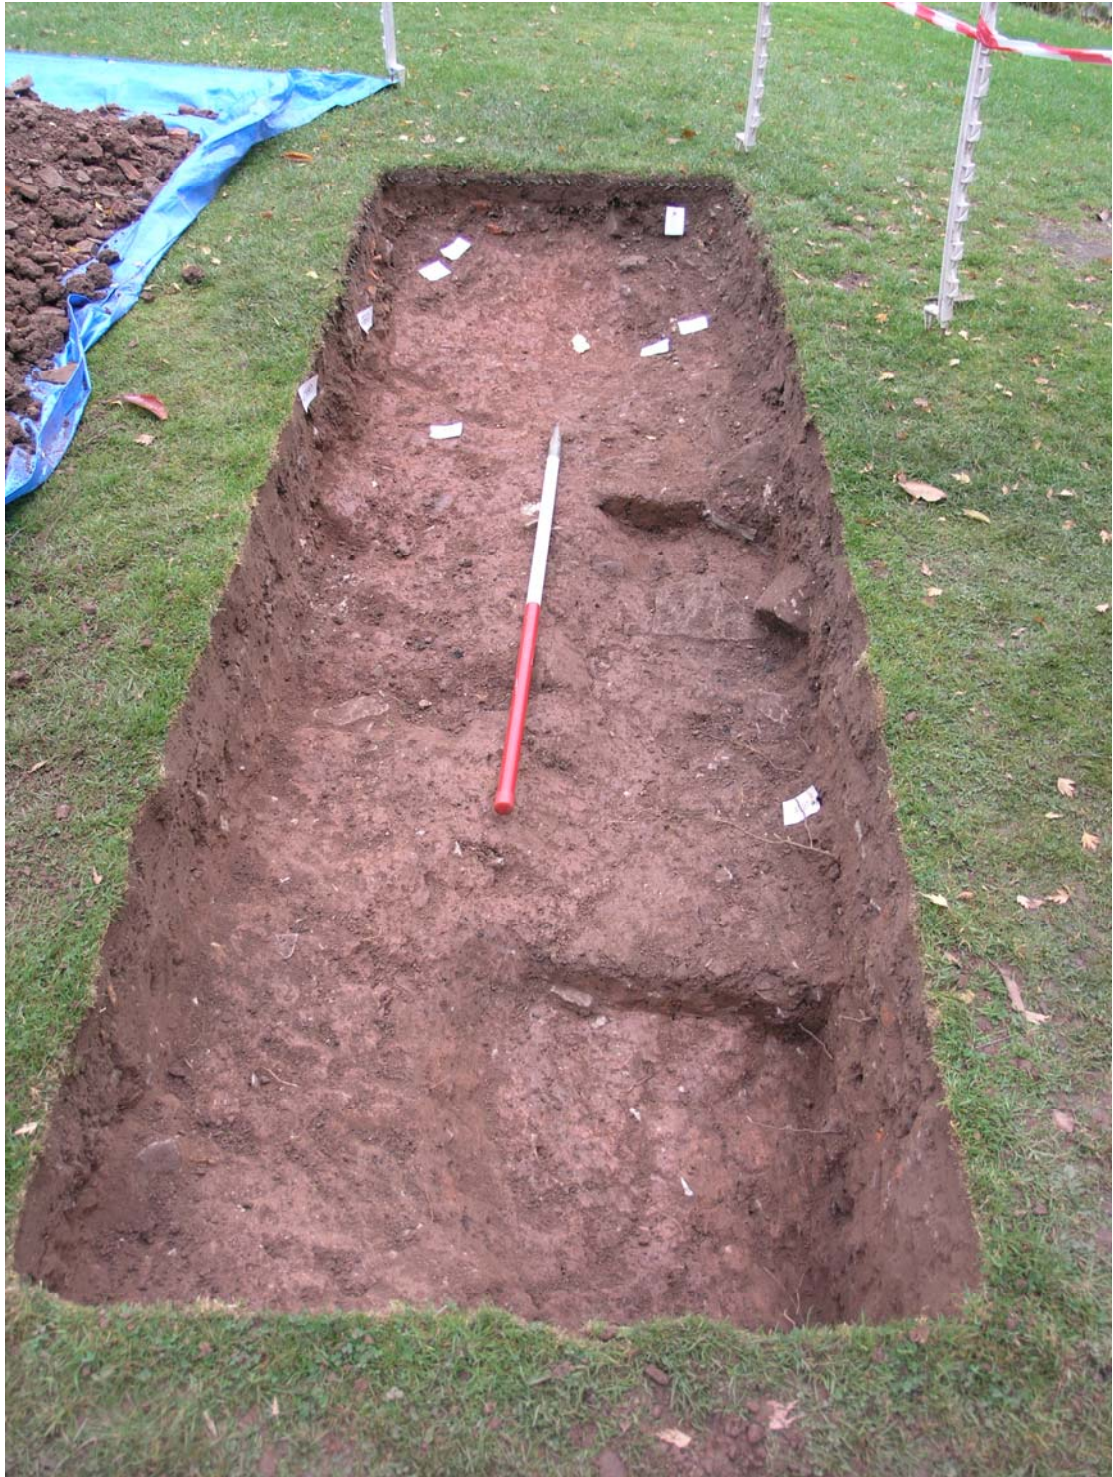
Plate 2: General view of Trench 2 upon completion of the excavation.
