**‘The Dinedor Origins Project’**  
**Site of Medieval Village, Dinedor: A Geophysical**  
**Survey.**

Report prepared by  
Christopher Atkinson, Community Archaeologist

Herefordshire Archaeology Report No 328.

May 2013

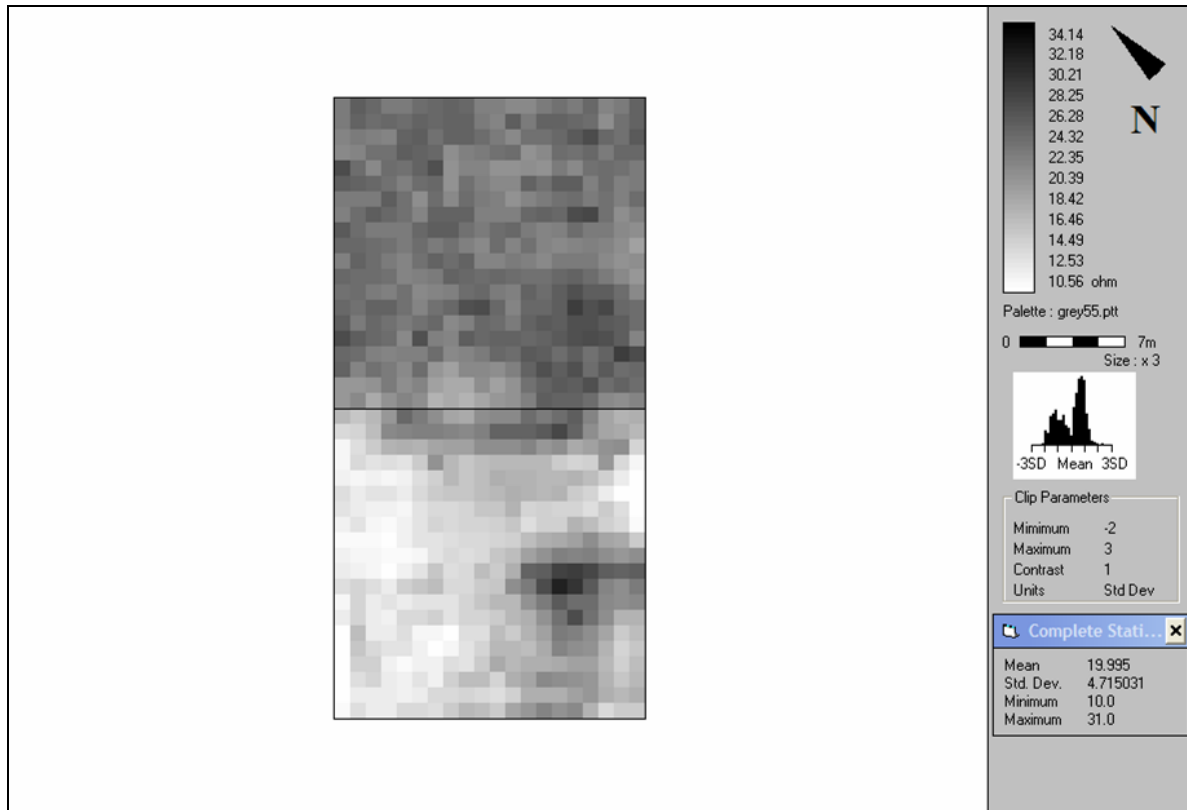
Figure 6: Raw resistance data within Area 1 of scheduled monument (HE224). © Crown Copyright, Geoplot Version 3.0 (2013)

The 20m x 40m (oriented northeast-southwest) area located within the southwest of the scheduled monument was surveyed in cold damp conditions. The location was chosen for geophysical analysis due to its close proximity to the main road and the presence of potential platforms (HER 52393 & 52394) identified over the course of detailed measured survey of the scheduled monument.

The results of the resistance survey provided a swath of readings between 31.0 Ohms and 10.0 Ohms (figure 6). The lower readings in Ohms would suggest the underlying soils to be less resistant (waterlogged/wet conditions, alluvial soils, buried ditches, pits) to the passing of a weak electric current; whereas the higher reading would indicate areas of increased levels of resistance (solid geology, well drained soils, buried structural remains).

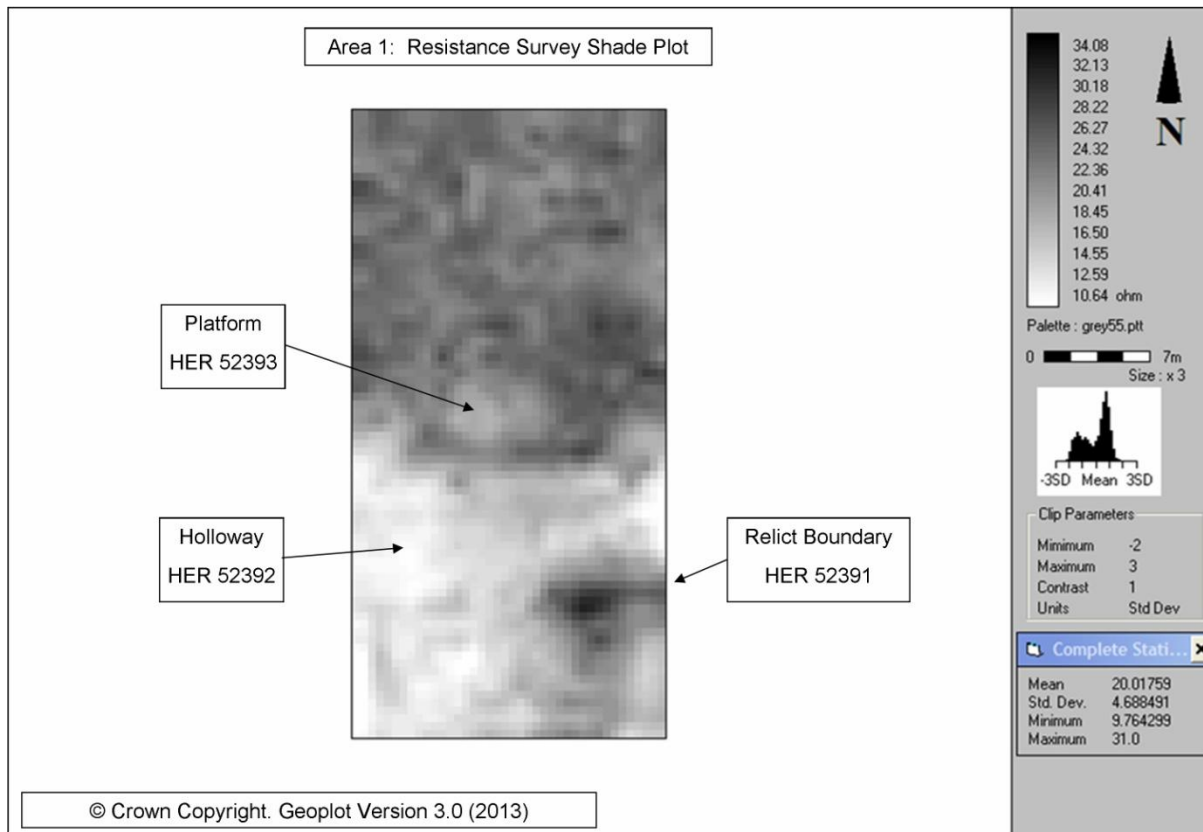
The anomalies encountered as a result of the survey closely relate to features identified during the course of the earlier field survey. The most prominent anomaly corresponds closely to the identified Holloway (HER 52392), represented by an area of low resistance within the south of Area 1 (figure 7).

As the topography rises above the Holloway to the north the survey indicates higher levels of resistance (figure 7). This may be the result of the underlying geological conditions identified as colluvial deposits of sand, gravel and clay.

Of particular interest is the relict boundary HER 52391, its location being represented by a linear anomaly of high resistance to the south of the Holloway (HER 52392). The higher level of resistance is noticeably along the northern edge of the relict field and may represent concentrated use of stone in its construction, either as a bank make-up material or as a stone revetment/wall (figure 7).

Figure 7: Annotated resistance survey results for Area 1, scheduled monument HE224. © Crown Copyright, Geoplot Version 3.0 (2013)

The location of the identified platform HER 52393 is also apparent within the reading obtained during the survey. The potential platform is highlighted as an area of lower resistance against the backdrop of the higher resistance to the north of the Holloway (HER 52392). As the results indicate the area to be of relatively low resistance the feature is less likely to represent a compacted platform surface as previously recorded. It may relate to the fill of a pit/quarry scoop into the underlying colluvial or the site of a tree, the lower resistance resulting from the fill of the void left by the roots.

3. To investigate by means of trial excavation the sub-rectangular anomaly at the summit of the relict boundary HER 52402 as a means of characterising its form and potential for representing an early structure/platform on the periphery of a small field.

4. Trial excavation of the relict boundary HER 52391 in order to identify the form of the feature. Is it an earth constructed terrace or of stone construction?

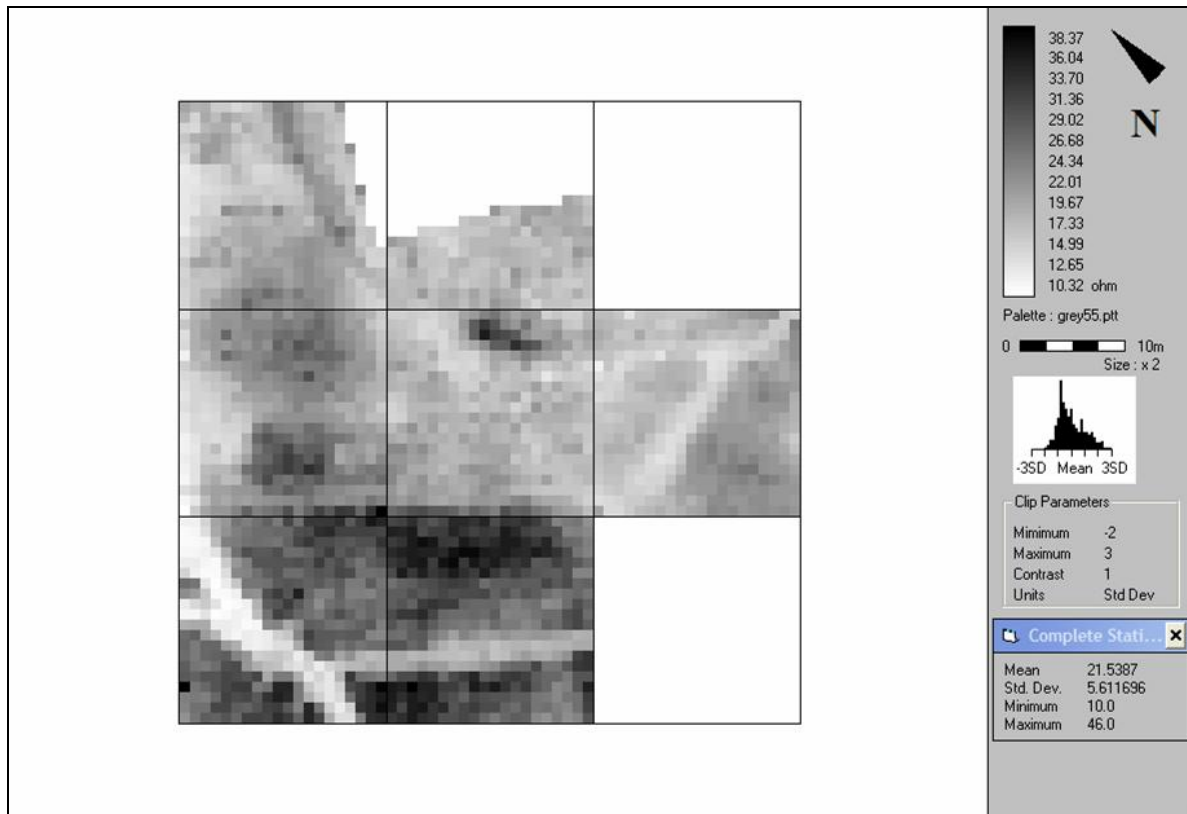
Figure 8: Raw resistance data within Area 1 of scheduled monument (HE224). © Crown Copyright, Geoplot Version 3.0 (2013)

Due to the identification of a number of platforms within a network of relict boundaries and holloways immediately to the south of St Andrew's Churchyard, seven 20m x 20m grid square were measured out and surveyed with the intention of confirming the presence of buried archaeological features representative of medieval activity.

The results of the resistance survey provided a swath of readings between 46.0 Ohms 10.0 Ohms (figure 8). The lower readings in Ohms would suggest the underlying soils to be less resistant (waterlogged/wet conditions, alluvial soils, buried ditches, pits) to the passing of a weak electric current; whereas the higher reading would indicate areas of increased resistance (solid geology, well drained soils, buried structural remains).

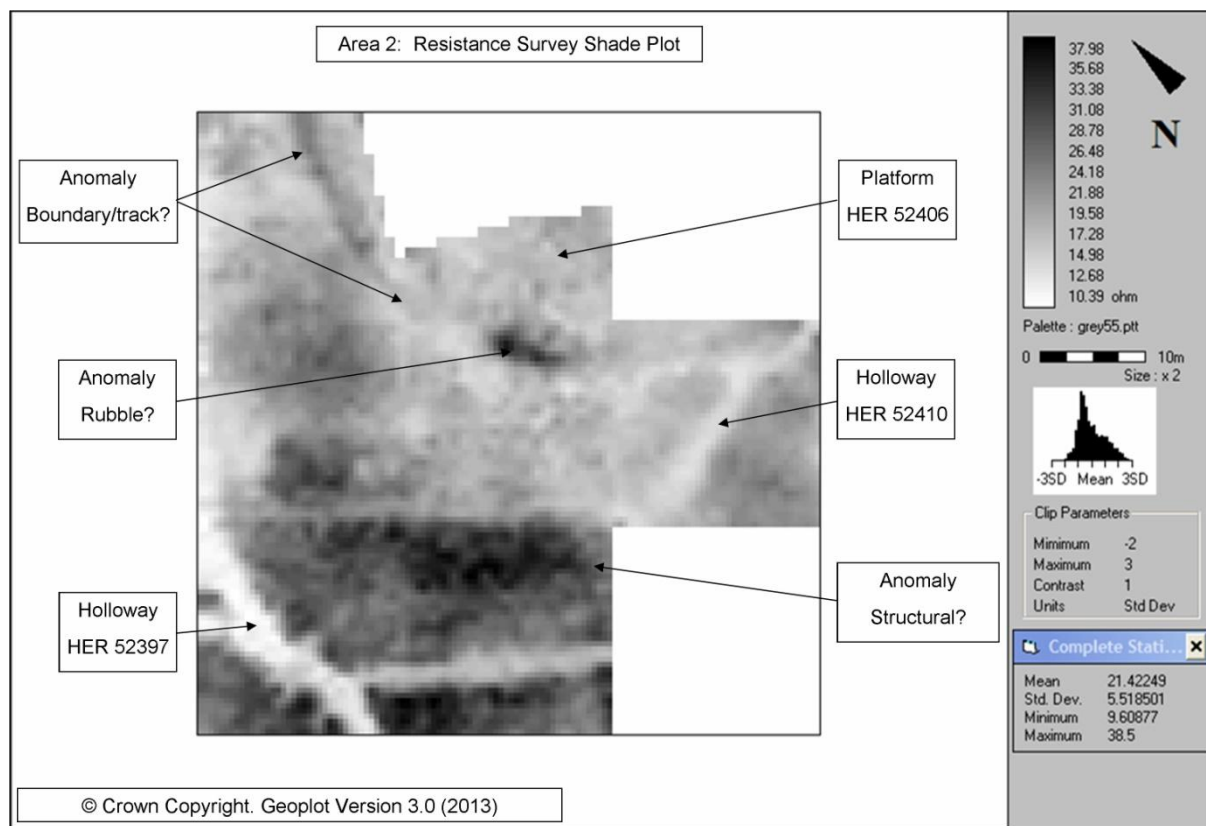
As with Area 1, the results of the survey within Area 2 closely respected the earthworks identified during the field survey (Atkinson, 2013). The dominant features identified during the survey were the courses of holloways/ditches (HER 52397 & 52410) represented by linear areas of low resistance (figure 9) due to a concentration of moisture within the hollow. Areas of high resistance are concentrated within the south of the survey area (figure 9) and concentrated within

areas interpreted as fields. It is likely however that the higher resistance represents the underlying superficial colluvial deposits rather than an introduction of material to create a well-drained condition. Upon the northern edge of the relict fields an anomaly of high resistance in the form of a sub-rectangular is evident. Due to the prominence and form of the anomaly there is a potential for it to represent a buried platform or structure (figure 9).

The platform, representative of the site 'The Garrison' (HER 52406) was revealed as an area of lower resistance with no clear indication for any buried architectural remains. Immediately to the south an anomaly of high resistance was identified. Due to its isolation and amorphous appearance, the anomaly may represent rubble (figure 9) attributed to the demolition of the 'The Garrison'.

Figure 9: Annotated resistance survey results for Area 2, scheduled monument HE224. © Crown Copyright, Geoplot Version 3.0 (2013)

Of particular interest is a curved, narrow, linear anomaly of high resistance within the northwest of the Area 2. The anomaly (figure 9) curves gradually to the southeast and tentatively follows the current extent of St Andrew's Churchyard. Upon the anomaly's western edge is a faint parallel line of lower resistance. The feature is likely man made and may simply represent an early path/track to allow access to 'The Garrison', from where the feature does not appear to continue. Interestingly however the feature is not evident from the ground unlike the site of 'The Garrison'.

A possible explanation for the feature is that it represents an earlier ecclesiastical boundary to the site of St Andrew's Church. Further investigation into the historic record is needed however.

1. To re-visit the site and carryout further geophysical analysis of the area between Area 1 & Area 2 in order to achieve a greater understanding of the buried archaeological potential.

2. To investigate by means of trial excavation the curvilinear anomaly to the west of St Andrew's Churchyard in order to determine the anomaly's form and to test the potential for it as representing an early boundary.

5. Trial excavation of 'The Garrison' site so as to determine its character and form. The clearly definable platform (HER 52406) despite the absence of any identifiable buried features is likely to reveal buried archaeological deposits relating to the early structure. Due to the scale of the L-shaped structure as indicated by the 1840 Tithe Map there is the potential for the structure as representing a hall with cross-wing of potential medieval origins.

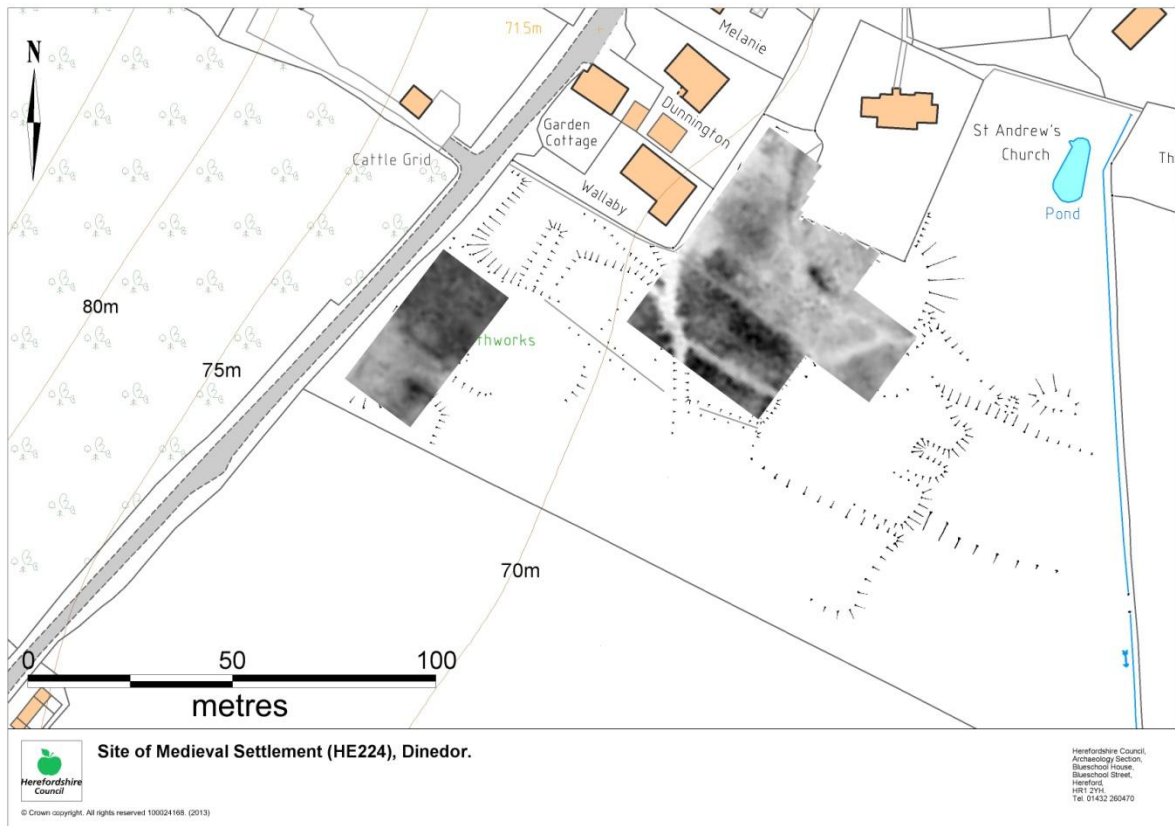
Figure 10: Results of the resistance survey in association with the detailed measured survey. © Crown copyright (2013). All rights reserved 100024168.

The results of the geophysical survey were in the first instance particularly successful in supporting the results of the earlier Level 3 survey of the scheduled monument (Atkinson, 2013). The individual field boundaries and holloways are clearly discernible as either anomalies of high or low resistance.

Although anomalies suggestive of buried archaeological features in association with the previously identified platforms are not apparent. This may simply be due to the subtlety of any buried features and the damp ground conditions at the time of the survey.

The results of the survey indicate the potential for further field evaluation.

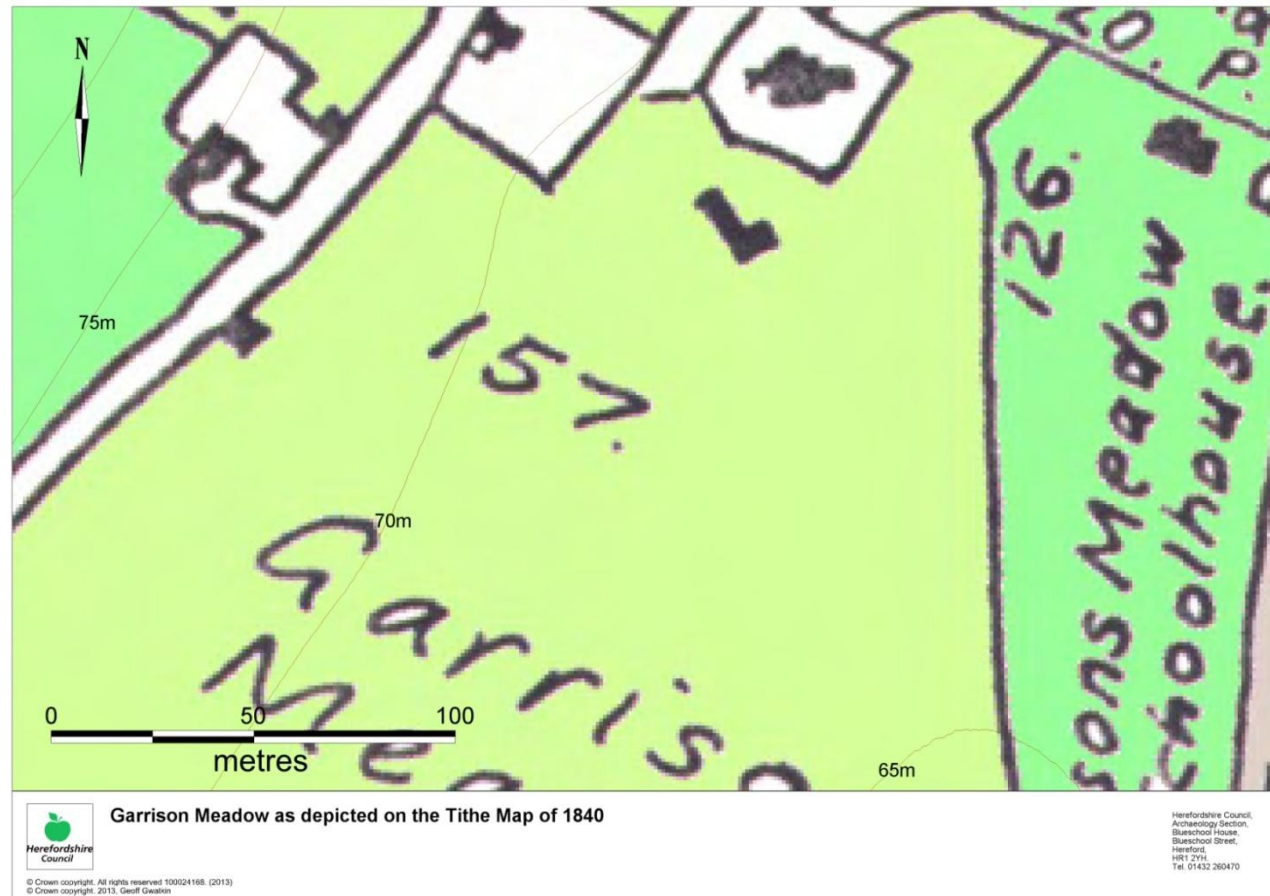
Figure 2: Survey area as depicted at the time of the 1840 Tithe Survey. © Crown copyright (2013). All rights reserved 100024168.

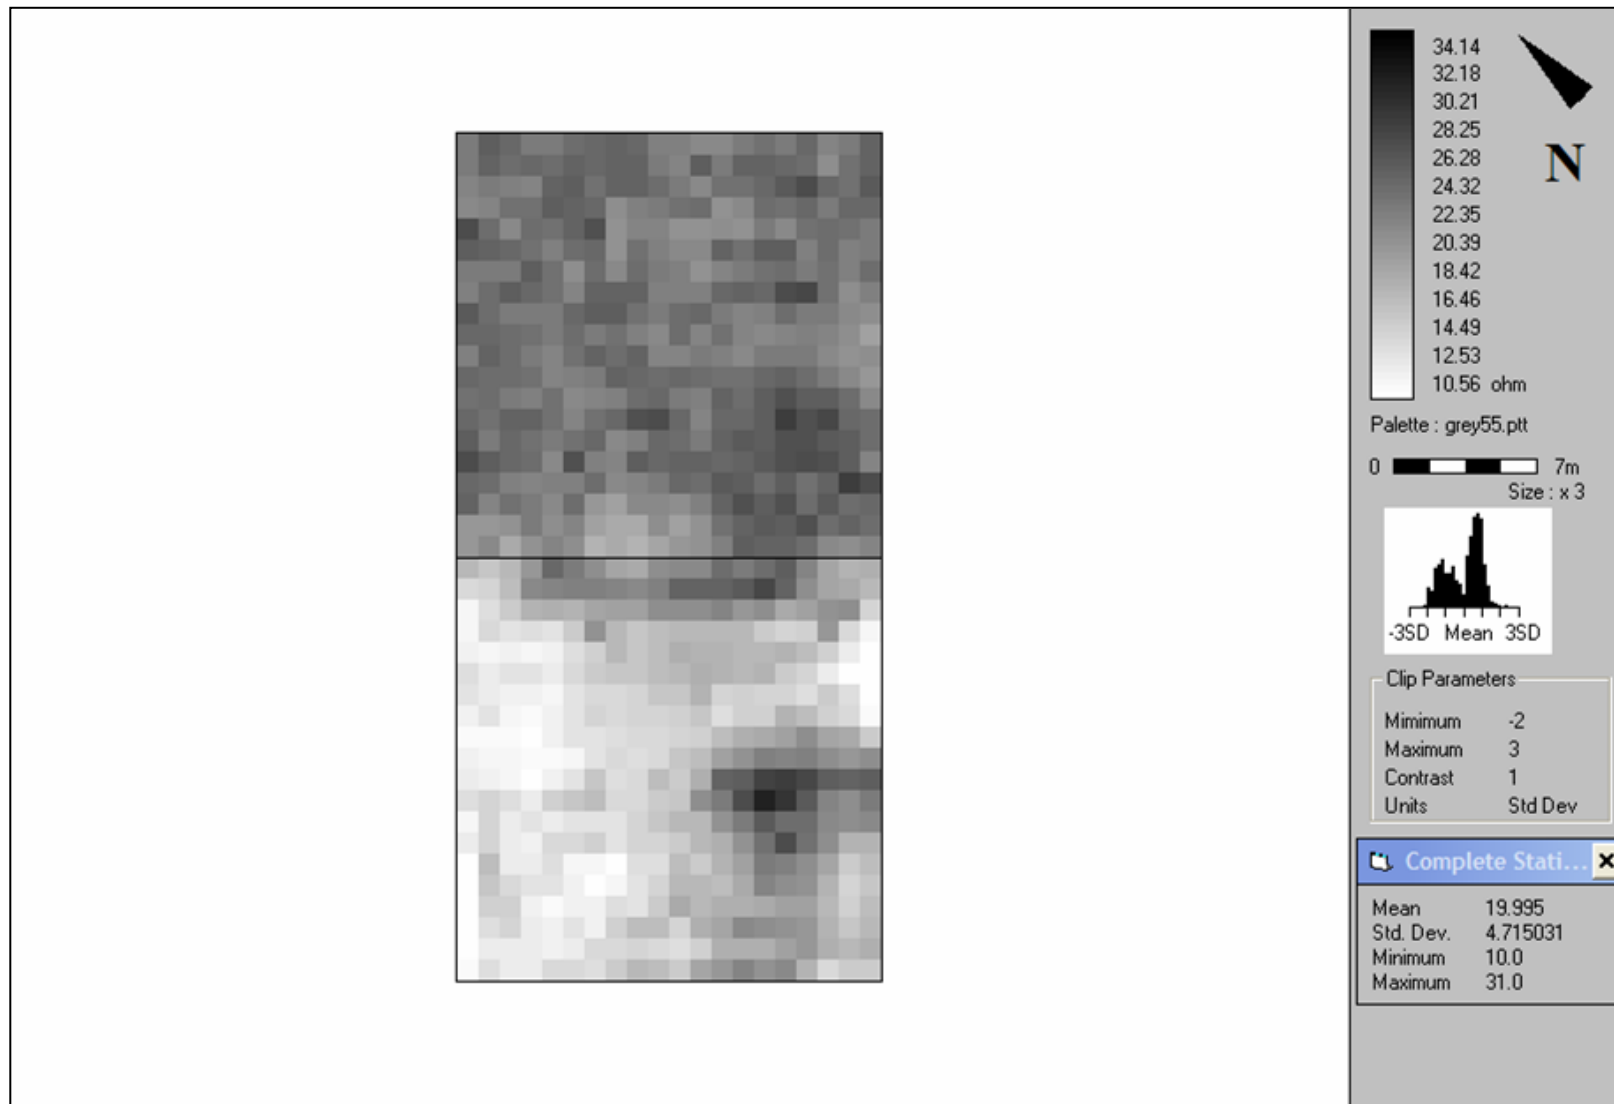
Figure 6: Raw resistance data within Area 1 of scheduled monument (HE224). © Crown Copyright, Geoplot Version 3.0 (2013)

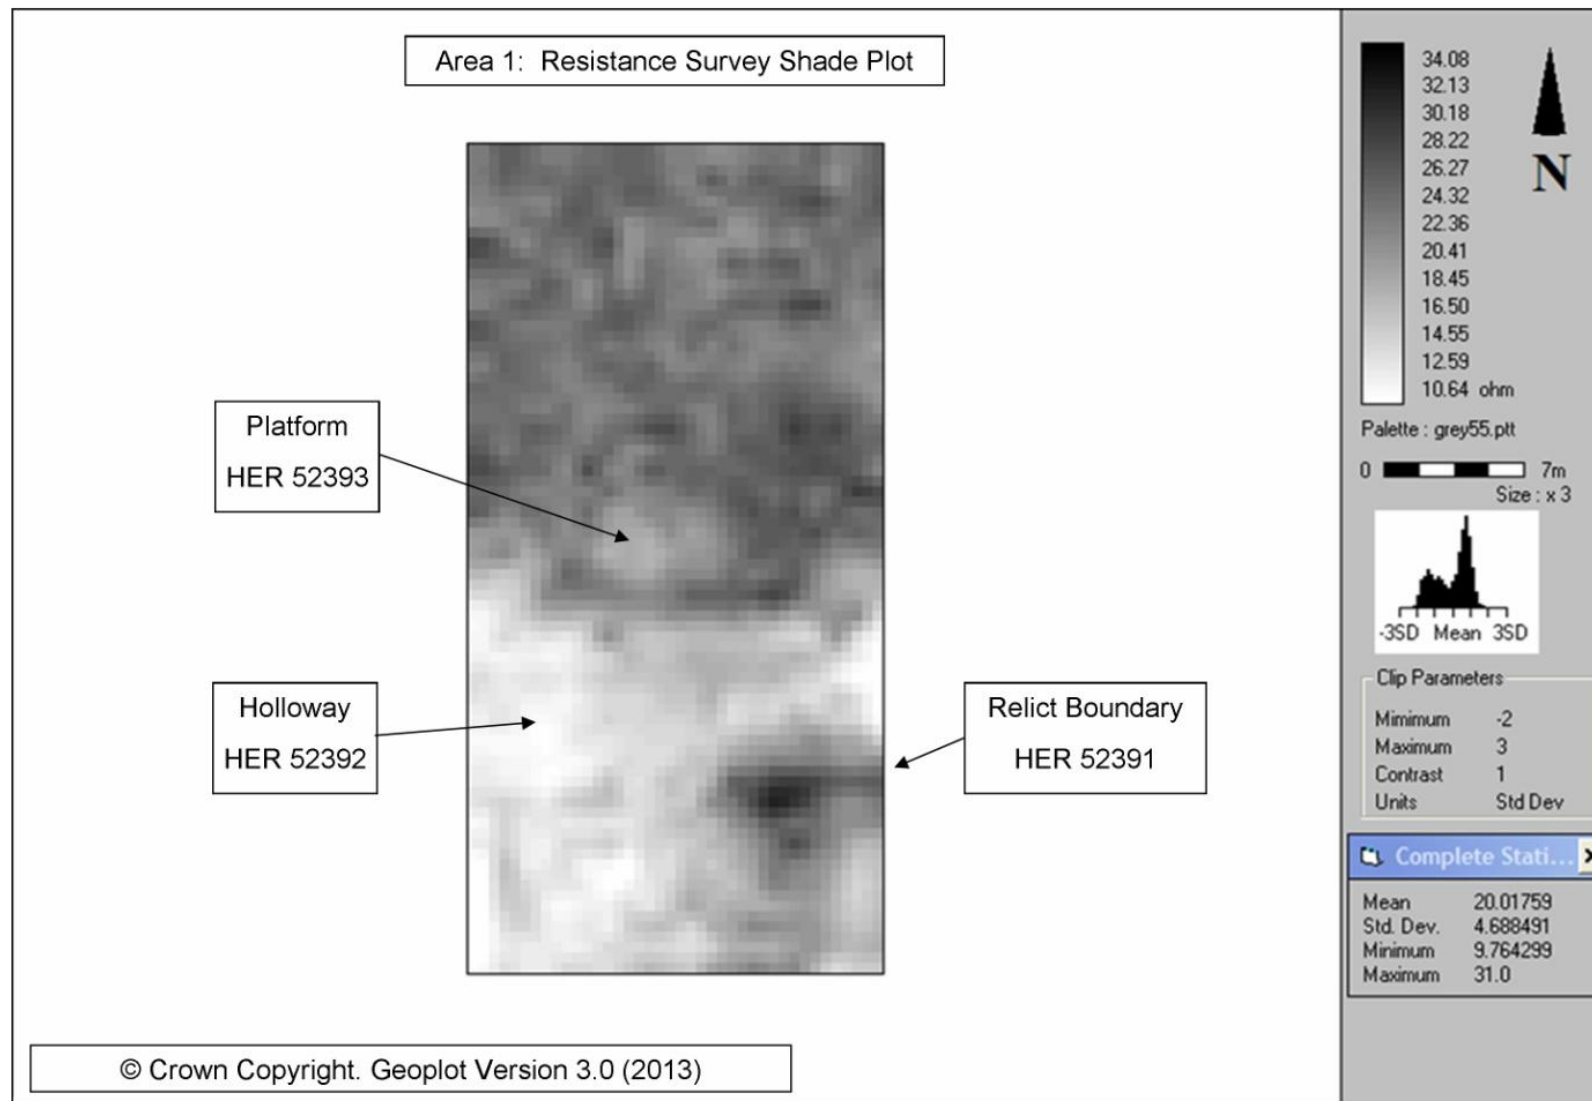
Figure 7: Annotated resistance survey results for Area 1, scheduled monument HE224. © Crown Copyright, Geoplot Version 3.0 (2013)

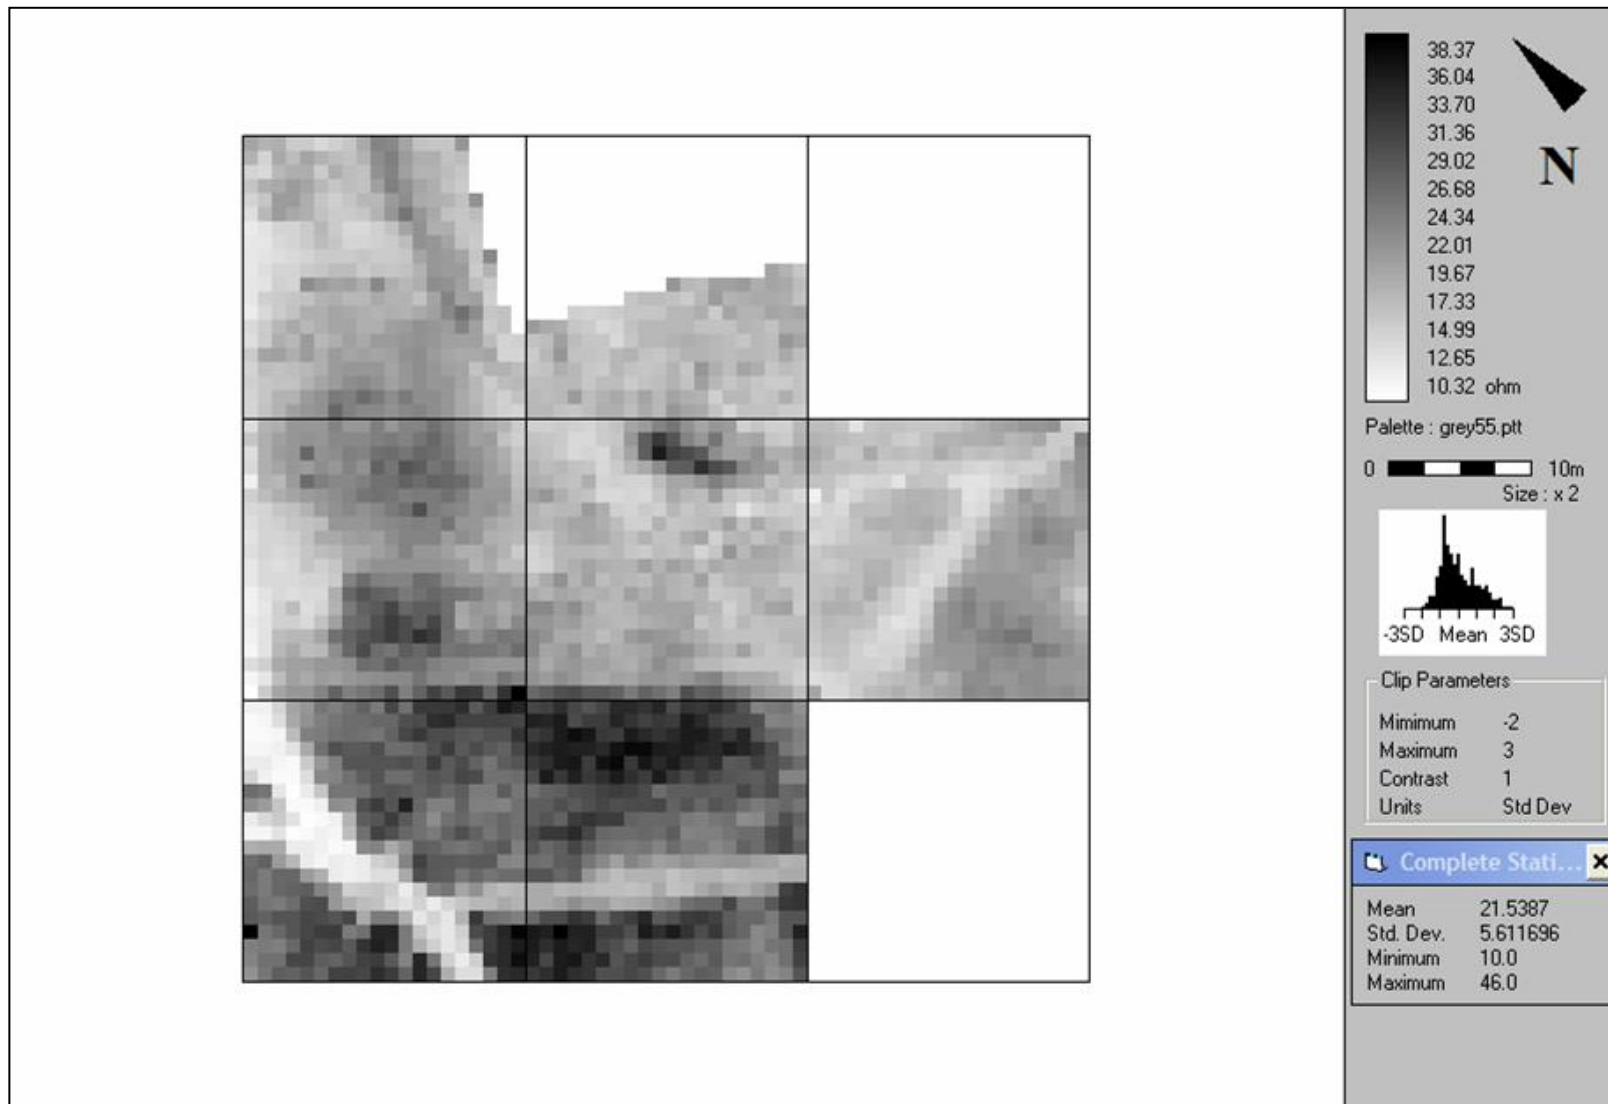
Figure 8: Raw resistance data within Area 1 of scheduled monument (HE224). © Crown Copyright, Geoplot Version 3.0 (2013)

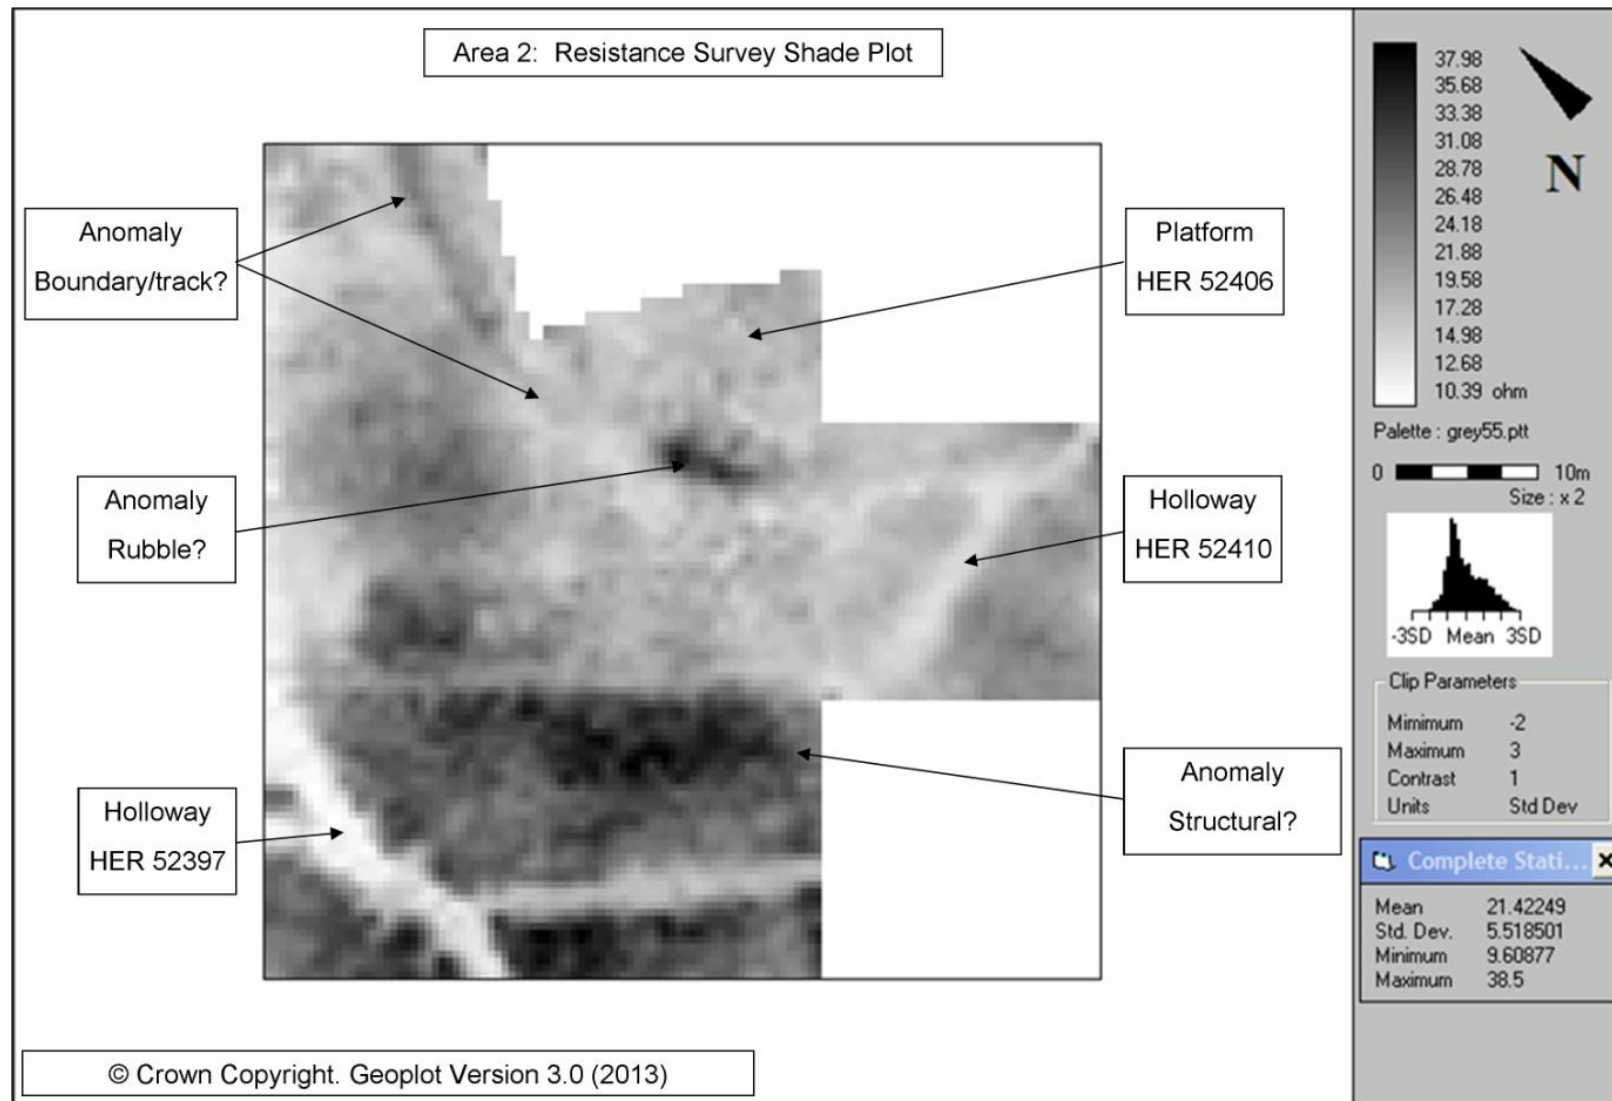
Figure 9: Annotated resistance survey results for Area 2, scheduled monument HE224. © Crown Copyright, Geoplot Version 3.0 (2013)

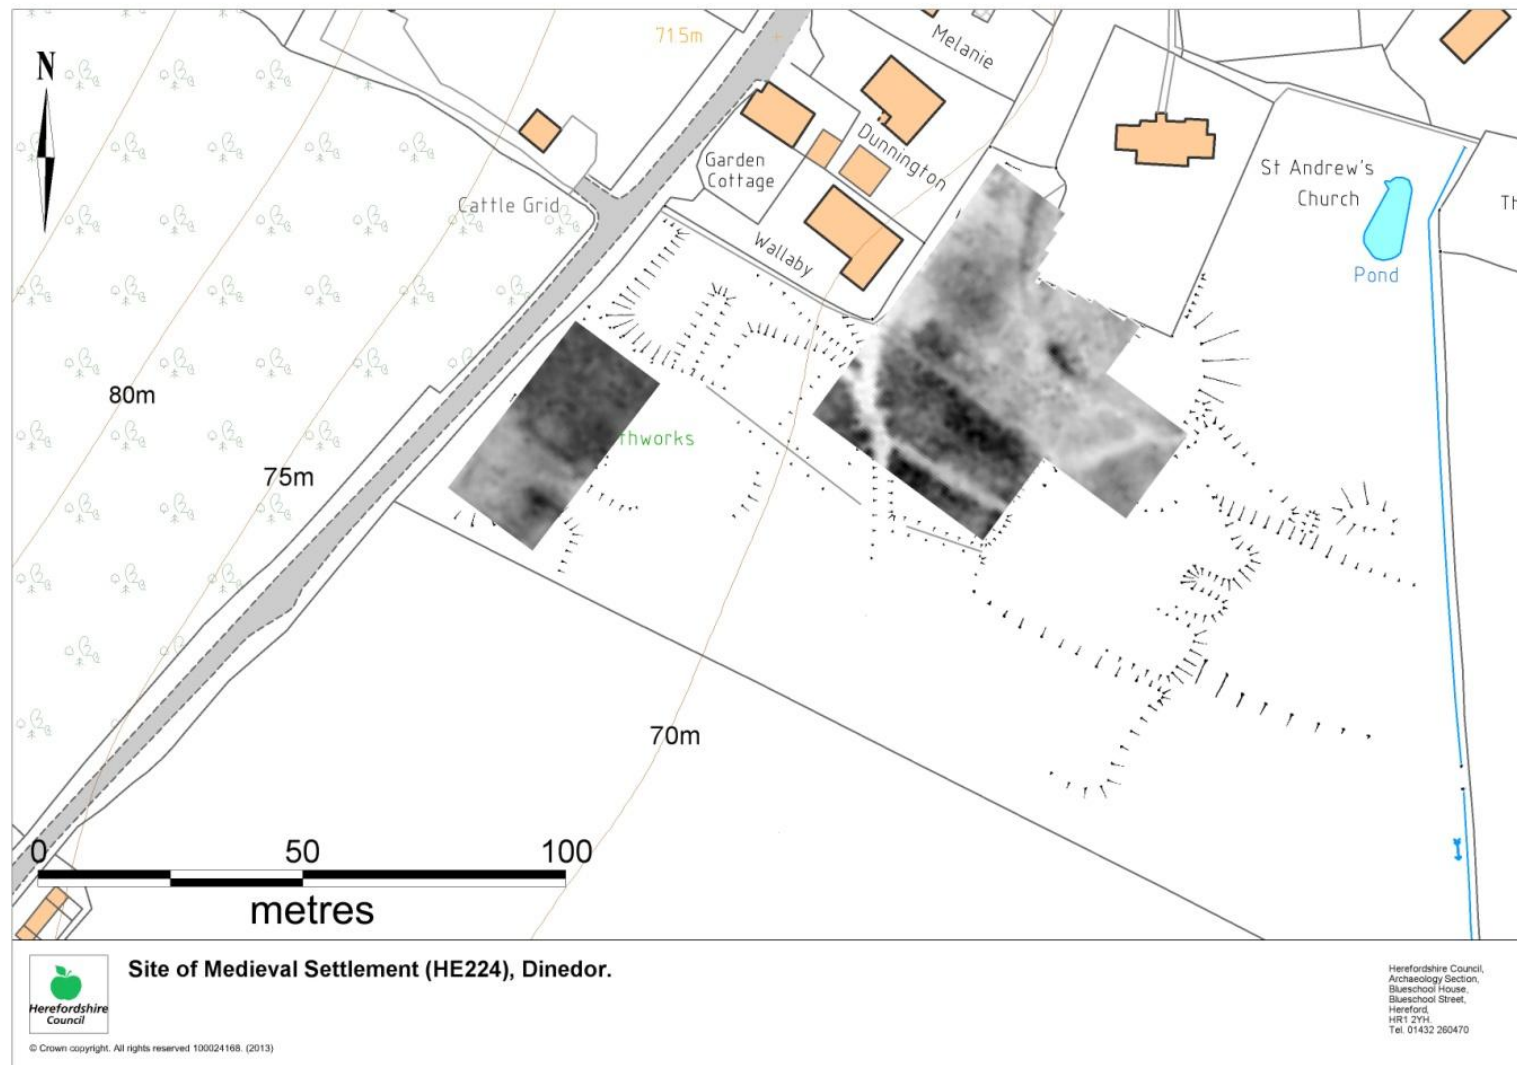
Figure 10: Results of the resistance survey in association with the detailed measured survey. © Crown copyright (2013). All rights reserved 100024168.
