SECTION 8 Wall Street

Section 8 illustrations

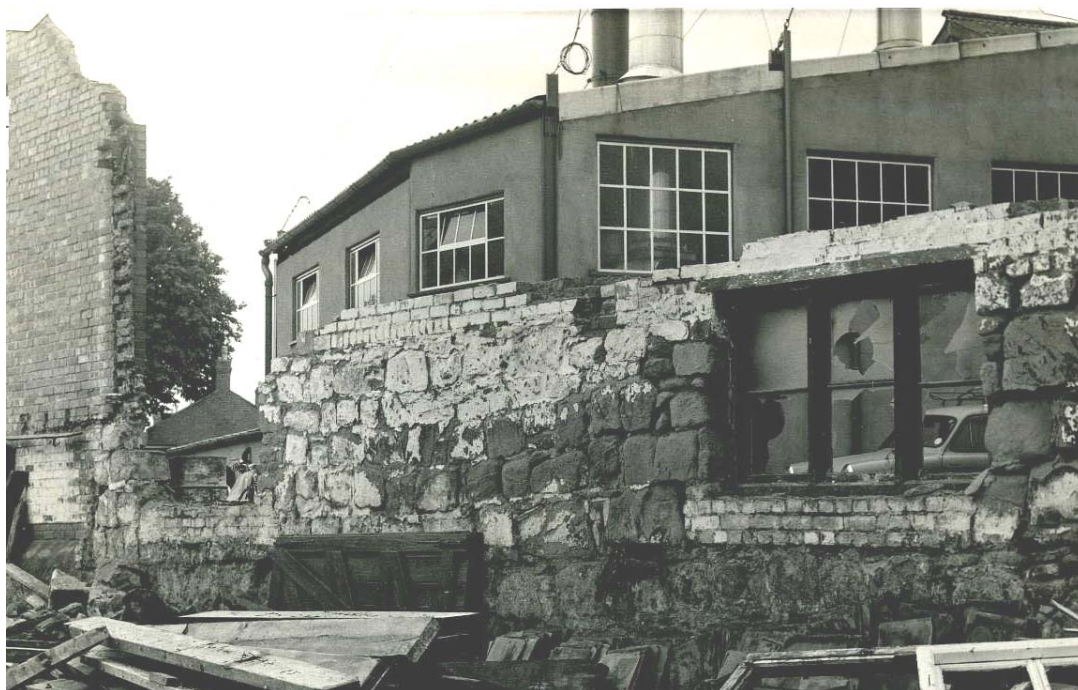
A stretch of the Wall Street wall, with the characteristics of primary city wall masonry, newly exposed by the demolition of buildings on the south side of New Market Street in August 1968 (City Council contract photographs file).

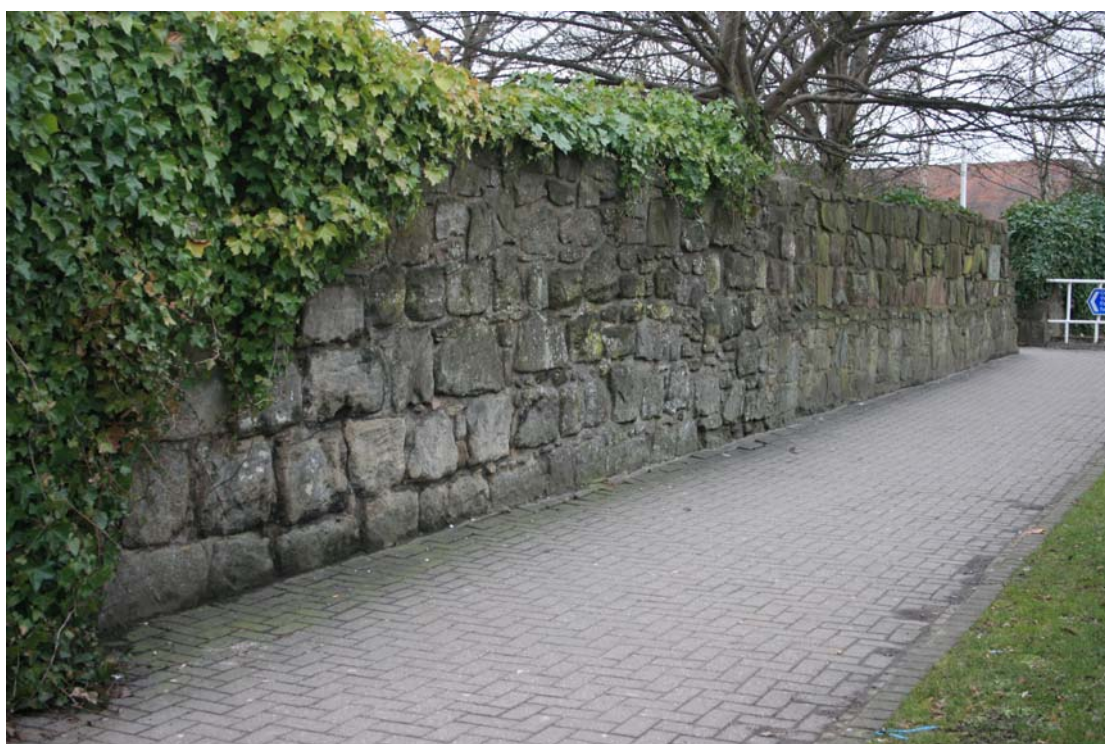
City wall masonry of probable 'primary' character (foreground), possibly as photographed above, to the east of the pedestrian entrance to the Tesco car park

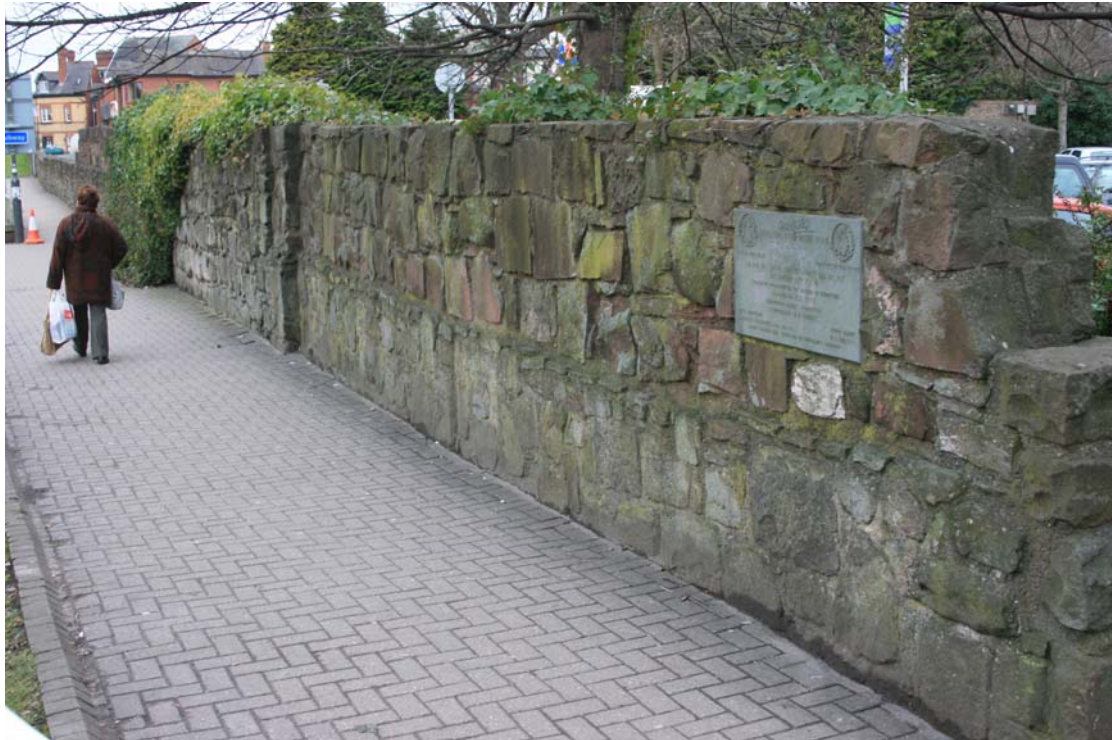
General view of the Wall Street section, looking east. The plaque in the foreground commemorates the opening of the Inner Relief Road in 1969 and, appropriately, is built into a section of 'reproduction' city wall masonry

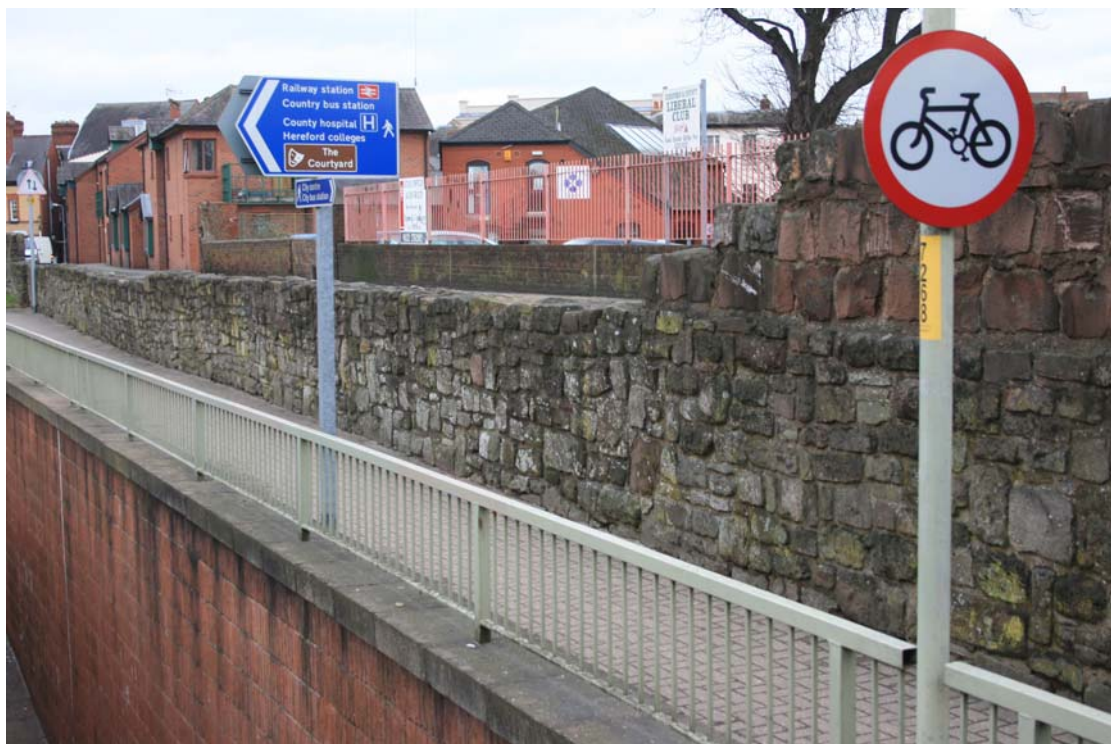
The Wall Street section, reduced in height alongside the pedestrian underpass. The eastern termination of the 'reproduction' masonry is visible

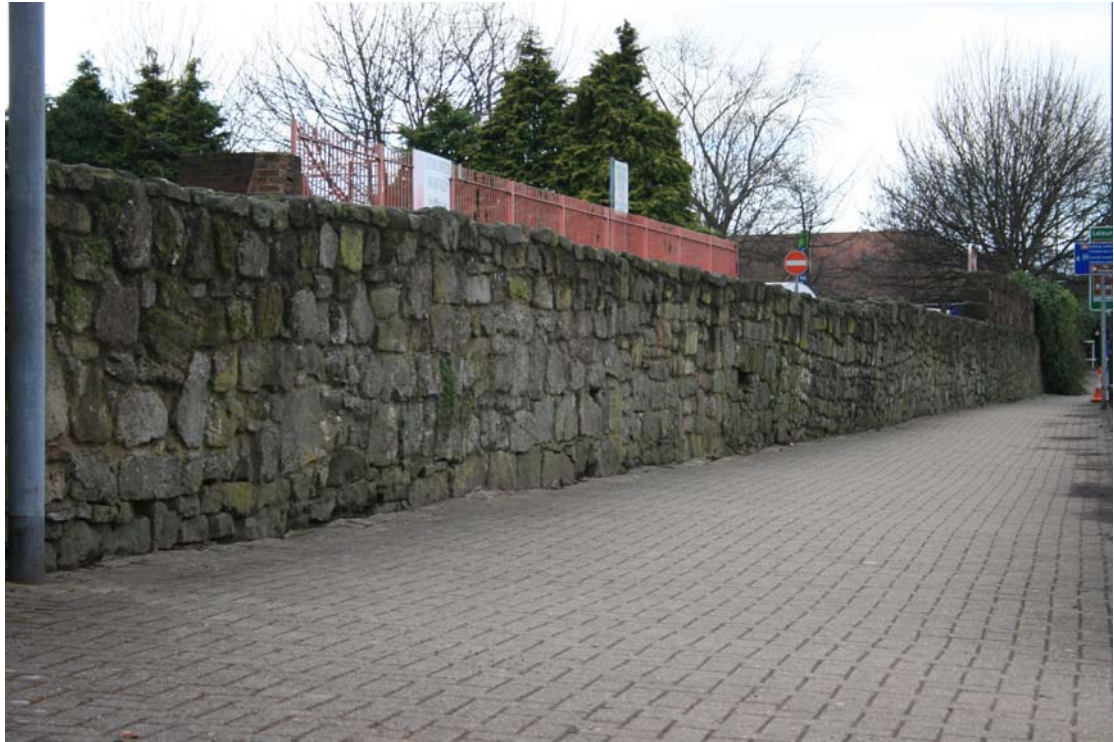
The Wall Street wall looking west alongside the New Market Street pedestrian underpass. The bowing of the courses is apparent. The date of this masonry is unknown but is likely to represent a long history of ad hoc repairs in the post-medieval period; the blocks in the foreground may represent re-set primary facing masonry

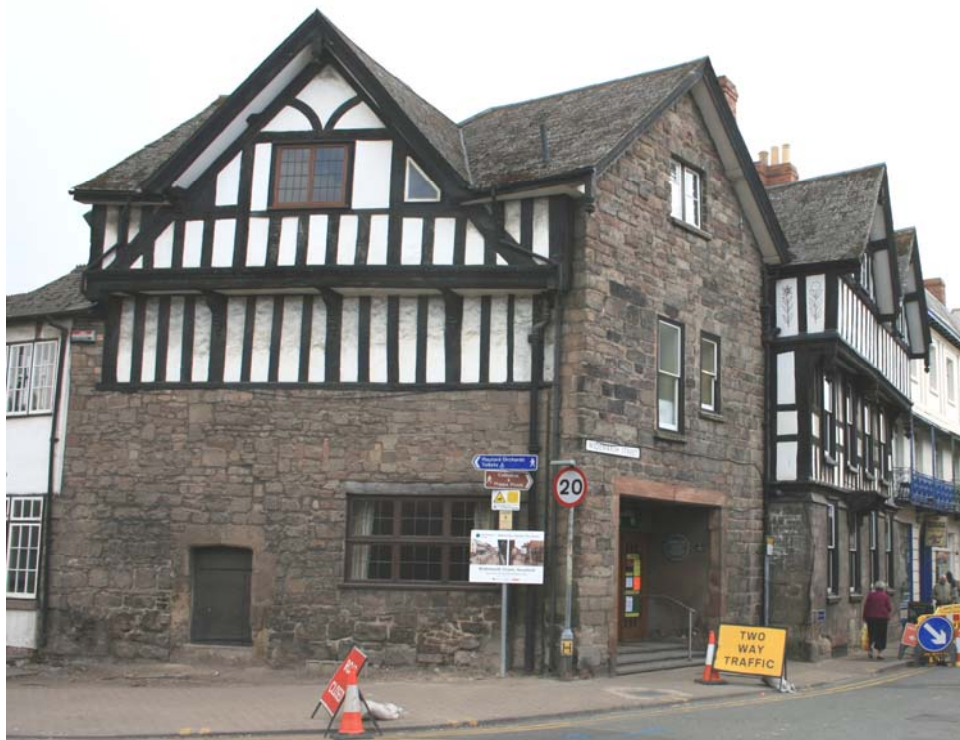
The only standing section of wall is part of the standing (listed) building 42 Widemarsh Street, and is in relatively sound condition. There is no on-site interpretation to indicate the significance of the wall, nor of the former presence of the Widemarsh Gate immediately adjoining.

The Farmers' Club, Widemarsh Street. The lower part of the north elevation (foreground, below window-sill level) contains stonework of characteristic city wall type. The stone gable (right) would have been built to replace the end wall of the medieval Widemarsh Gate on its demolition in 1799

- Provision of an on-site interpretation panel, within an over-arching design framework, on the ground immediately north of the Farmers Club elevation. This area – currently bare earth and uneven – also requires local re-paving. This is a critical nodal point in access between the historic city centre and the ESG regeneration area to the north, and provision for heritage interpretation should be built into any redesign of this crossing.

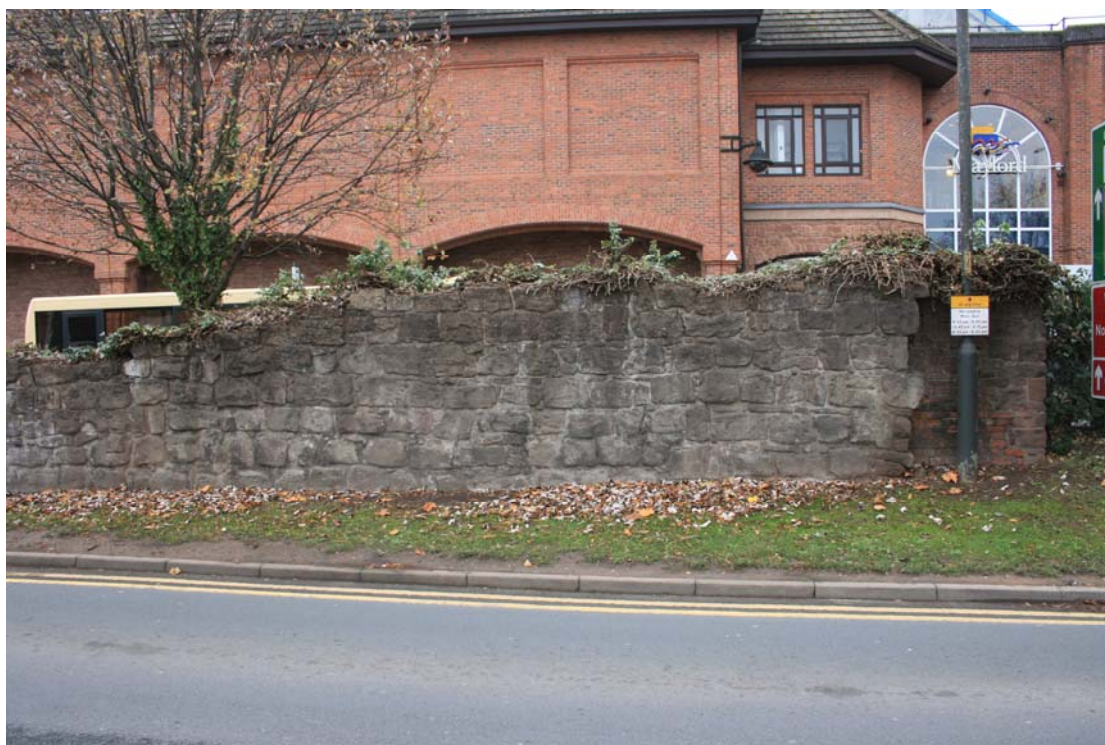
The western end of the Maylord Orchards wall, exterior face

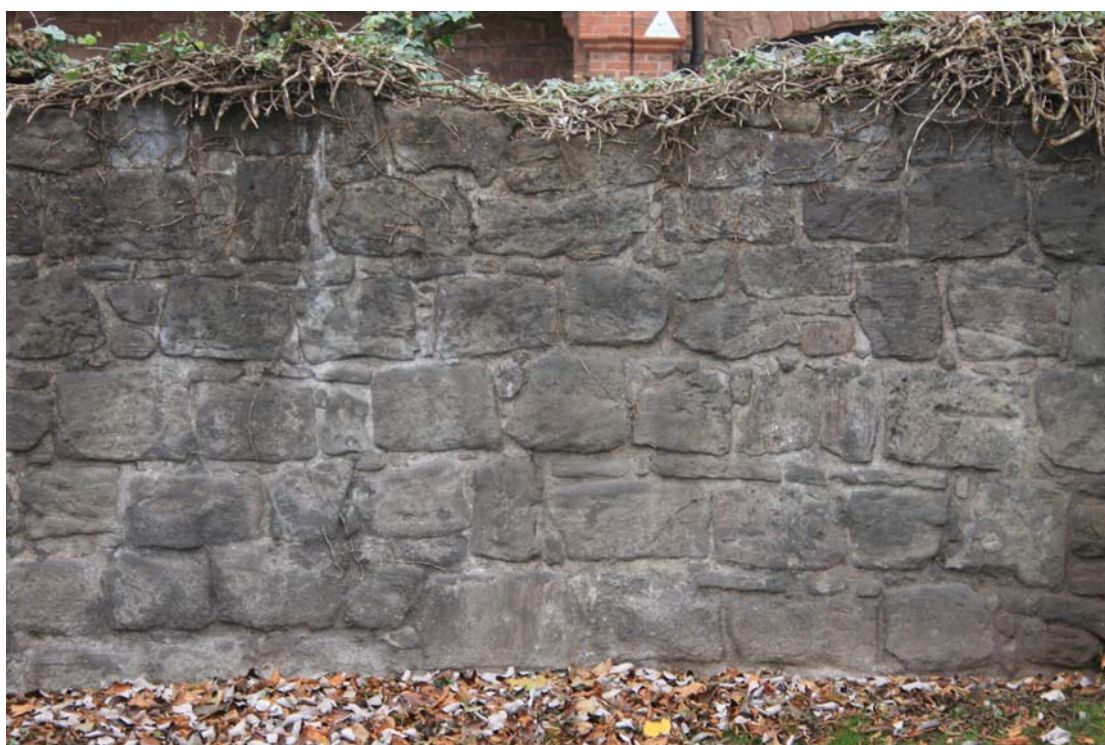
Detail of the probably primary medieval outer-face masonry

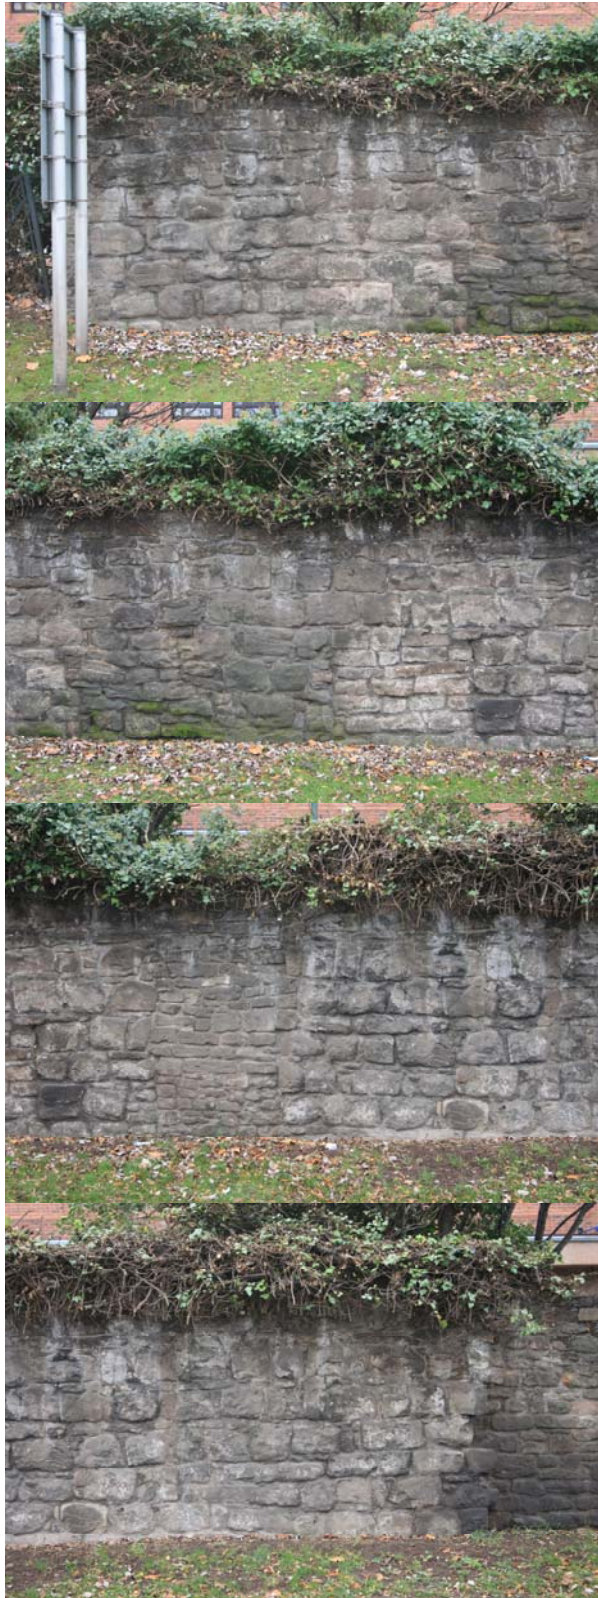
Sequential overlapping photographs of the outer face of the Maylord Orchards wall (western section) showing blocked openings in the primary type masonry. From east (top) to west (bottom). The last change in build shows the beginning of a set-back face, probably a repair in the 'SPAB' tradition

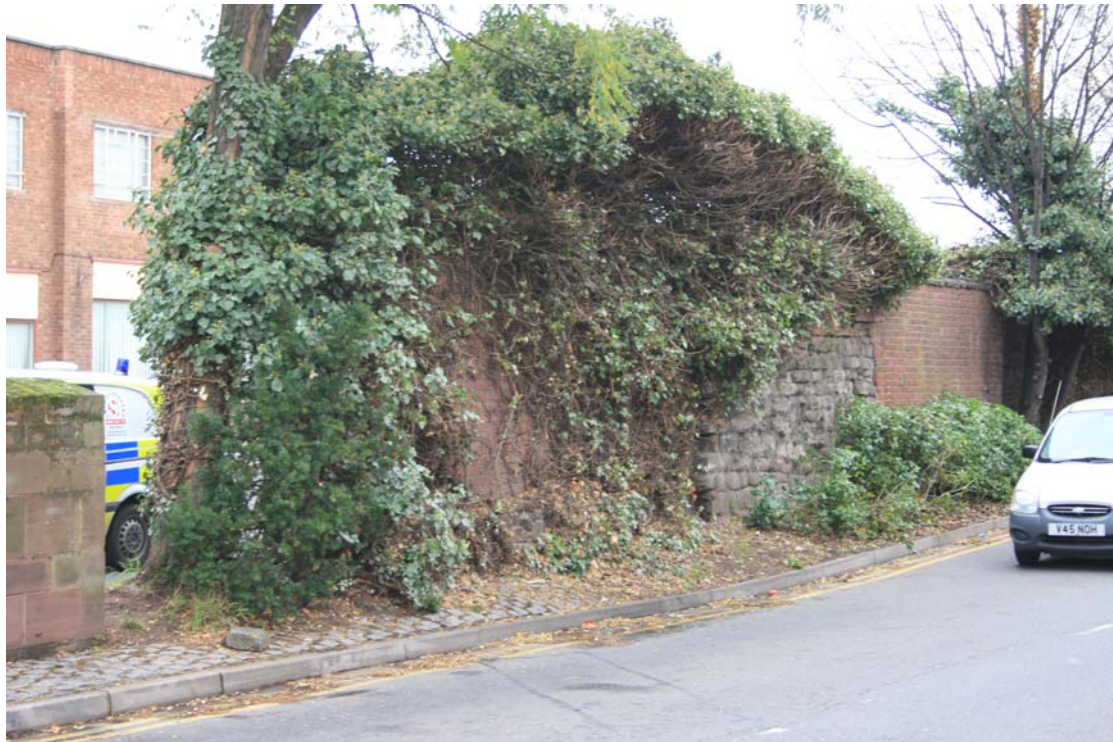
Until the autumn of 2009 this section of wall was so overgrown (mostly by ivy) that it was virtually unrecognisable as a masonry structure. The outer face is currently clear of undergrowth though further work remains to be done on the wall top (western section, east end). There is also an issue with potential root damage into the masonry wall footings and underlying rampart from the mature cherry trees planted along the inner face of the wall, probably contemporary with the completion of the shopping centre c.1986.

The inner face of the Maylord Orchards wall, looking east from the west end (2009). The problem of ivy, tree growth and the close proximity of traffic to the wall face is apparent

- A re-design of the setting of this section of the wall should take place in the context of any downgrading and re-design of the inner relief road (Blue School Street). An improved setting for the wall would highlight (literally and figuratively) rather than detract from its significance. On-site interpretation should be placed in conjunction with any new pedestrian routes passing through this area.

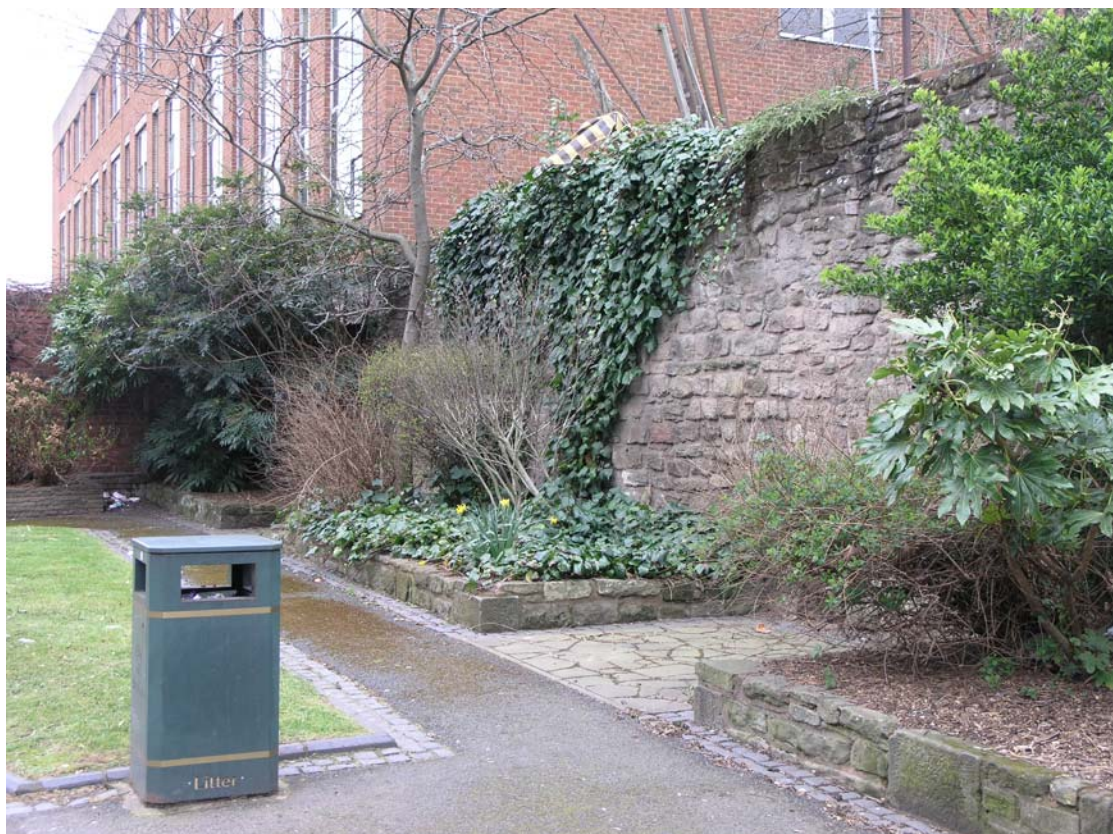
- The proposed downgrading of the Inner Relief Road offers a great opportunity for the improvement of the setting of the wall. A critical step in the process would be the removal of the electricity sub-station (which shows signs of subsidence cracks over the infilled city ditch).

The Bastion Mews wall, east end, looking east towards the Police Station. The electricity sub-station (overgrown wall, left) interrupts the view of the wall and disguises its continuity from Bastion Mews eastwards

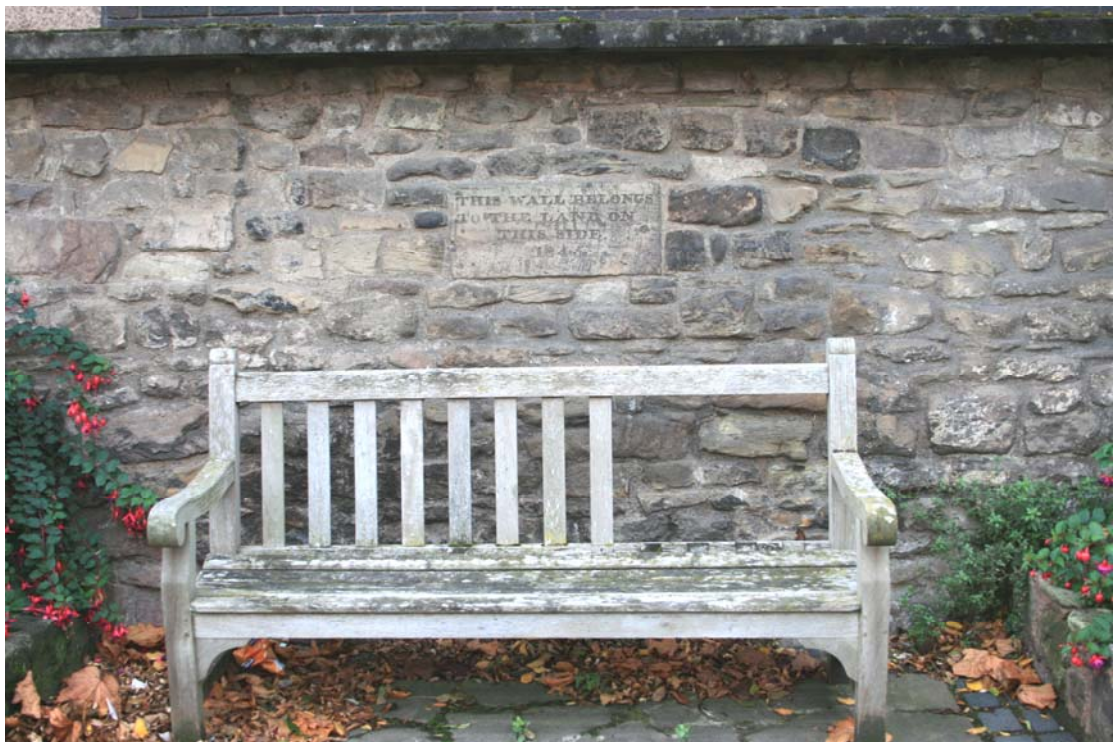
The (rebuilt) wall in front of the Bath Street Police Station. The plaque reads 'This wall belongs to the land on this side [ie the former ditch] 1845'

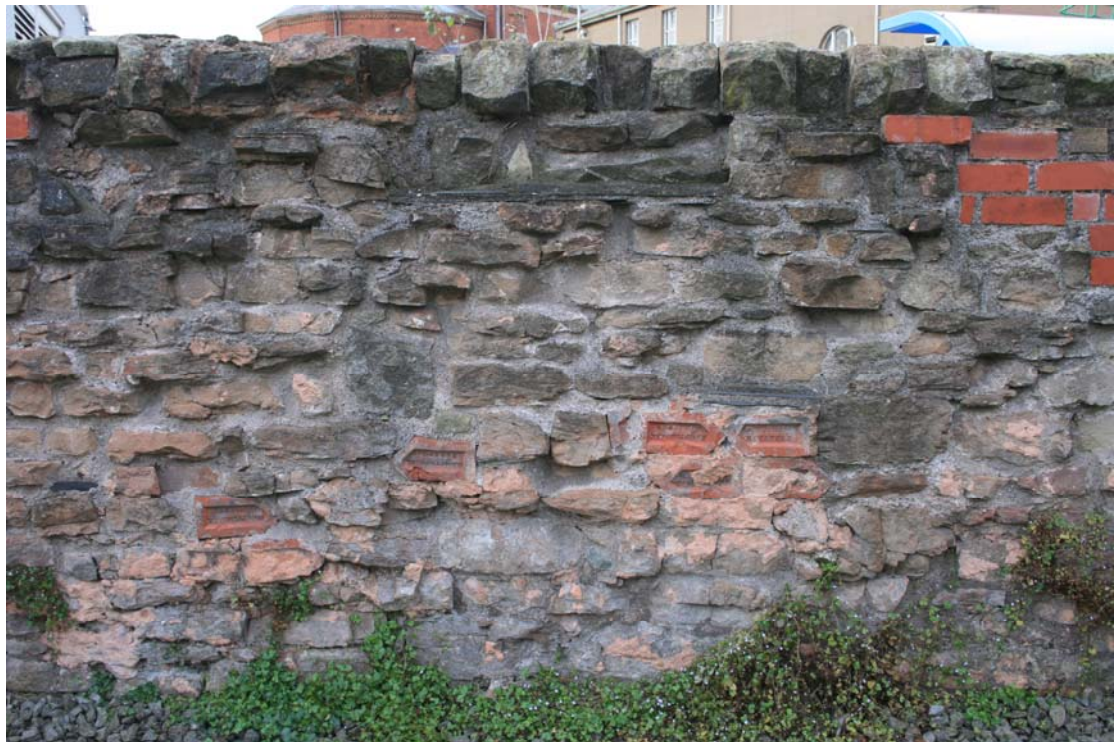
The present condition of the lengths of wall comprising this section is generally good, though the easternmost length – the car-park boundary wall – is in an eroded state and in need of re-pointing.

Detail of the rebuilt wall section making extensive use of 19th-century brick at the rear of the car-park east of the Bath Street Police Station

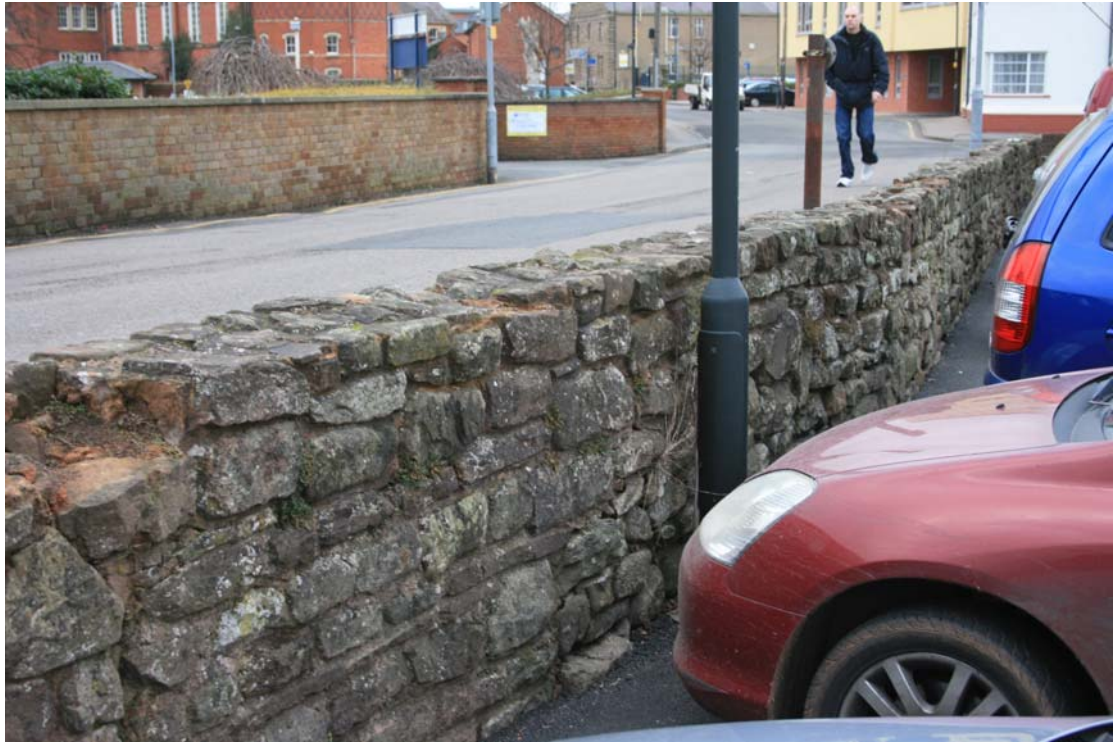
The wall here is in fair condition: there is some ivy growth on the exposed face and a need for re-pointing in some areas. The principal issue here is a lack of interpretation: there is no clue that this low retaining wall is part of the city wall circuit, leaving it more vulnerable than it would be were its significance to be more easily apparent.

The Gaol Street/Bath Street car park wall, looking west (above), east (below). The wall beyond the lamp-post (above) is entirely modern; in front of the lamp-post the more regularly coursed masonry picks up the line of the medieval city wall. Gaol Street behind is at a higher (rampart-top) level than the car park (in the ditch)

- Provision of on-site interpretation to draw attention to the existence of the wall
- Provide for sympathetic rebuilding of the wall following the city wall line in any future redevelopment by means of a design or development brief (long-term)

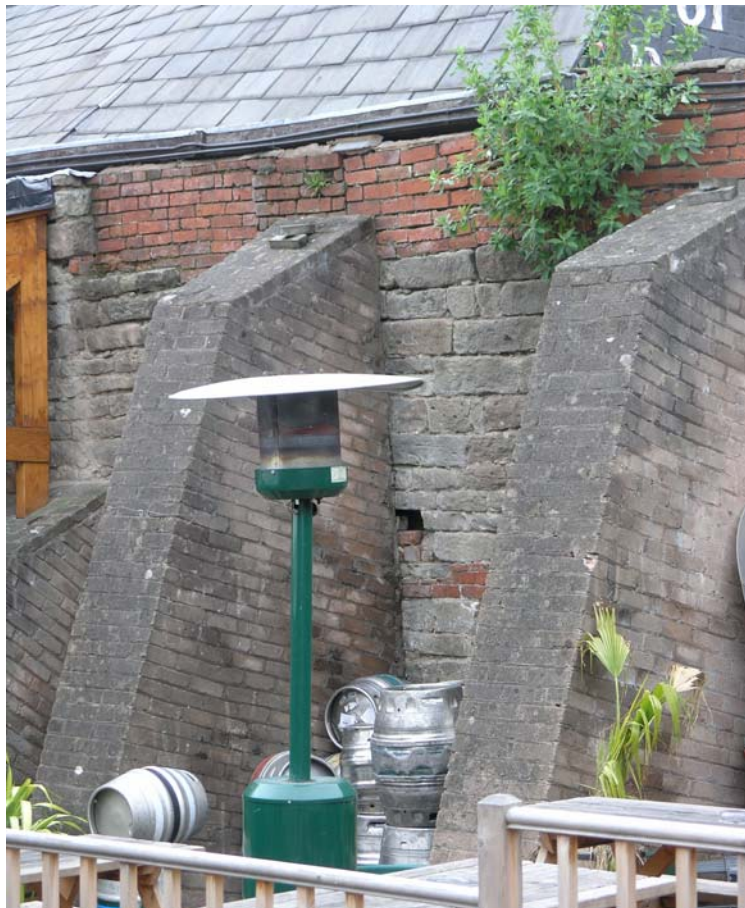
The exposed sections of city wall either side of St Owen's Street are in generally sound condition and are maintained as they form components of party walls between adjacent properties. The substantial outward lean (about 300mm out of plumb in a wall of c.3m height) of the wall in the Barrels yard appears to have been stabilised by the buttresses, though these are most unattractive and are substantial enough to obscure much of the monument. More sympathetic and less obtrusive buttressing would improve the monument and its immediate setting.

The city wall (outer face) in the yard at the rear of the Barrels pub on St Owen Street (2008). The extreme modern buttressing hides much of the unique masonry of this section

- Installation of on-site interpretation relating to the former St Owen's Gate as part of a city-wide scheme.
- Encouragement of the Barrels' owner to install improved, less intrusive buttressing

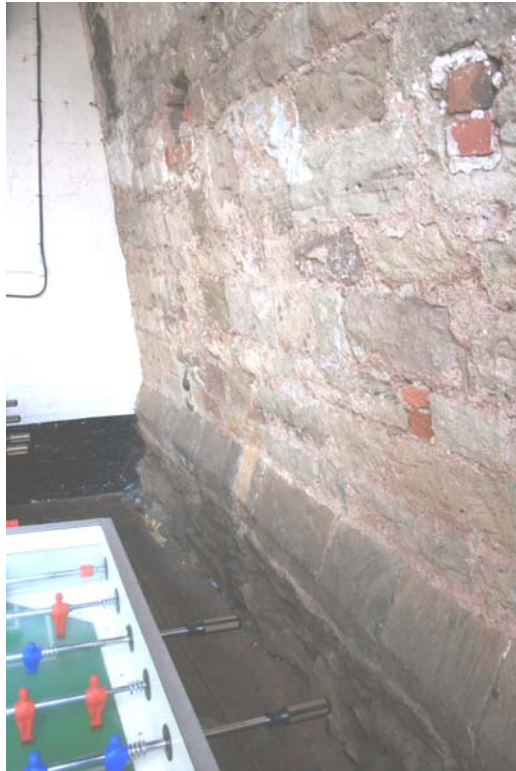
Detail of the wall in the Barrels, showing the extreme outward lean and the chamfered ashlar plinth with foundation courses below

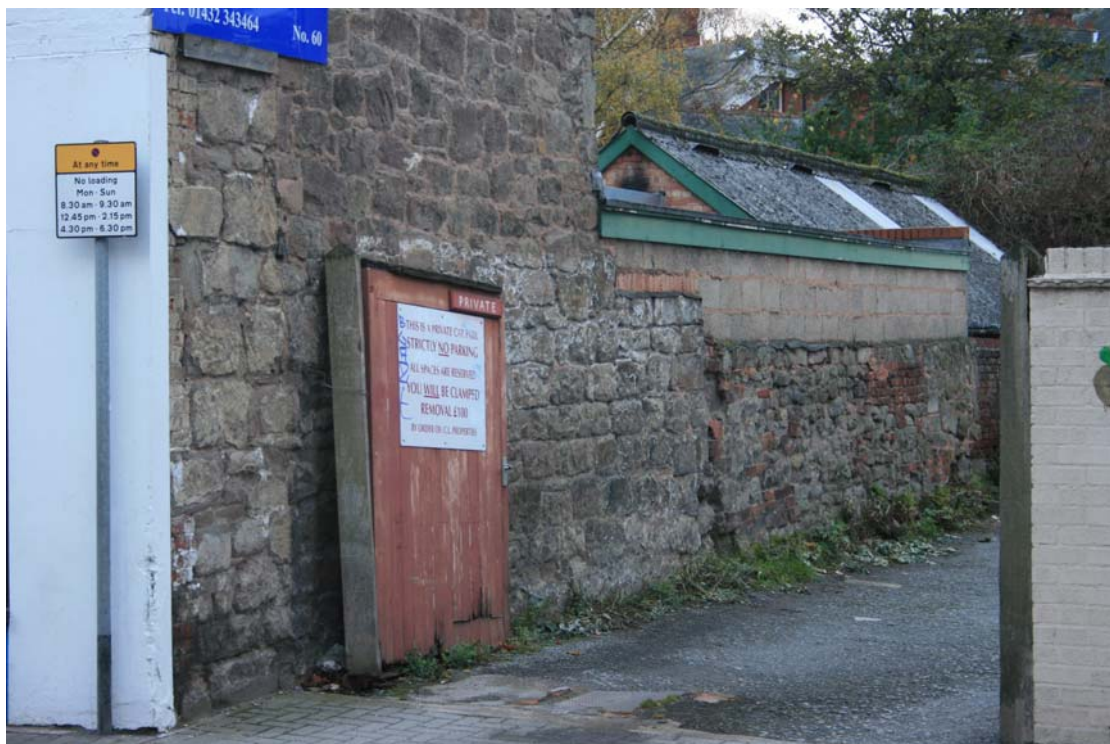
The city wall (inner face) on the south side of St Owen Street. There are clear differences between the ? primary masonry at ground-floor level, the upper floor of the frontage building, and the garden wall to the rear on the city wall line

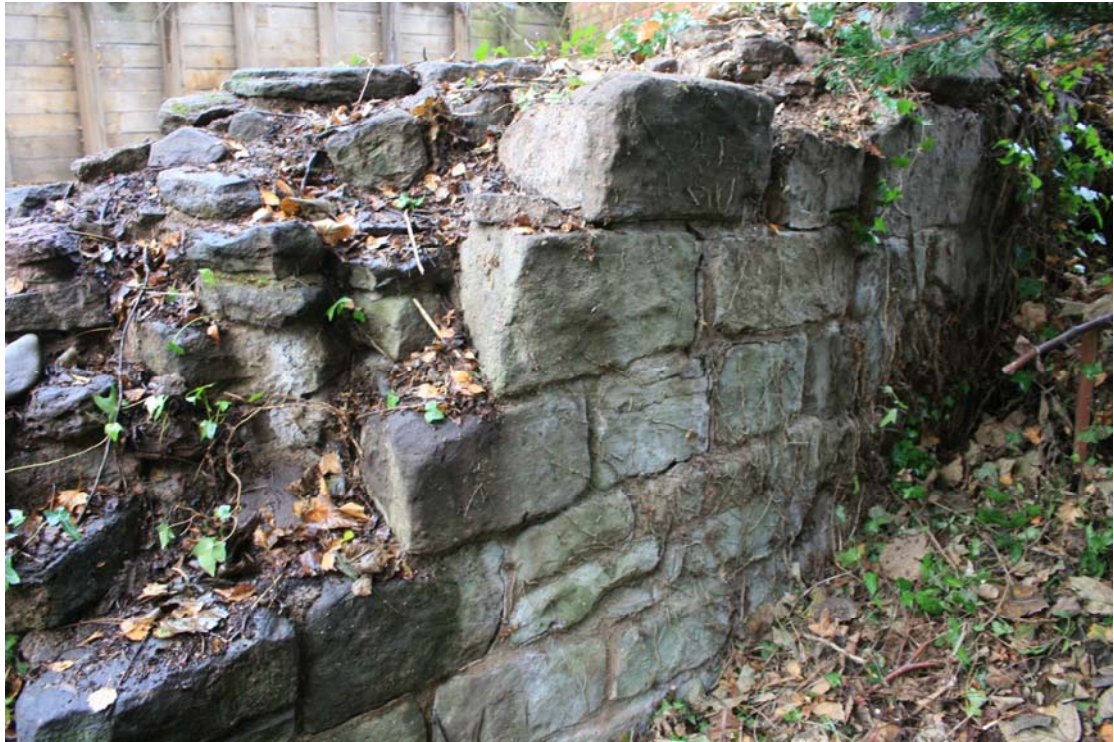
The city wall to the north of the entrance to the Cantilupe Street excavation. Excavation showed the face in this area to have been substantially rebuilt, possibly in the Civil War

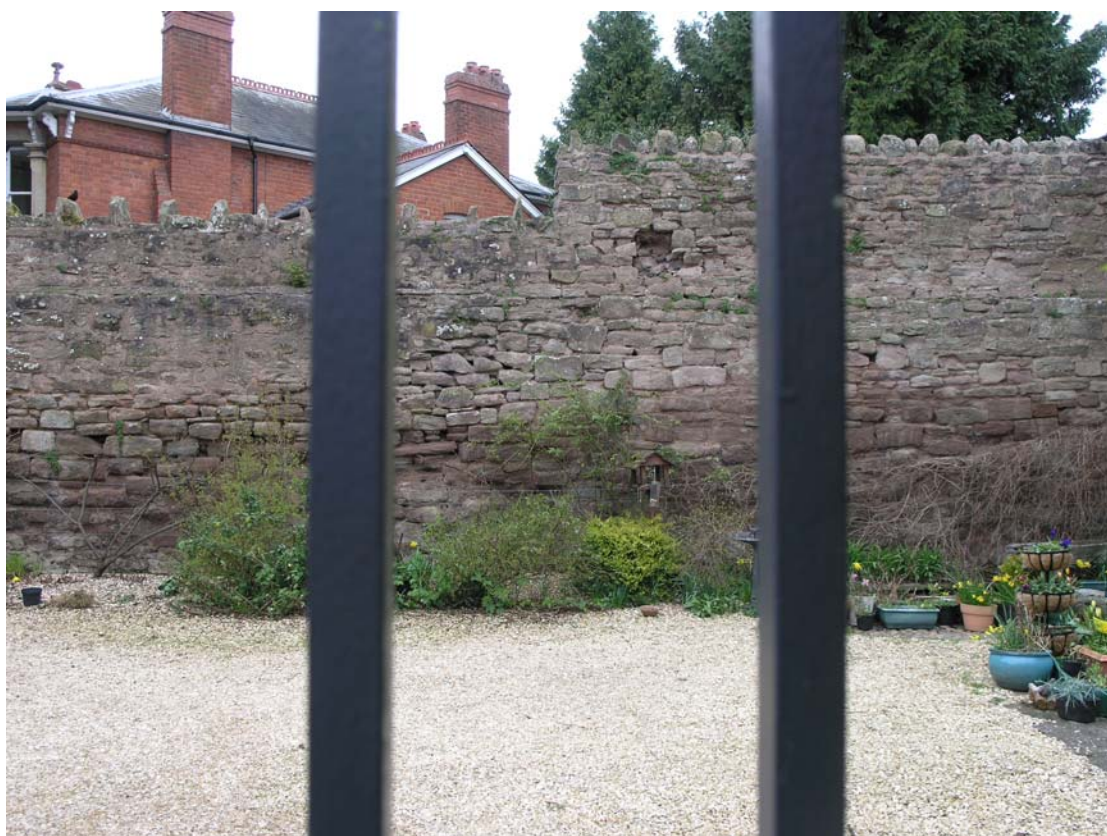
The wall in the garden of 14 Mill Street. The offset ledge marks the transition from the retaining wall to the garden wall on top. The condition of the wall in terms of missing and eroded stones, voids and lack of pointing is evident

- Develop signage/guides to raise awareness of and direct visitors towards the Cantilupe Street excavation site.
- Encourage/facilitate repairs to the city wall standing in the garden of 14 Mill Street.
- Encourage/facilitate the clearance of debris from and necessary repairs to the city wall in the back garden of 66 St Owen Street
