‘The Dinedor Origins Project’

**Site of Medieval Village, Dinedor: An Archaeological
Field Survey.**

Herefordshire Archaeology Report No. 327

April 2013

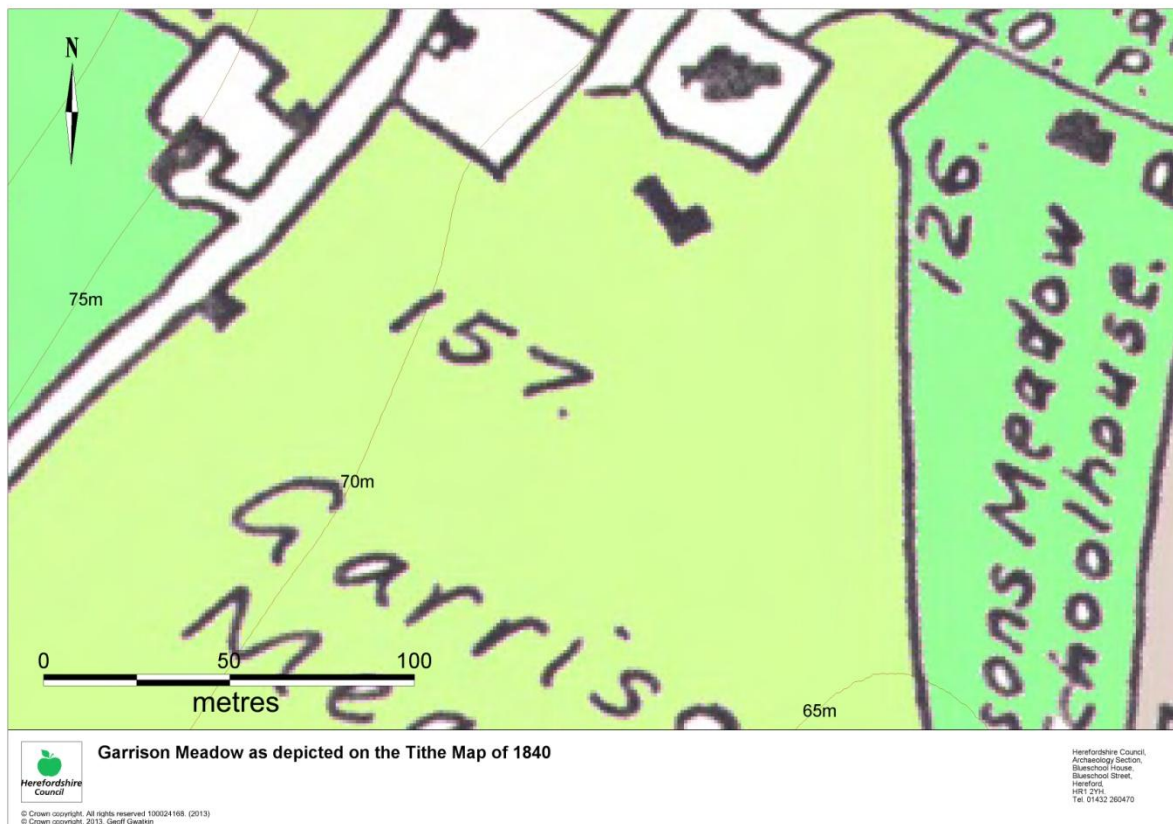
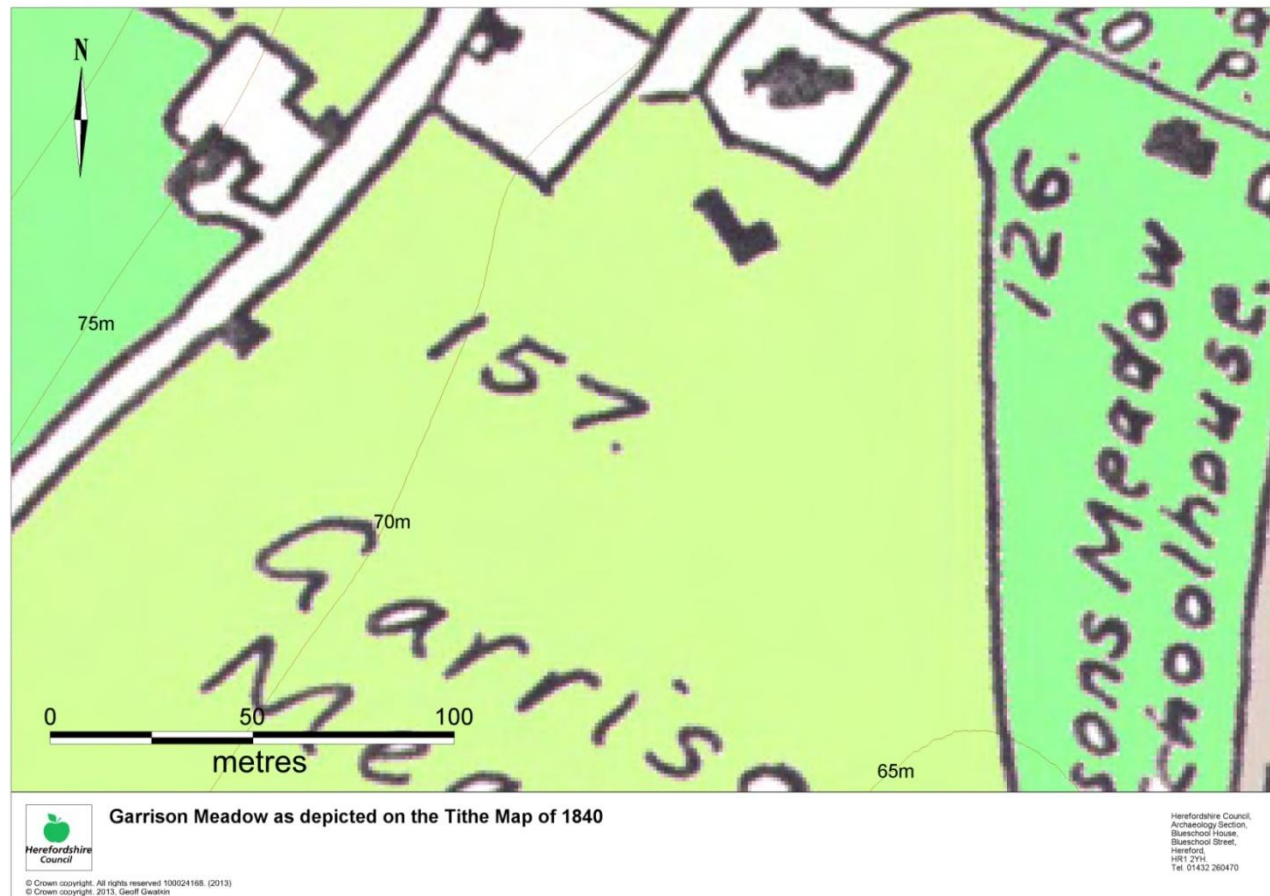
Figure 2: Survey area as depicted at the time of the 1840 Tithe Survey. © Crown copyright (2013). All rights reserved 100024168.

The earliest detailed map resource of the scheduled monument (HE224) was in the form of the 1840 Tithe Map (figure 2). The survey in association with its annotation, notes the site to have been under pasture at this date. The survey also notes the location of two structures within the immediate vicinity of the now scheduled area, the first is a small rectangular structure along the roadside and the second is a larger structure identified as '*The Garrison*' to the south of the churchyard. Following on from the publication of the Tithe maps both structures had been removed as evident from the First County Series Survey published between 1843 and 1893 (figure 3). This map also marks the locations of a number of mature trees which are now absent from the field. It is possible the location of the trees represent the location of earlier field divisions. By this date the field had been enclosed to represent its current extent.

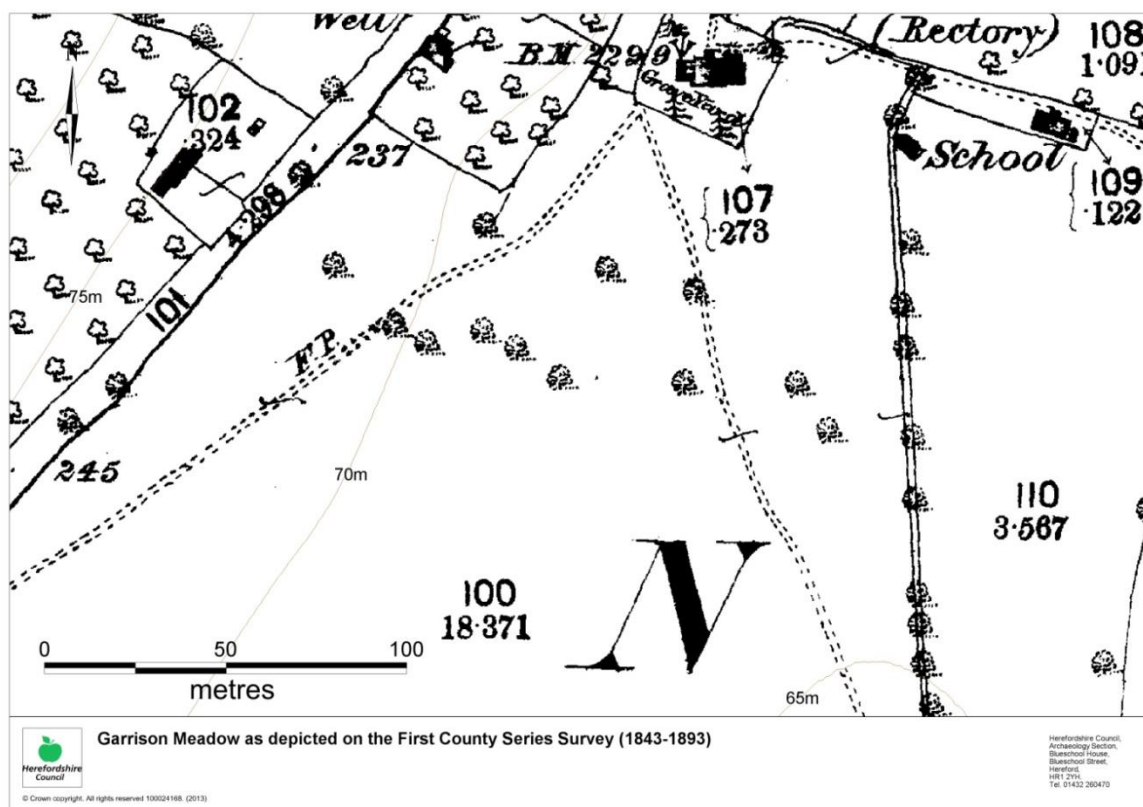
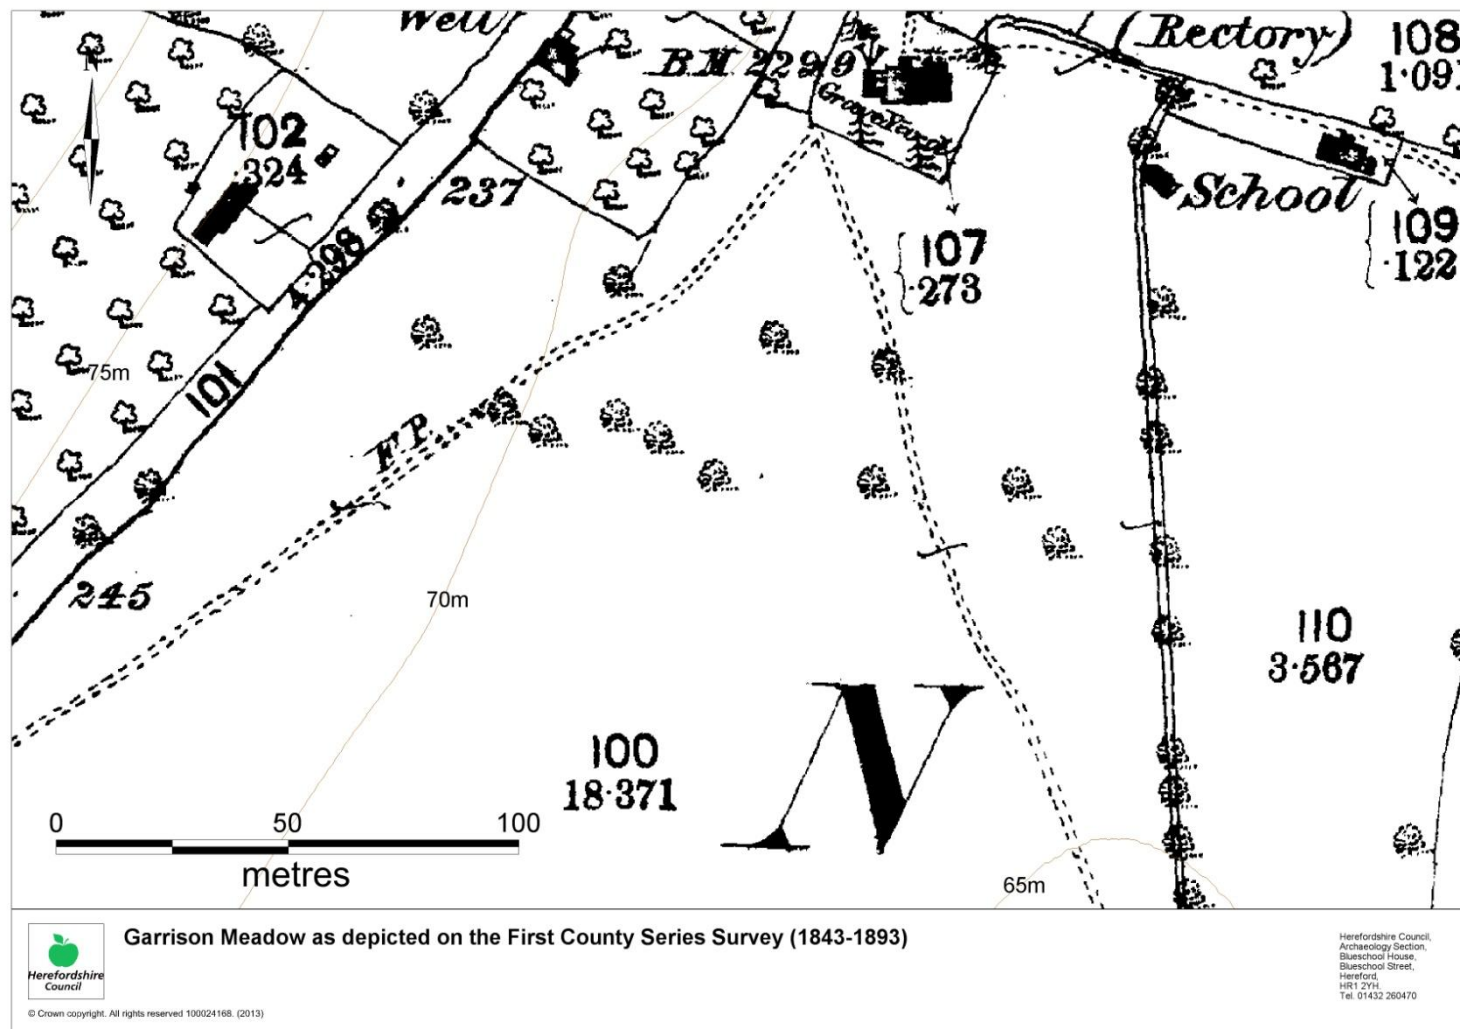
Figure 3: Area of investigation at the time of the First County Series (1843-1893). © Crown copyright (2013). All rights reserved 100024168.

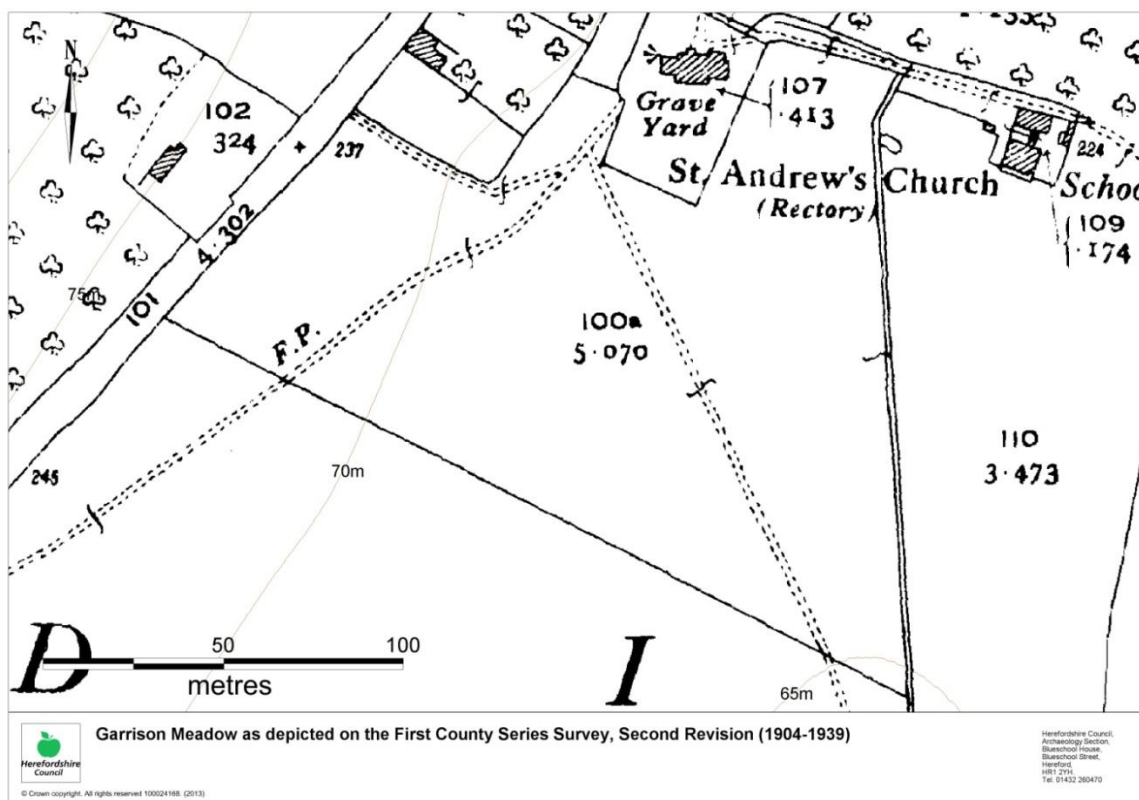
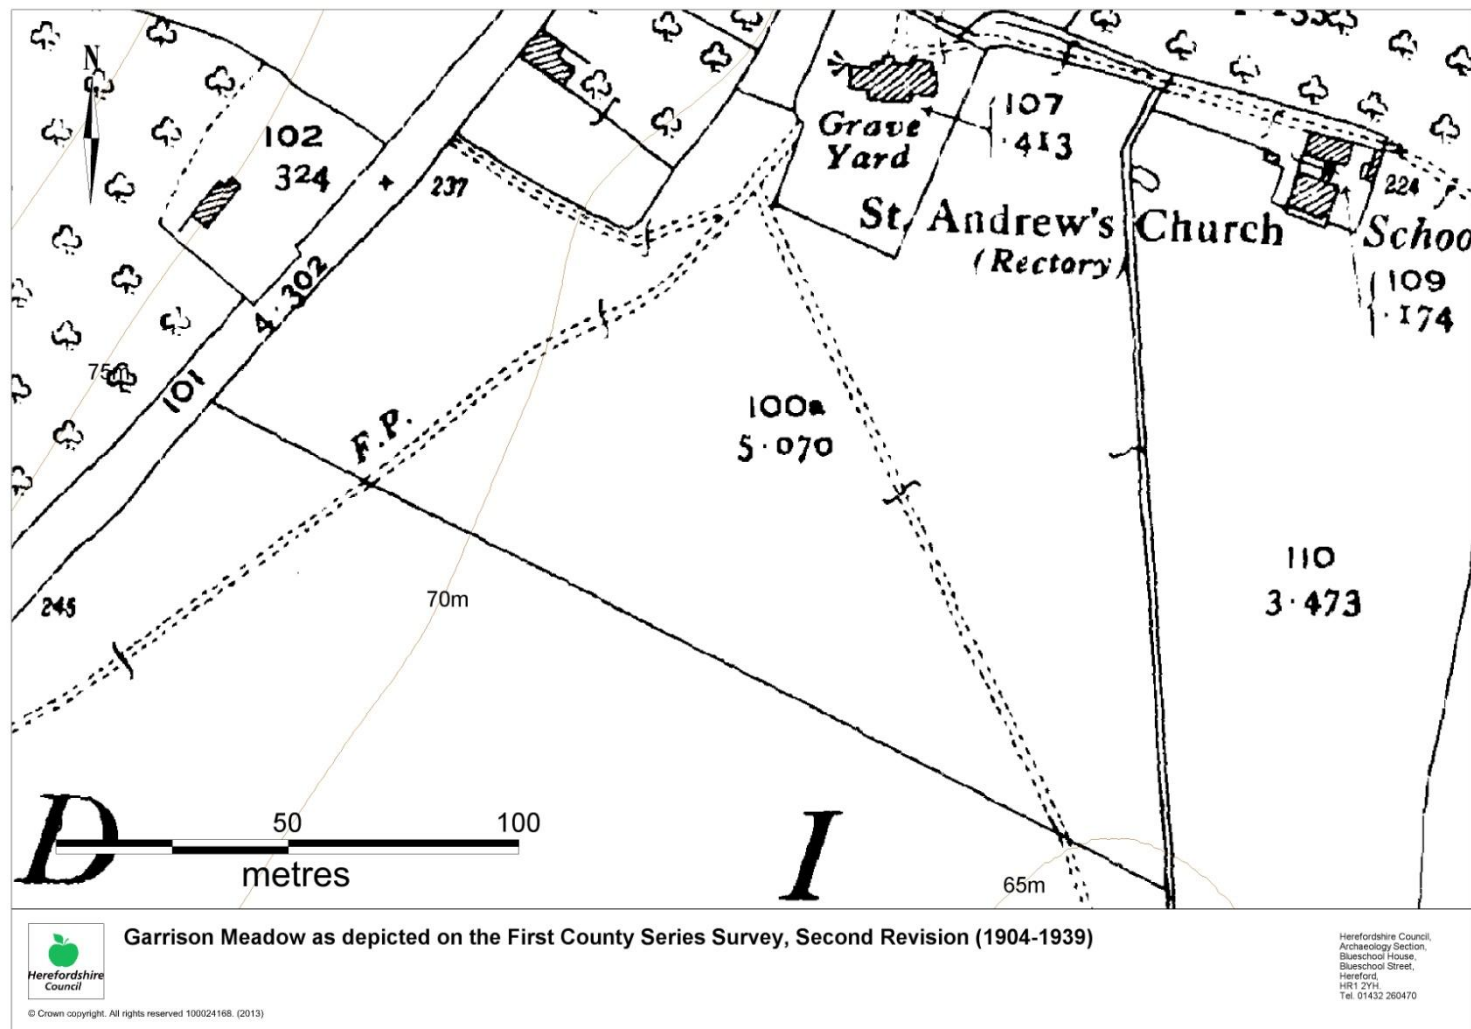
Figure 4: Area of investigation at the time of the First County Series, 2nd Revision (1904-1939). © Crown copyright (2013). All rights reserved 100024168.

At the time of the First County Series, Second Revision (1904-1939) Survey (figure 4) the trees identified on the earlier survey had either been removed or omitted from the survey. It is also clear that by this date the churchyard had been extended to the south where it infringes on the site of '*The Garrison*'.

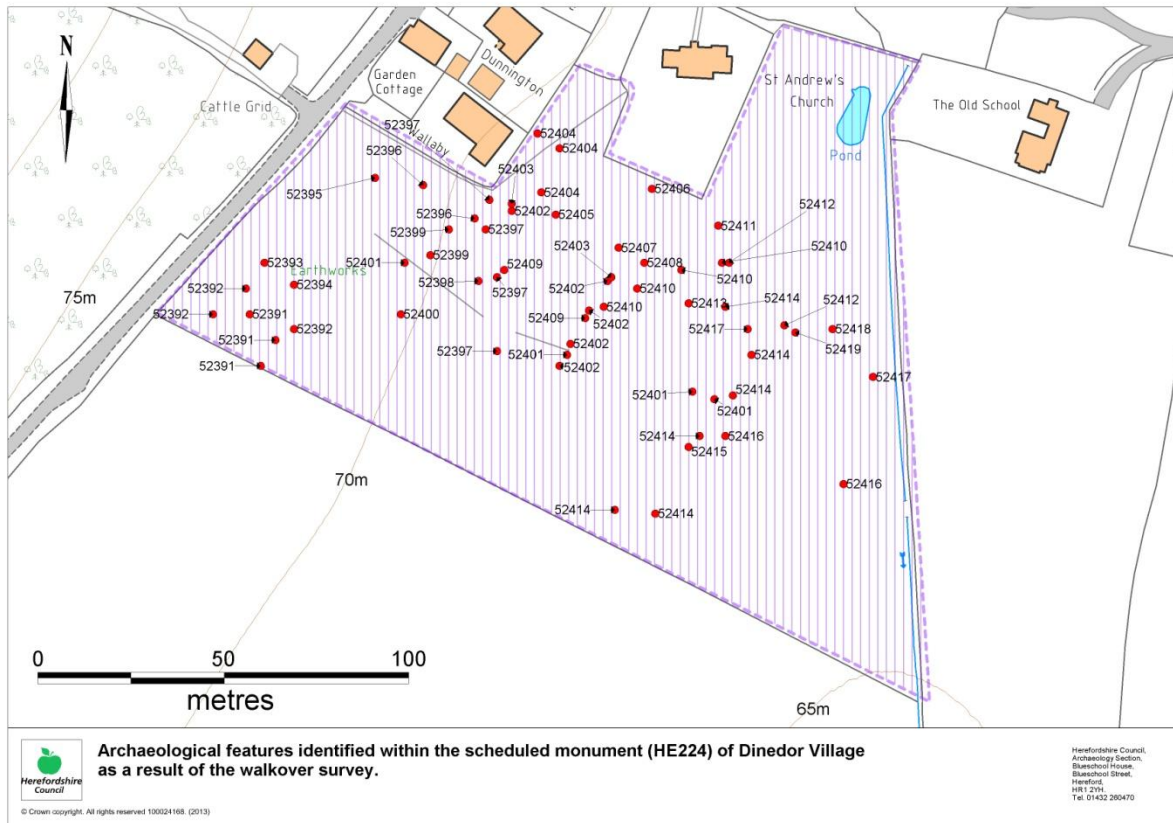
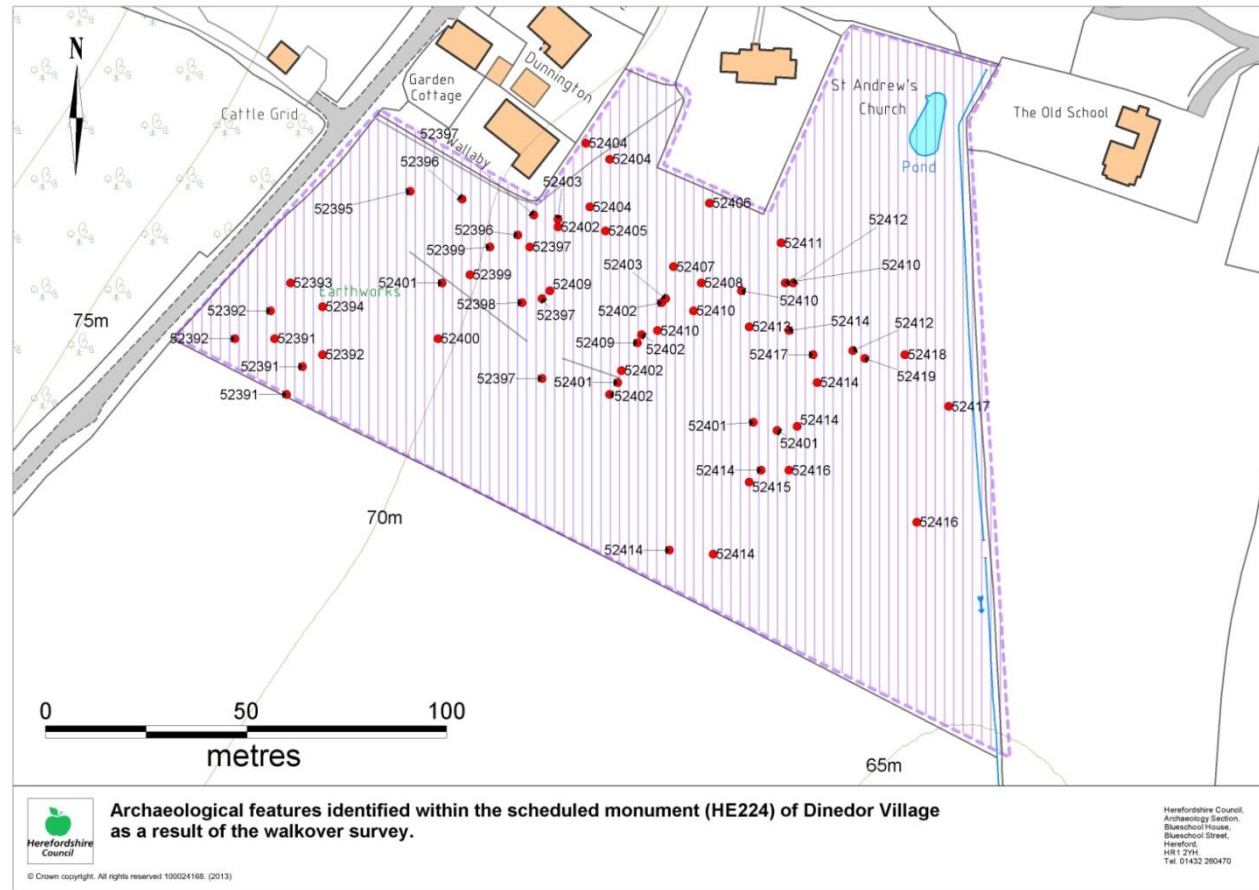
Figure 5: Location of archaeological features identified as a result of the walkover survey. © Crown copyright (2013). All rights reserved 100024168.

A total of 29 new Historic Environment Records (HER) (Appendix 1) were produced as a result of the walkover survey (figure 5), the majority of which relate to features indicative of land divisions (*HER 52391, 52398, 52399, 52402, 52412, 52414, 52416, 52417*). A possible six platforms were identified (*HER 52393, 52394, 52400, 52406, 52407, 52408*), four of which are clustered immediately south of the churchyard. A small network of possible holloways (*HER 52392, 52396, 52397, 52410*) were also recorded.

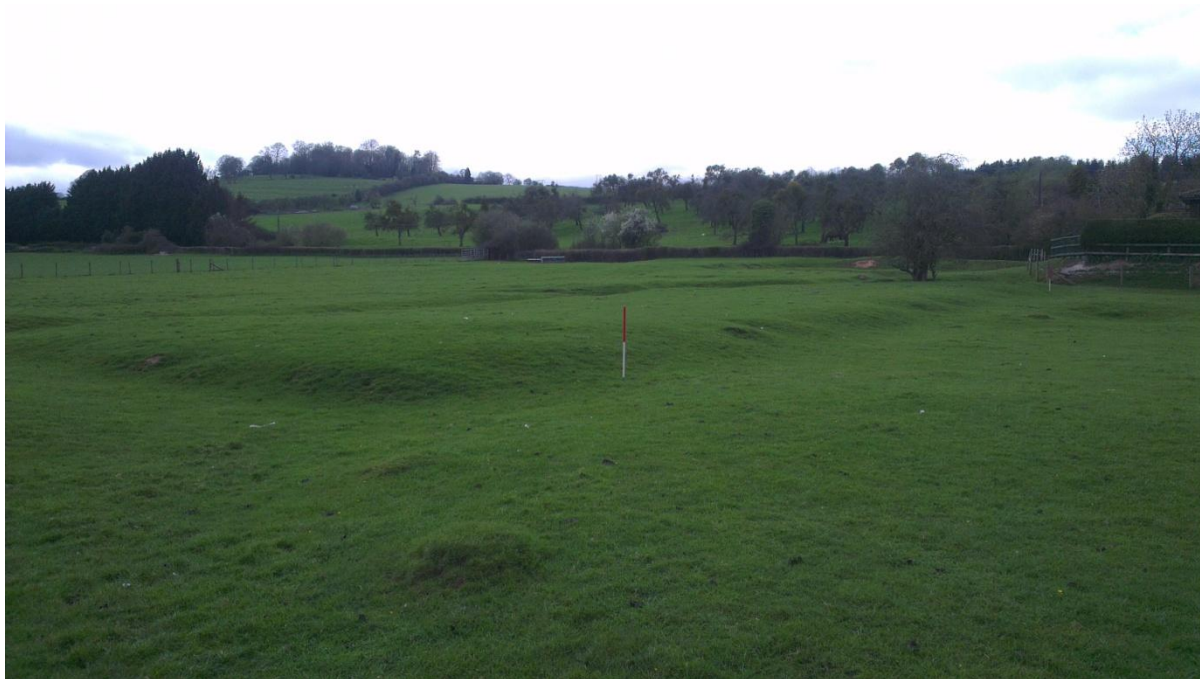
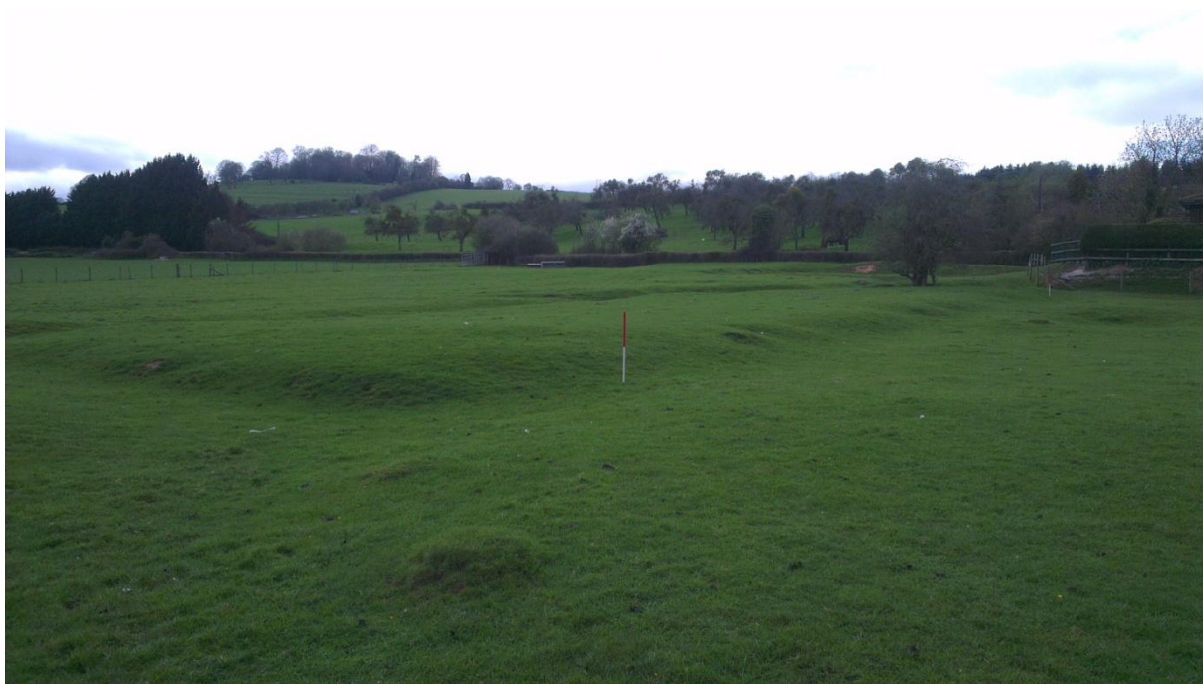
40m to the west of relict boundary (*HER 52414*), a parallel boundary (*HER 52402*) in the form of a terrace with southeast-facing steep slopes and sharp angled summit stands. Due to similarities in form it is possible the two features (*HER 42402, 52414*) are contemporary in construction. To the southwest the terrace gradually peters-out whereas to the northeast the boundary forms a right-angle to enclose the northern extent of the relict field. The terrace continues until it is truncated by the course of a possible holloway/water channel (*HER 52397*); beyond which any evidence for the terraces continuation has been removed by modern landscaping.

Plate 5: Relict boundary (HER 52402) viewed from the northeast. © Herefordshire Archaeology.

Plate 5: Relict boundary (HER 52402) viewed from the northeast. © Herefordshire Archaeology

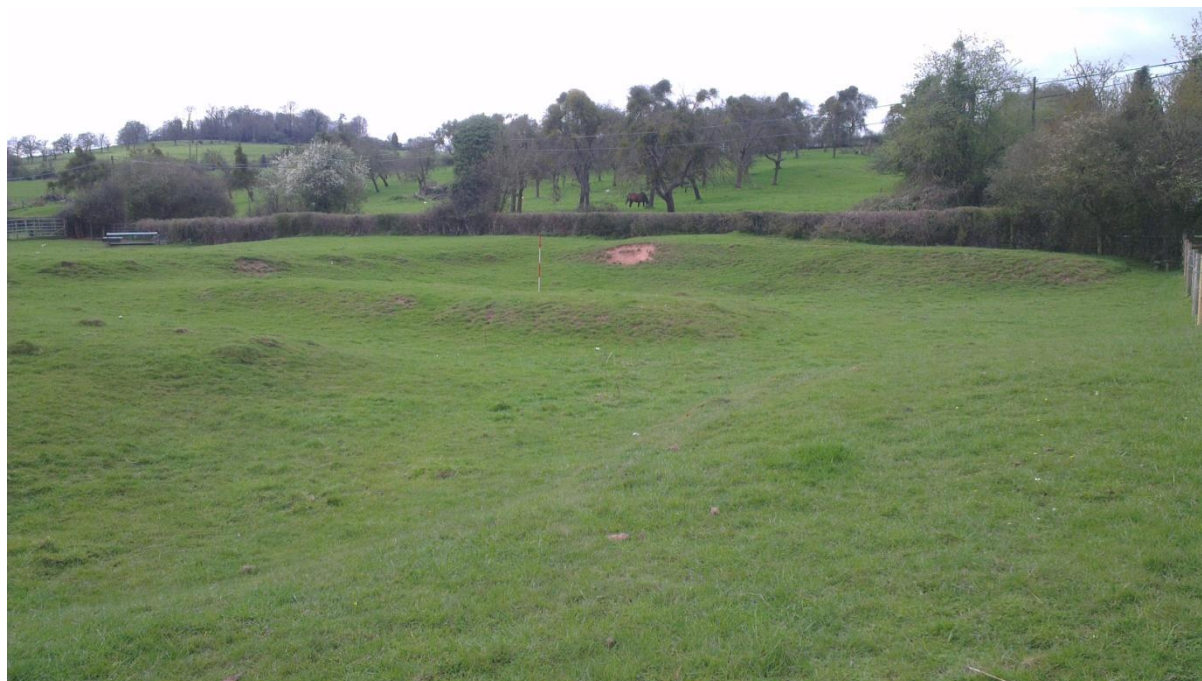
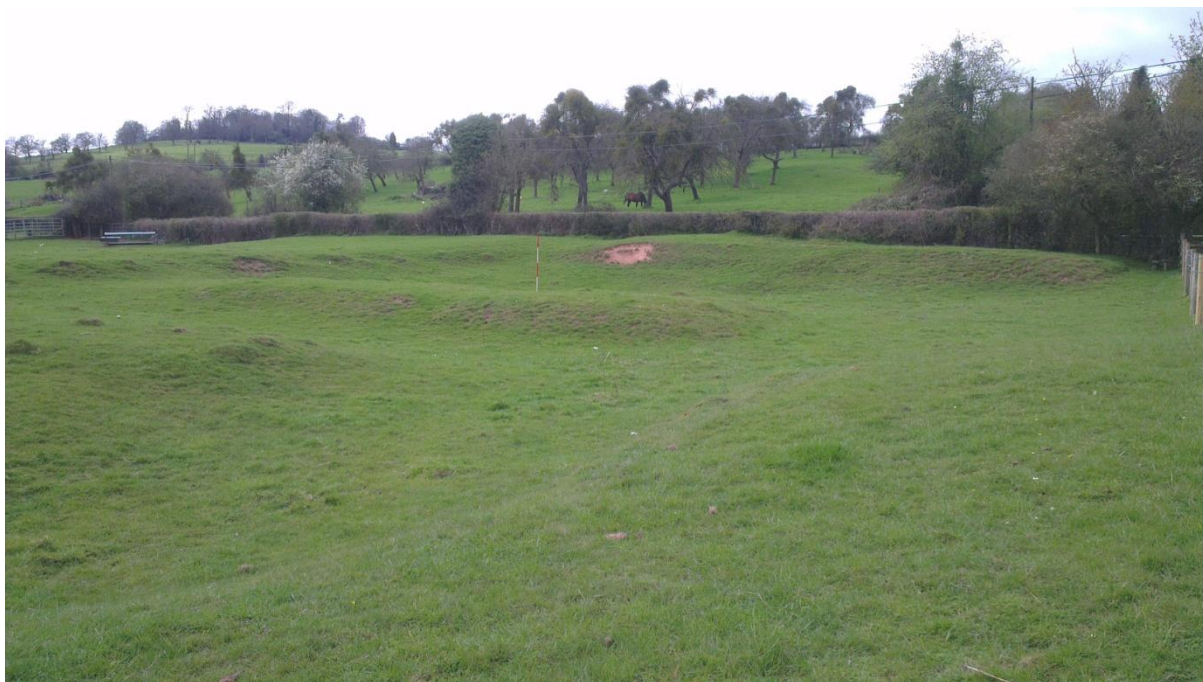
Within the northwest corner of the site, adjacent to the road is a substantial sub-rectangular hollow (*HER 52395*) with a broad prominent bank dividing the hollow in two on a north-northeast by south-southwest alignment. The hollow measures approximately 24m wide northwest-southeast by c.25m long northeast-southwest. The hollow is up to 1.9m deep however its northern extent has been truncated by modern landscaping. Access to the hollow appears to have been from the east by means of a holloway (*HER 52396*) that links with the holloway/water channel (*HER*

52397). The hollow (*HER 52395*) is likely to represent a disused quarry, excavated as a means of extracting the underlying sands and gravels for construction purposes.

Plate 11: Possible quarry site (*HER 52395*) viewed from the northeast. © Herefordshire Archaeology.

Plate 11: Possible quarry site (HER 52395) viewed from the northeast. © Herefordshire Archaeology

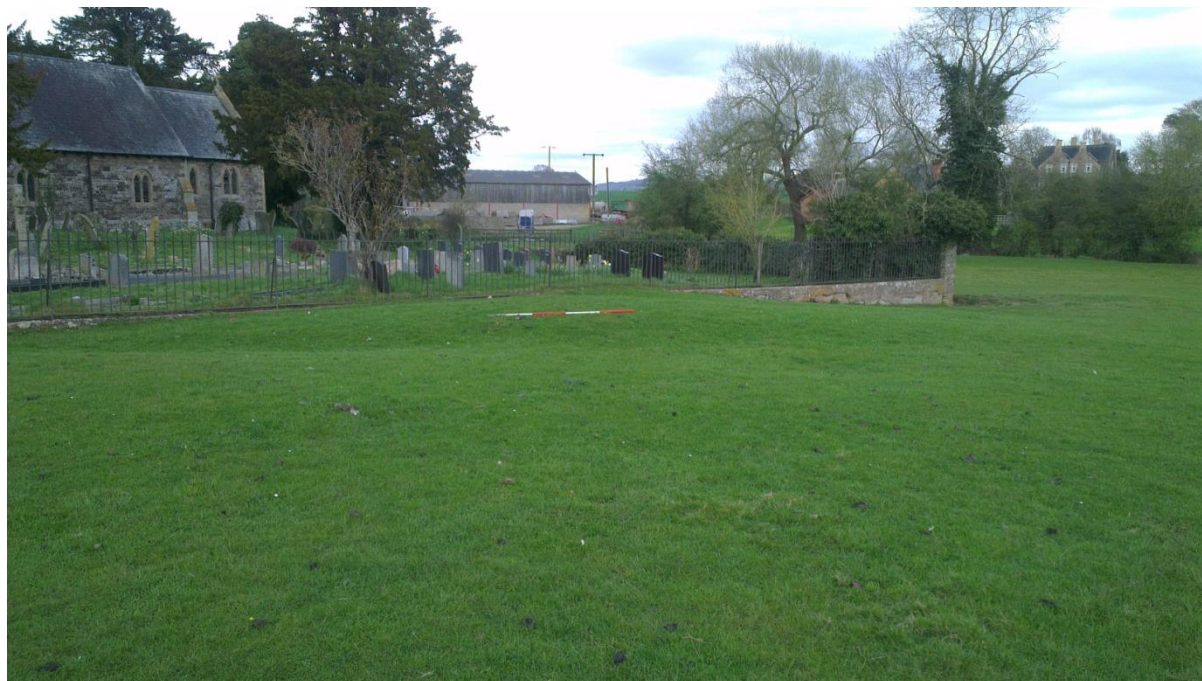
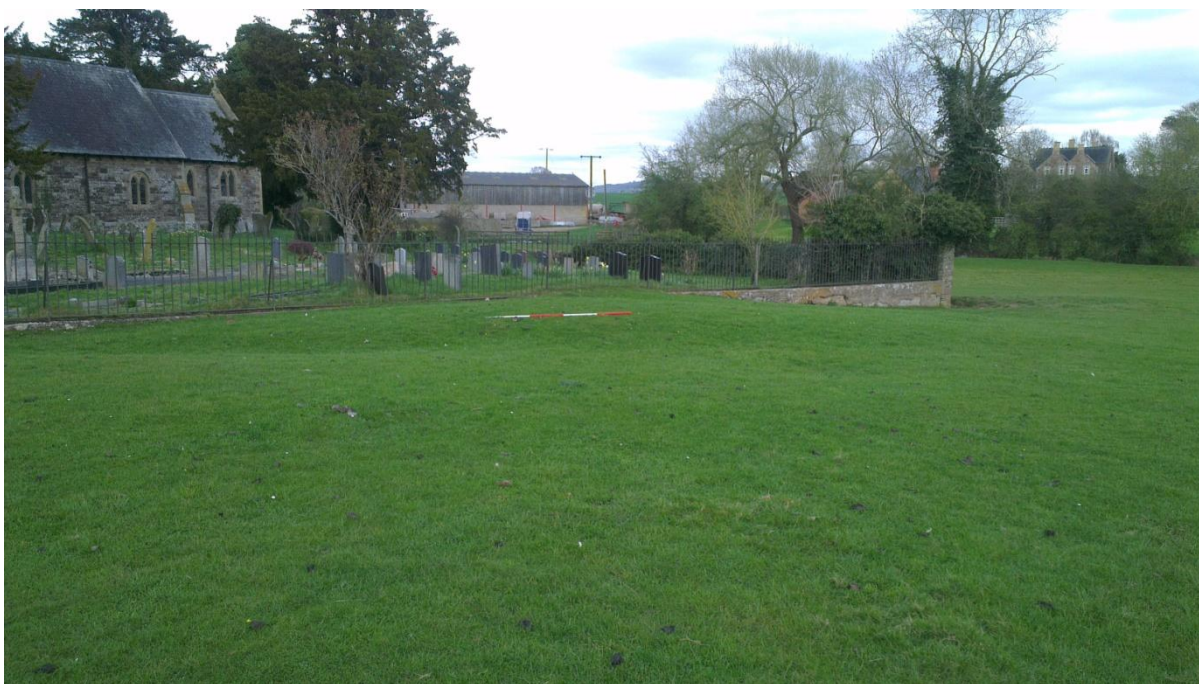
South of the churchyard a number of raised platforms were identified. The platform (*HER 52406*) represents the site of 'The Garrison' a structure identifiable on the 1840 Tithe Map (figure 2), the platform extends into the churchyard to the north. The platform is approximately 12m long east-west by 8m wide north-south and it stands up to 0.4m high. Along its southern edge is a ditch 1m wide, 0.2m deep. The platform has been cut dividing it between north and south by the construction of the churchyard boundary.

Plate 19: Platform (*HER 52406*) representing the site of 'The Garrison'. Viewed from the southwest. © Herefordshire Archaeology.

Plate 19: Platform (HER 52406) representing the site of 'The Garrison'. Viewed from the southwest. © Herefordshire Archaeology.

Despite this a number of platforms, potentially attributed to settlement were identified. The most prominent (*HER 52406*) relates to the site of 'The Garrison' a building identified on the 1840 Tithe Map (figure 2) the site of which partially lies beneath the current extension of St Andrew's Church graveyard.

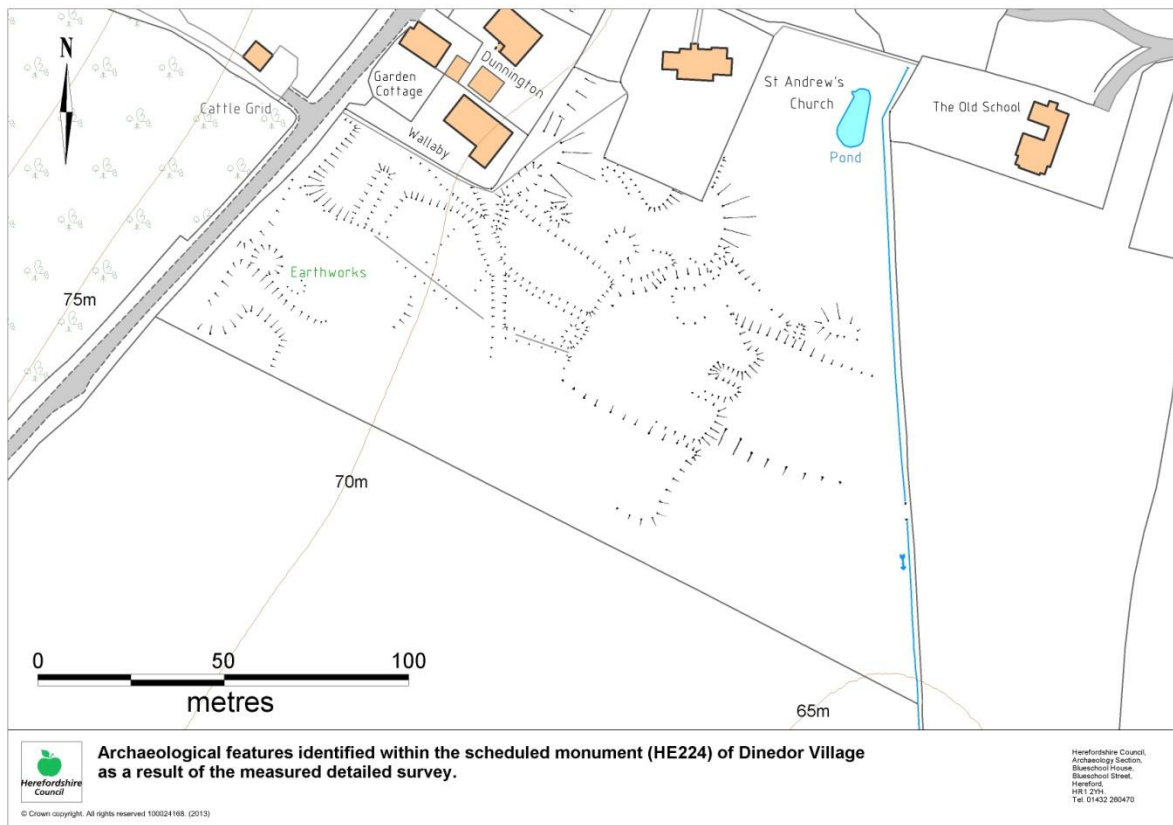
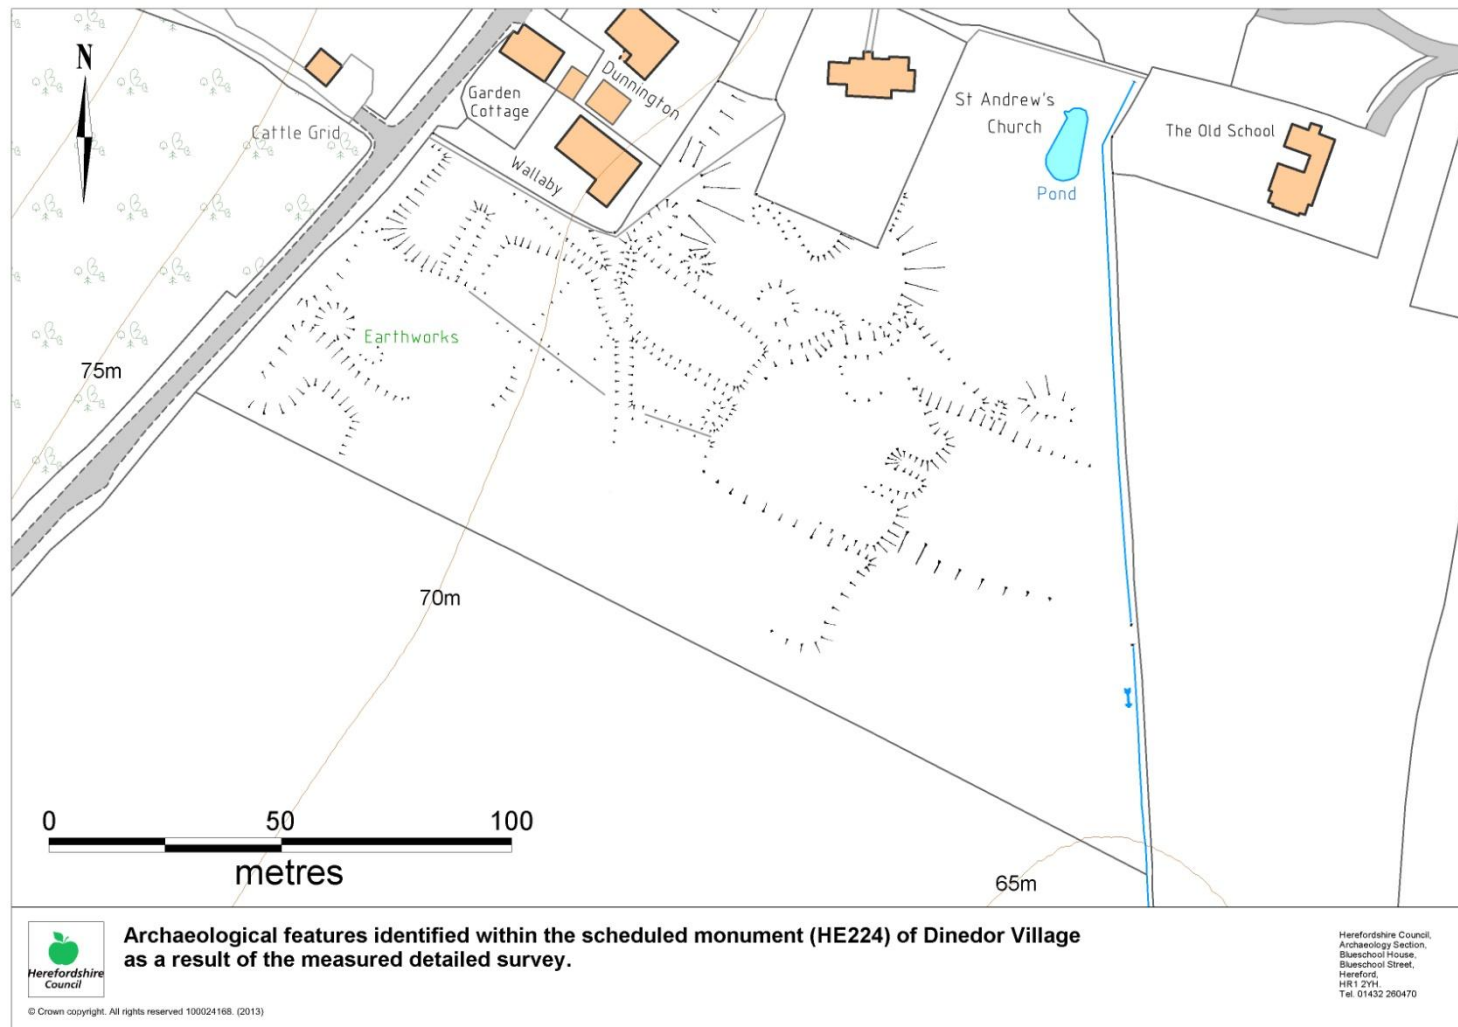
Figure 6: Results of the measured survey detailing the extent of the standing earthworks. © Crown copyright (2013). All rights reserved 100024168.

The earthwork remains identified through the course of the walkover survey were recorded by means of a measured survey (figure 6/Appendix 2) to a scale of 1:500. Over the course of the investigation breaks in slope as well as chronological sequences were mapped using a Leica *Builder509* Total Station in order to produce an accurate point-in-time plan of the monument.

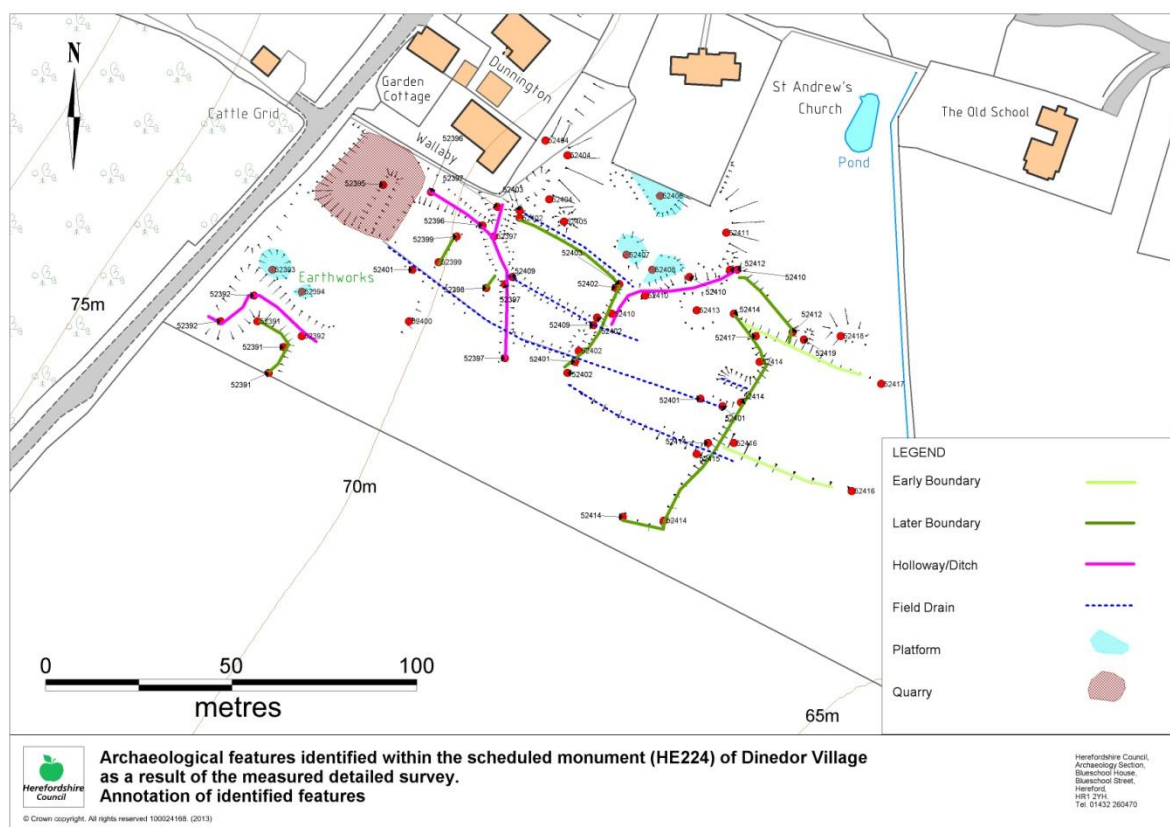
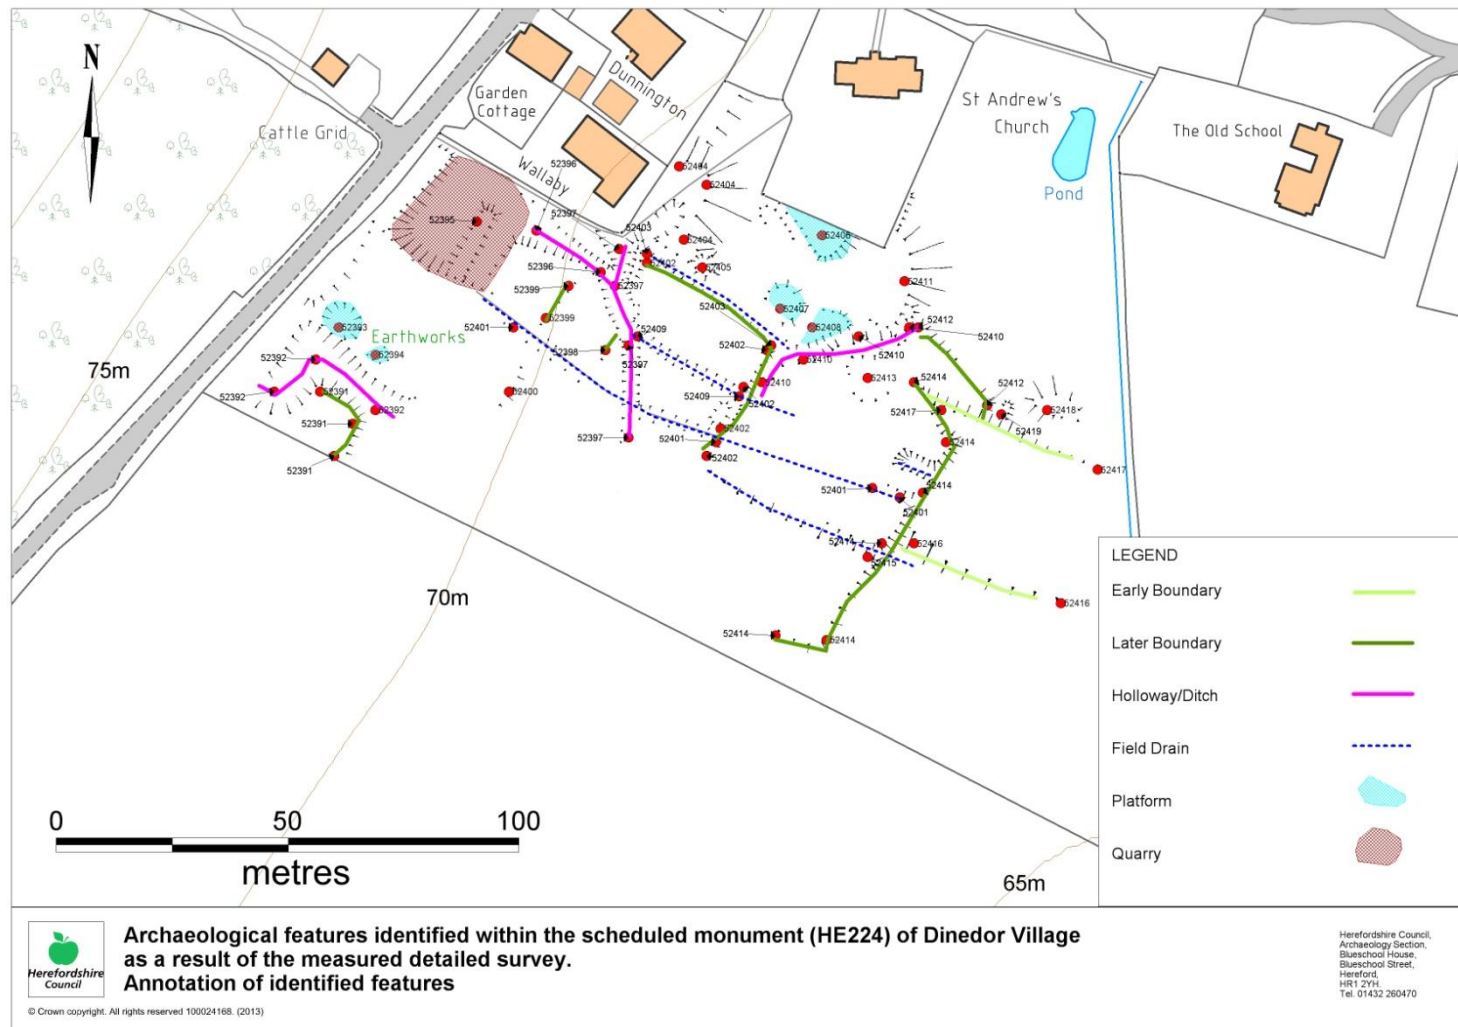
Figure 7: Annotated plan of the measured survey, highlighting the key features discussed in this report. © Crown copyright (2013). All rights reserved 100024168.

Figure 7: Annotated plan of the measured survey, highlighting the key features discussed in this report.

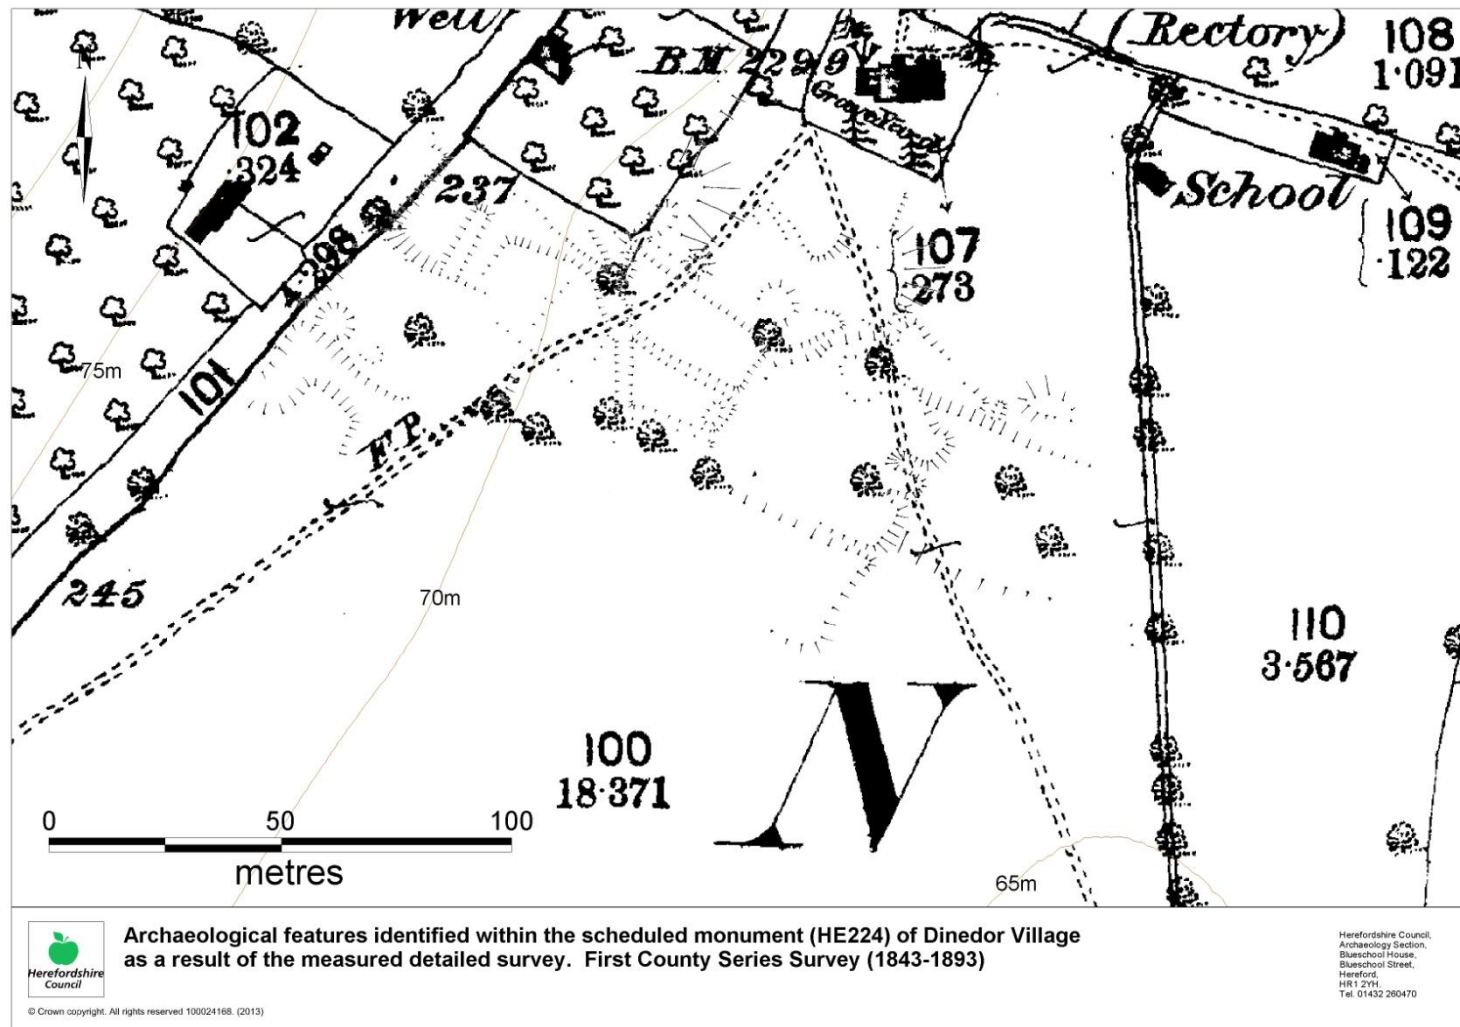
Figure 8: Results of the measured survey rectified onto the First County Series Survey (1843-1893). © Crown copyright (2013). All rights reserved 100024168.
