‘The Dinedor Origins Project’

**Site of Medieval Village, Dinedor: An Archaeological
Field Survey.**

Herefordshire Archaeology Report No. 327

April 2013

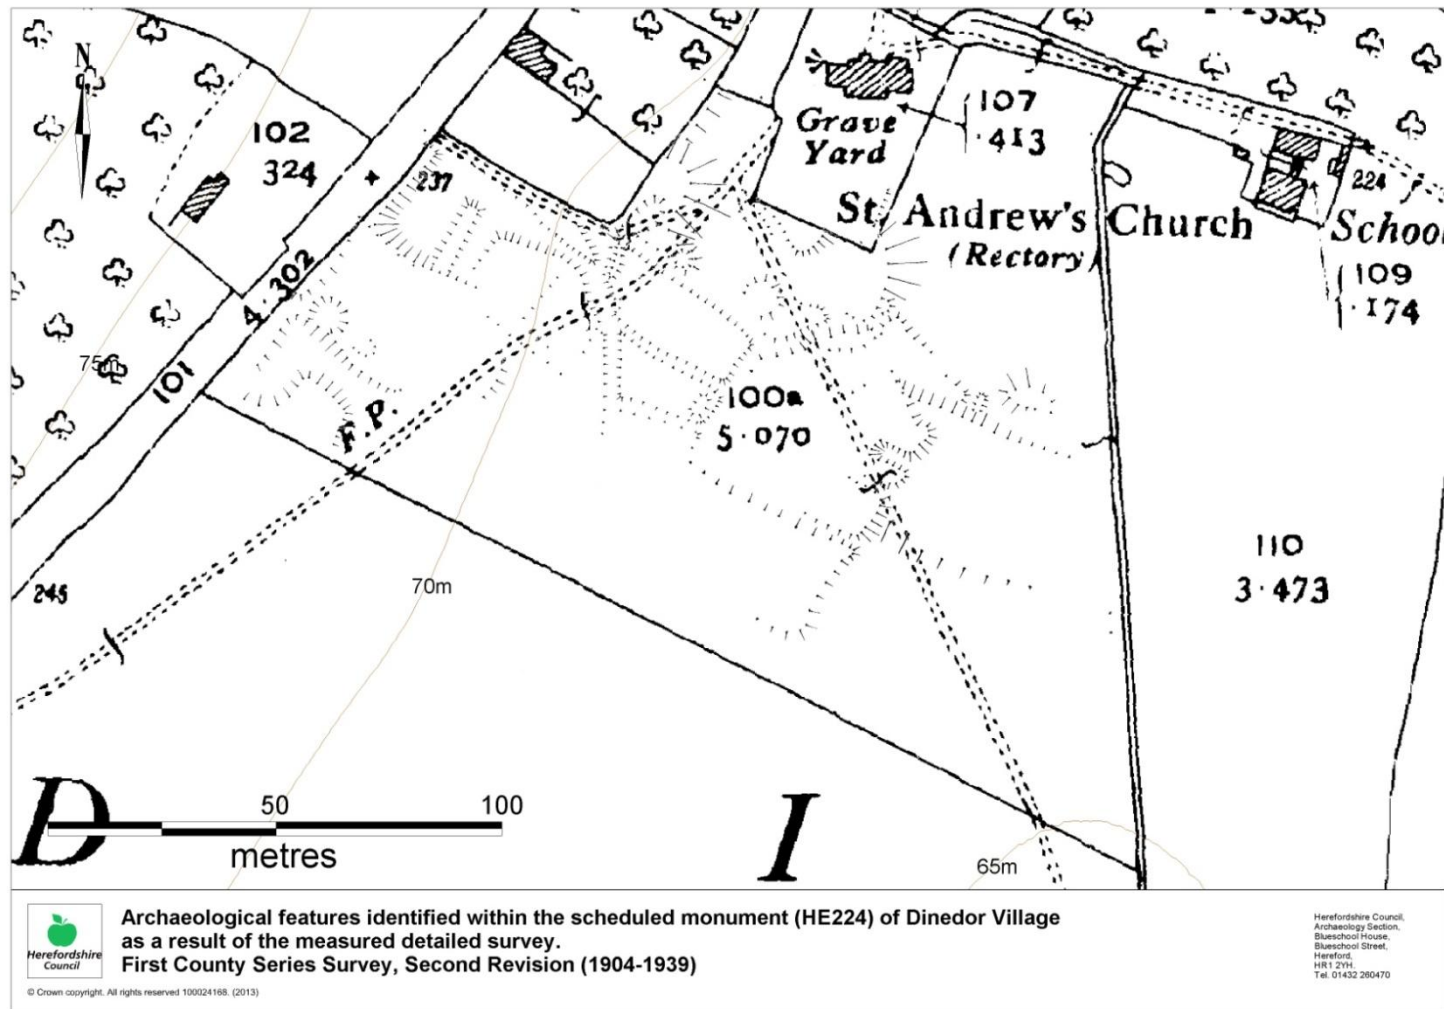
Figure 9: Results of the measured survey rectified onto the First County Series Survey, Second Revision (1904-1939). © Crown copyright (2013). All rights reserved 100024168.

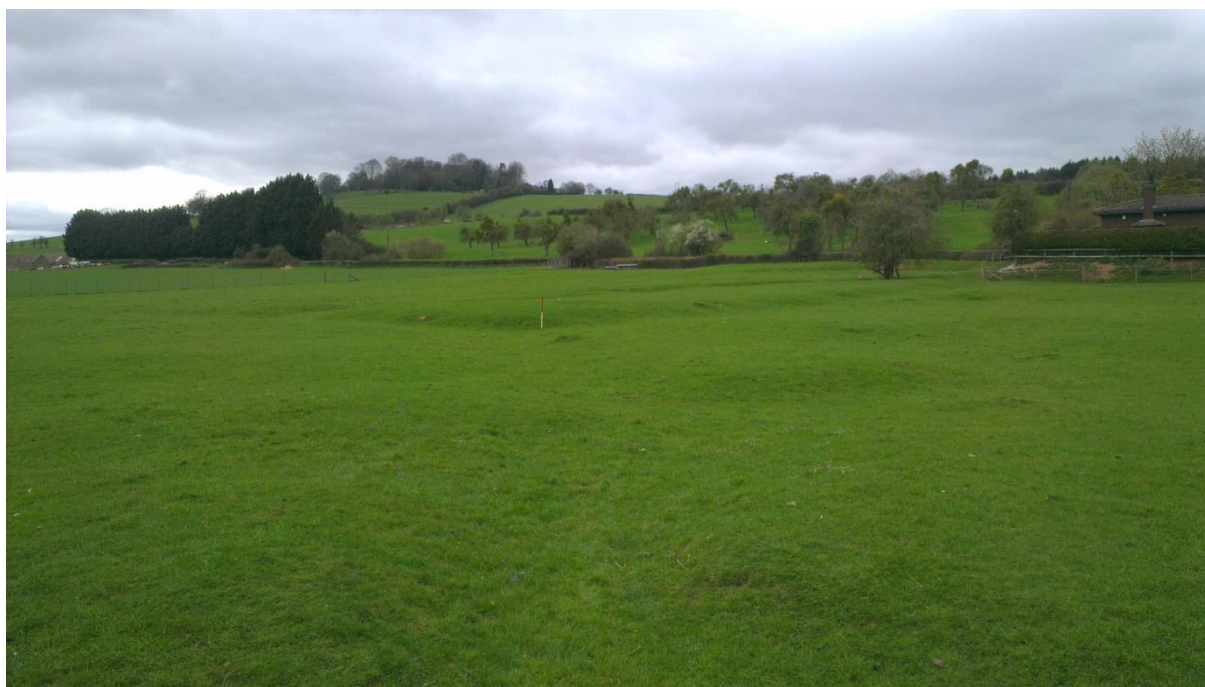
Plate 1: View of the scheduled area from the northeast with Dinedor Hill beyond. © Herefordshire Archaeology

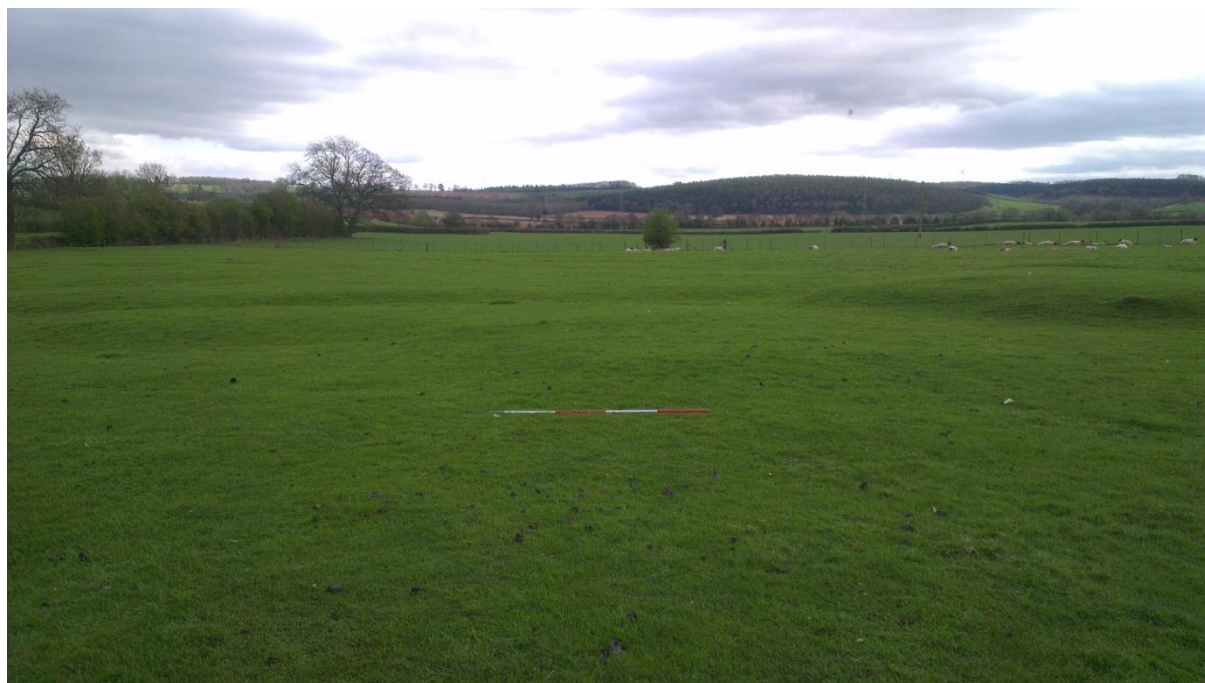
Approximately 10m to the south of the platform (*HER 52406*) is the site of two irregular platforms (*HER 52407, 52408*) on a roughly north-west alignment. The western most (*HER 52407*) stands 0.3m high with outward faces to the north, east and south. The slopes are gentle leading to a level summit with access obtainable from the west. The platform summit measures 6m diameter. To the east this platform overlooks the sub-rectangular platform (*HER 52408*). The platform is raised to the north, east and south from where it overlooks a ditch/holloway (*HER 52410*). It stands up to 0.2m high and measures c.13m long northeast-southwest by 5m wide. Access to the platform would have been from the west.

Plate 2: View of subtle platforms (HER 52407 & 52408) overlooked by relict boundary (HER 52402) from the south (right). © Herefordshire Archaeology

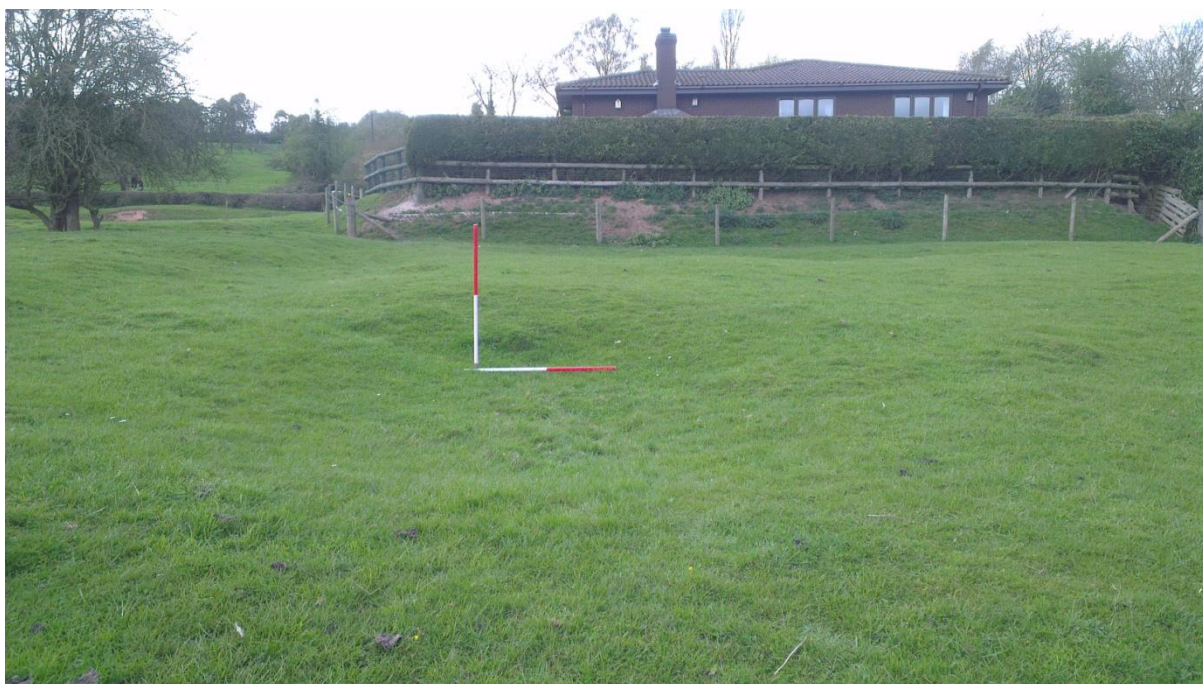
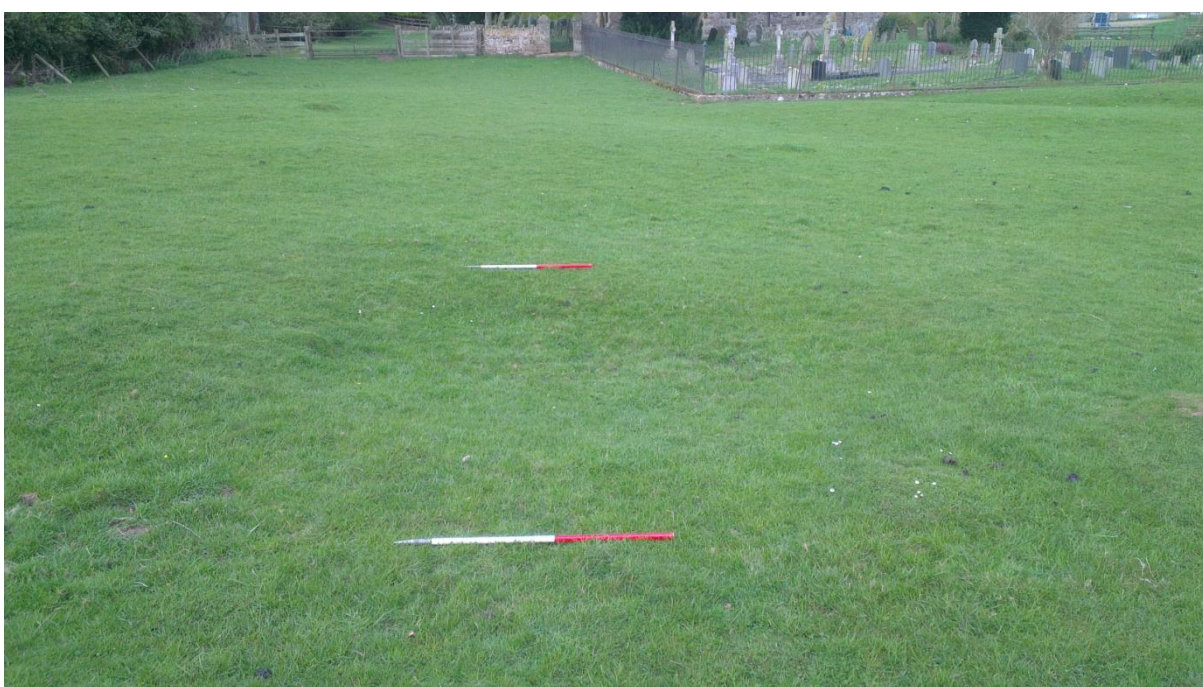
Plate 3: Possible tree throw (HER 52405) viewed from the east. © Herefordshire Archaeology

Plate 4: Possible tree-throw (HER 52405) viewed from the south. © Herefordshire Archaeology

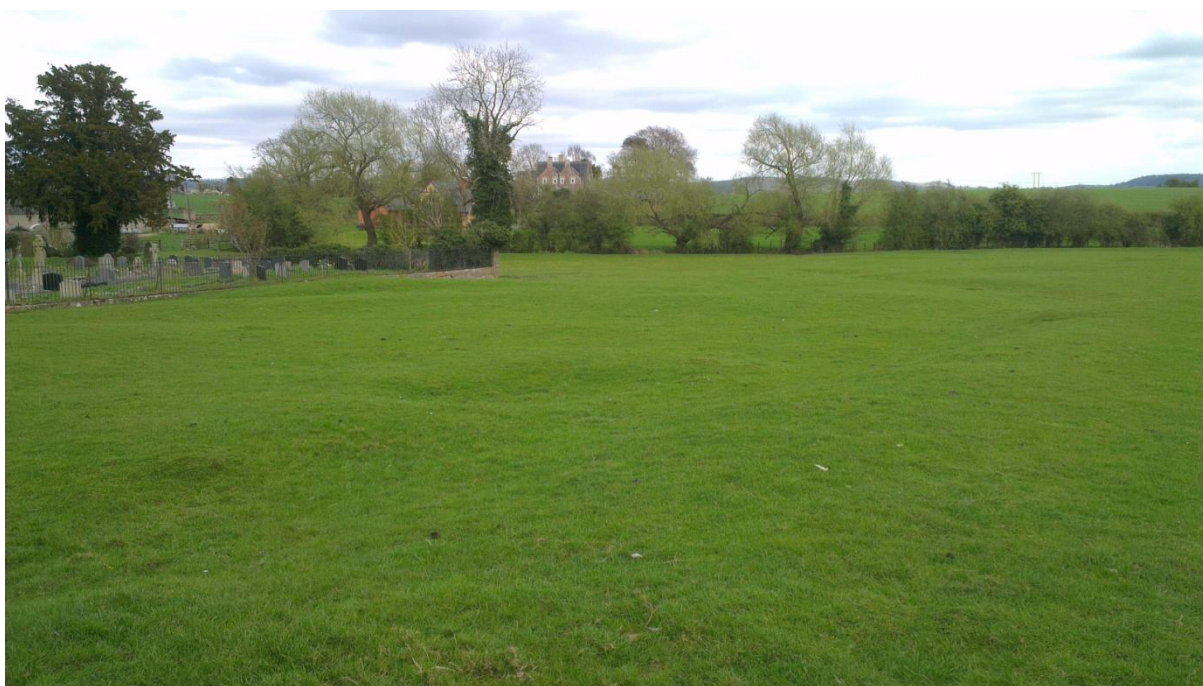
Plate 6: View of the site to the northeast from the summit of the relict boundary (HER 52402). © Herefordshire Archaeology

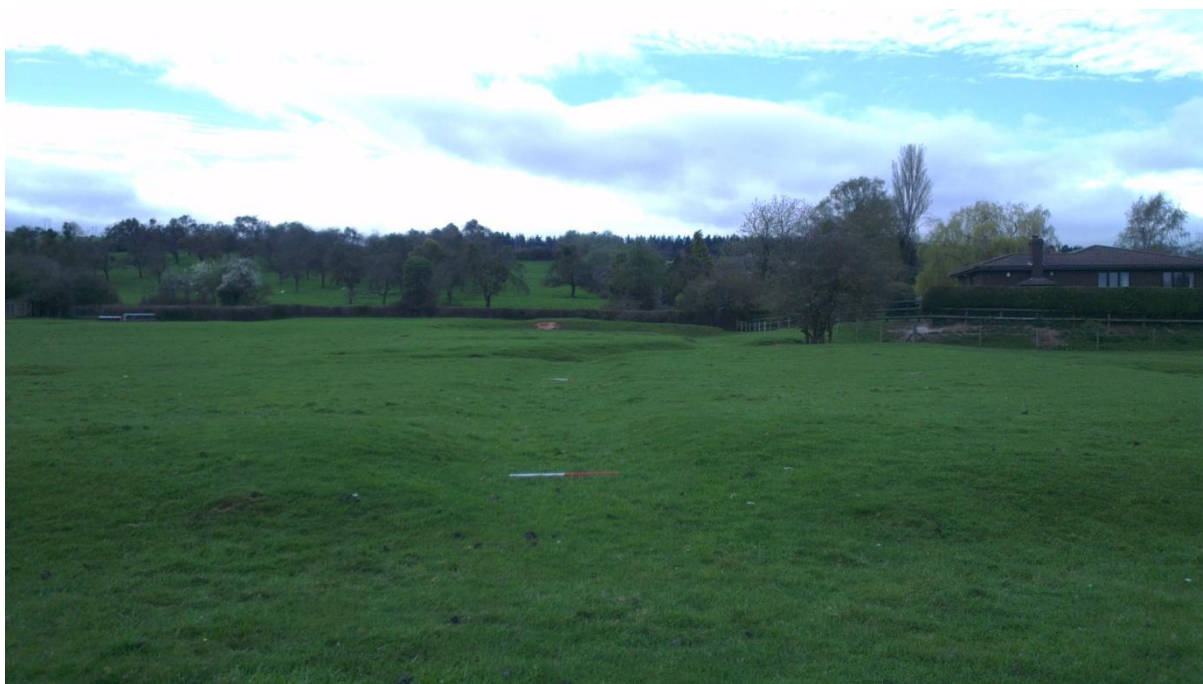
Plate 7: Drainage cut (HER 52409) through relict boundary (HER 52402). Viewed from the west. © Herefordshire Archaeology

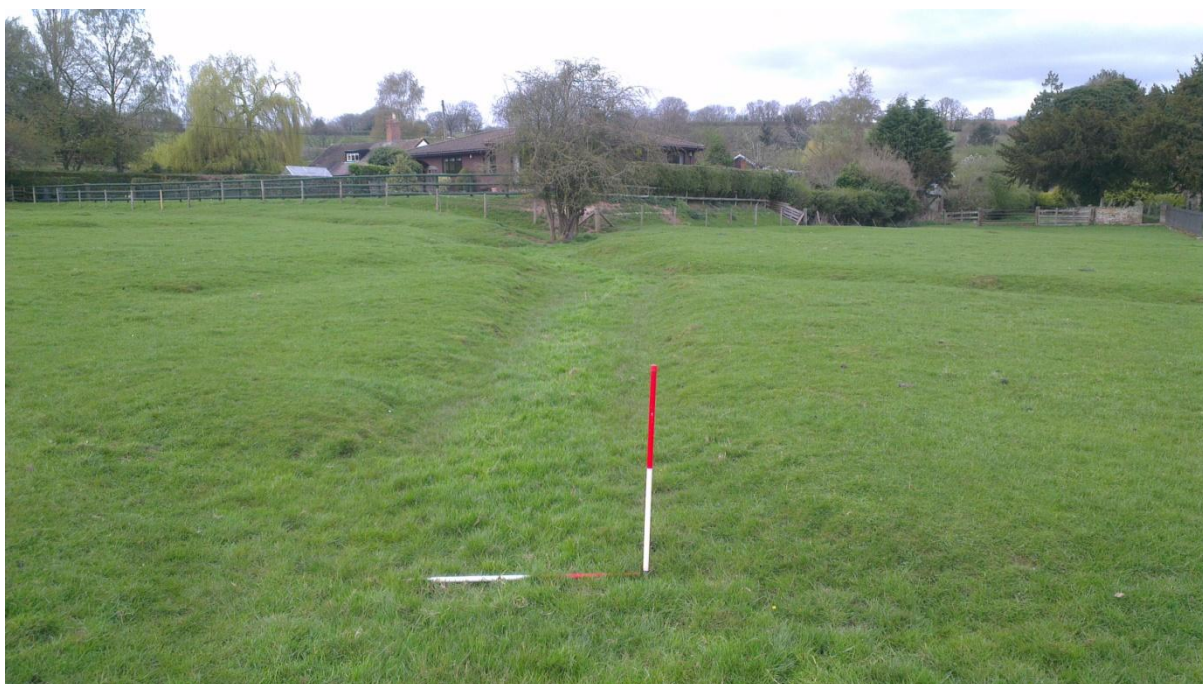
Plate 8: Holloway/water channel (HER 52397) running through enclosure marked by the relict boundary (HER 52402). Viewed from the south. © Herefordshire Archaeology

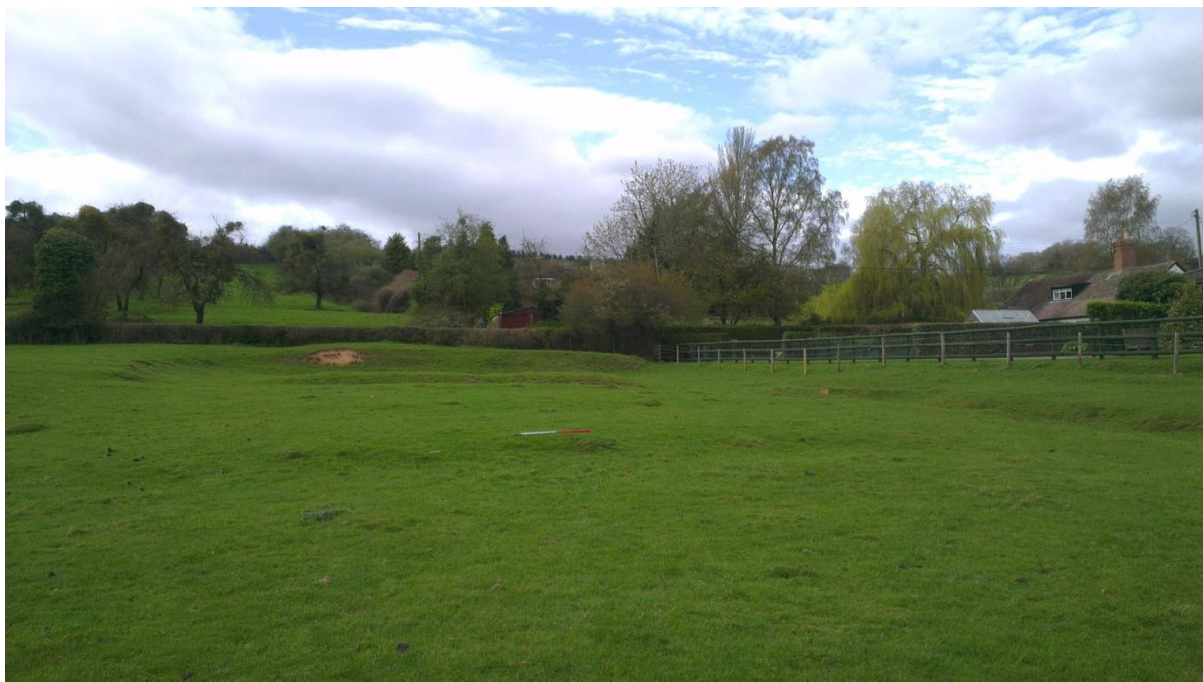
Beyond the holloway/water channel (*HER 52397*) two subtle terraces are evident (*HER 52398, 52399*) standing no more than 0.3m high and orientated northeast-southwest. Due to the subtle nature of the features they may represent the positioning of later, less intrusive boundaries such as a fence. The slight terracing might therefore represent soil creep from the west.

Plate 9: Subtle relict boundary (HER 52399) viewed from the west. © Herefordshire Archaeology

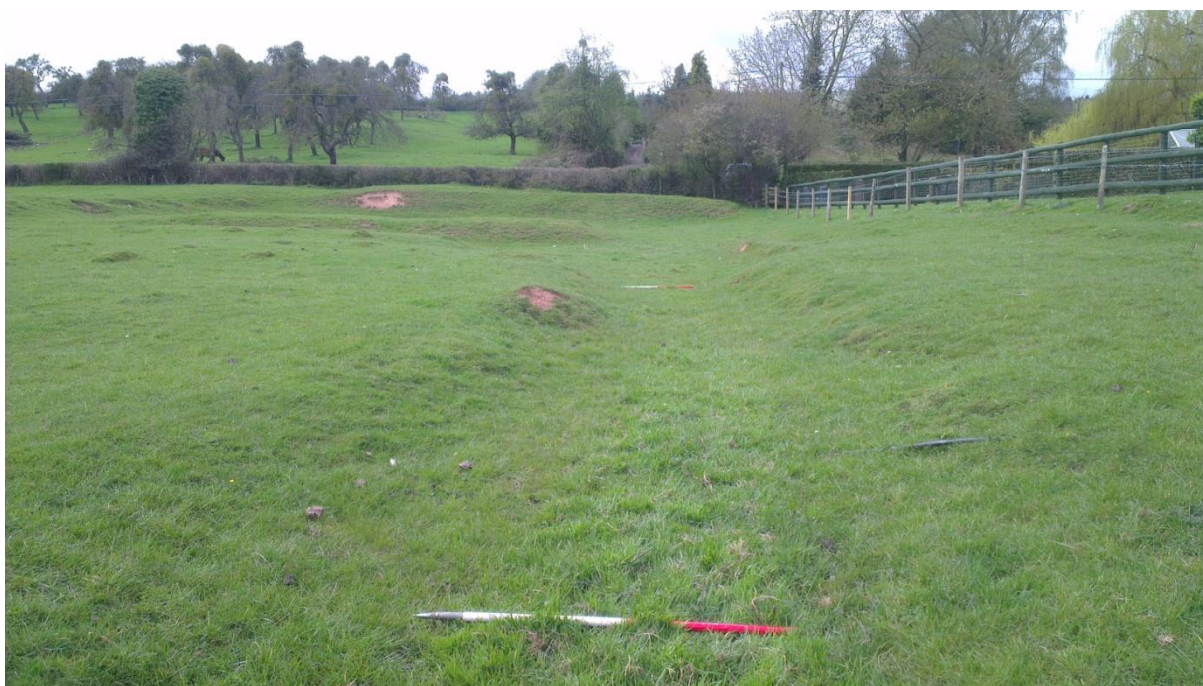
Plate 10: Holloway (HER 52396) viewed from the west from where it extends to support quarry (HER 52395). © Herefordshire Archaeology

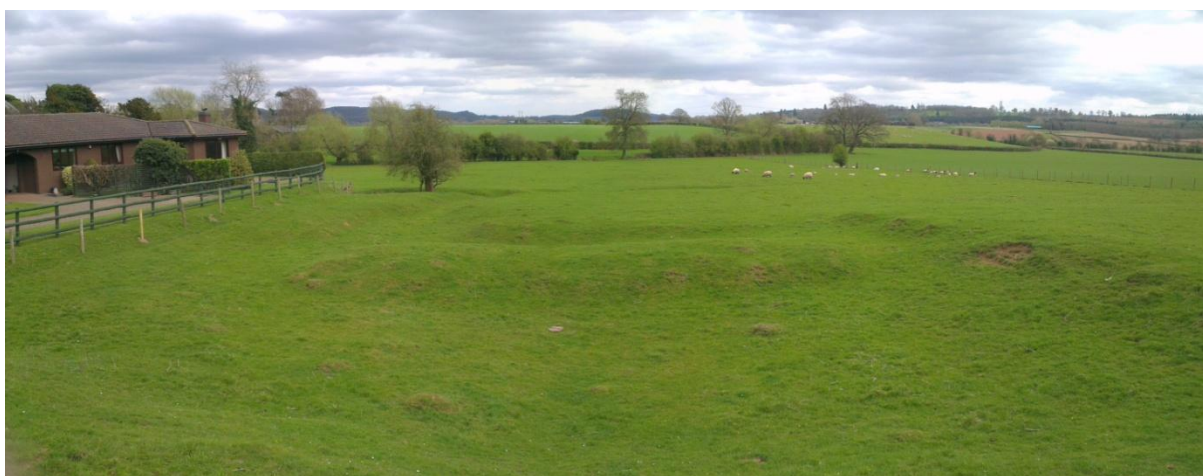
Plate 12: Possible quarry site (HER 52395) viewed from the west. © Herefordshire Archaeology

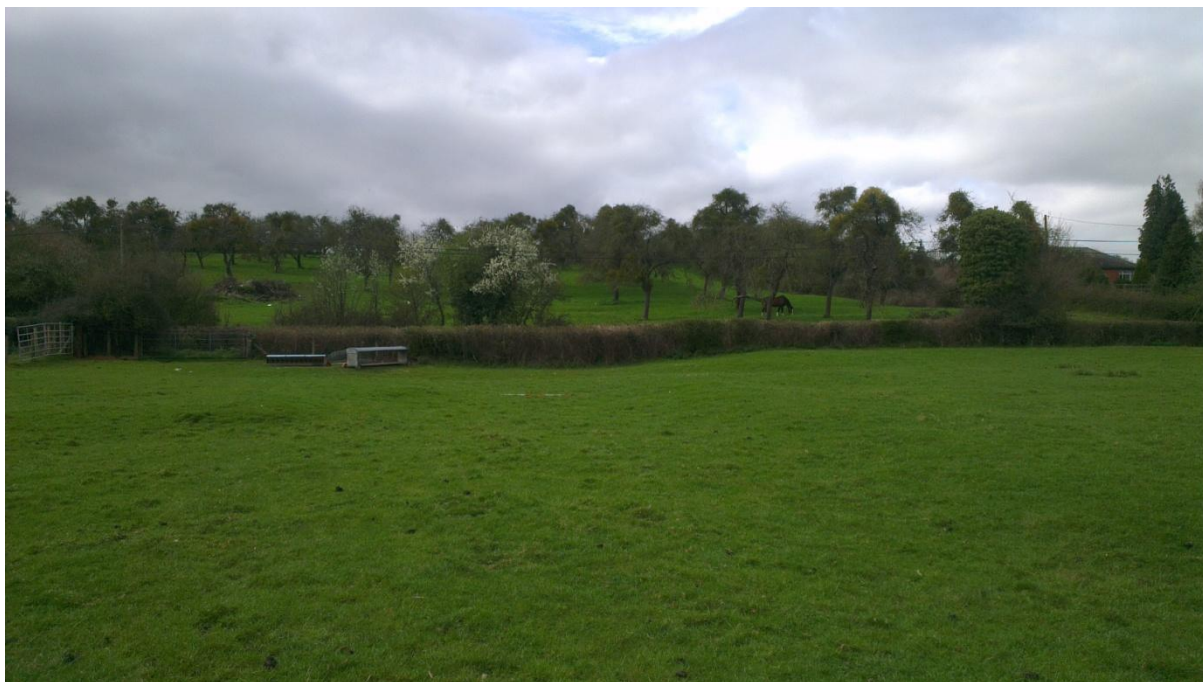
Within the southwest corner of the scheduled area is the course of a relict field boundary (*HER 52391*) in the form of a southeast-facing terrace standing approximately 1m high. To the north-northeast the boundary forms a right-angle to orientate to the northwest from where it peters-out after c.14m. At this location the foot of the terrace is marked by holloway (*HER 52392*) to the north and west where it exits the field through a modern gate. The holloway (*HER 52392*) and terraced boundary (*HER 52391*) are either contemporary or the holloway is a later infringement on an already established yet obsolete field boundary. To the south the terrace (*HER 52391*) ends abruptly at the modern field boundary beyond which is a field of improved pasture.

Plate 13: (Centre) Holloway (HER 52392) and relict boundary (HER 52391) to the south (left). Viewed from the east. © Herefordshire Archaeology

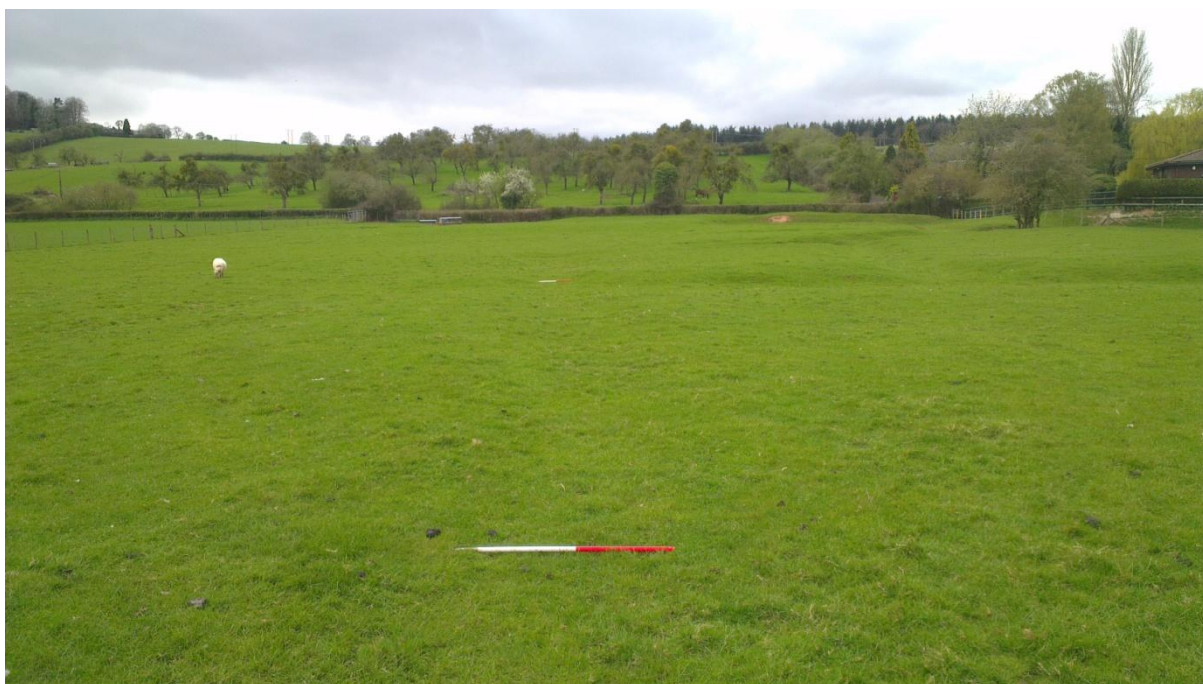
Orientated approximately east-west and cutting almost all of the features identified are a series of field drains (*HER 52401, 52403, 52409, 52415*), undoubtedly constructed to drain water from the west and channel it to the east from where a stream flows to connect with Tar's Brook at the valley basin.

Plate 14: Field drain (HER 52401) viewed from the east. © Herefordshire Archaeology

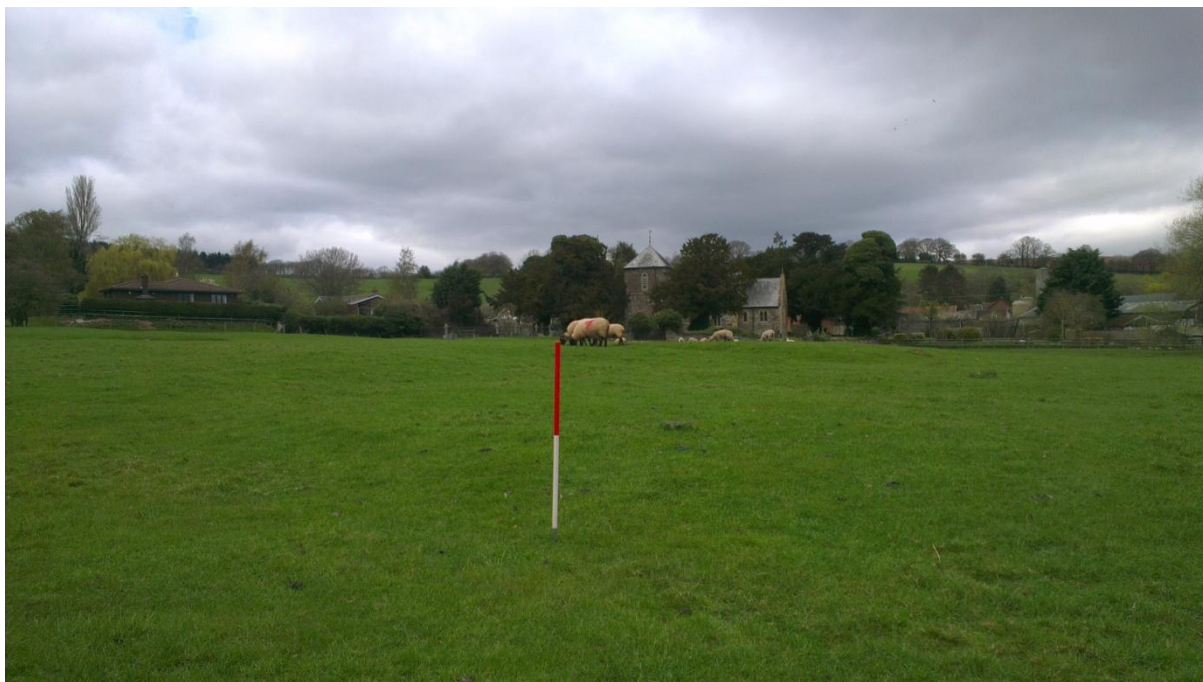
Plate 15: Early relict boundary (HER 52416) viewed from the southeast. © Herefordshire Archaeology

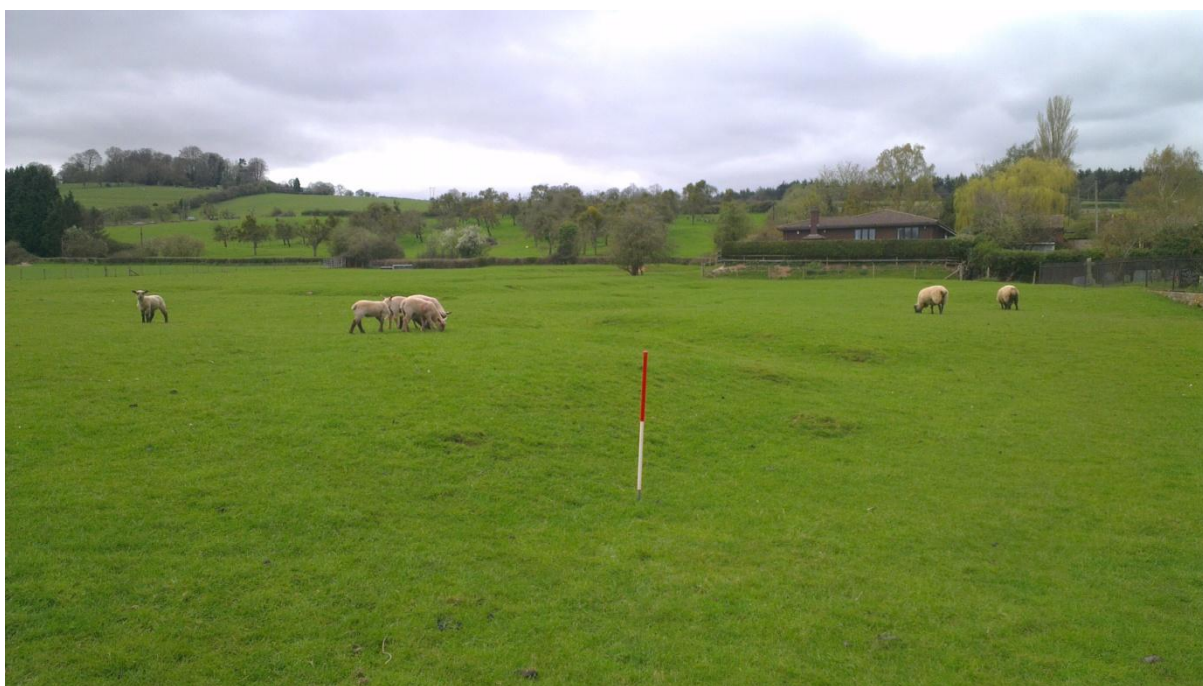
To the northeast of the boundary (*HER 52412*) is a boundary with a break to allow for access into the area enclosed by that recorded as (*HER 52414*). The feature in question (*HER 52412*) overlies and extends from the north-face of the early relict boundary (*HER 52417*) on a north-northwest orientation. The boundary stretches for c.20m before it is truncated by a shallow ditch/holloway (*HER 52410*). At its centre there is a break in the terrace to allow for access into field from the east, this is represented by a gentle ramp approximately 3m wide which leads to a subtle circular depression (*HER 52413*) within the field interior approximately 8m diameter and 0.05m deep. Beyond the ditch/holloway (*HER 52410*) the terrace could be argued to continue to the southeast corner of the churchyard, although it's possible the boundary followed the course of the ditch/holloway (*HER 52410*) to the west where it links with the corner of terraced boundary (*HER 52402*).

Plate 16: Relict boundary (HER 52412) with ramp to allow access viewed from the east. © Herefordshire Archaeology

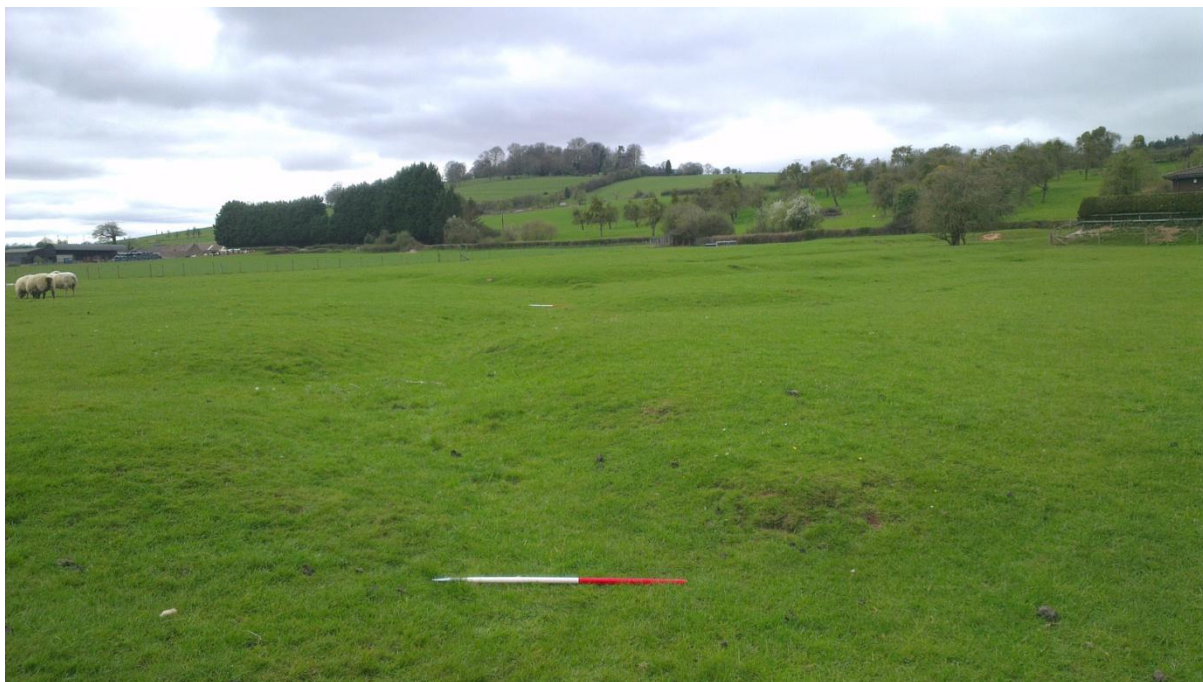
Plate 17: Holloway/ditch (HER 52410) traversing the site. Viewed from the northeast. © Herefordshire Archaeology

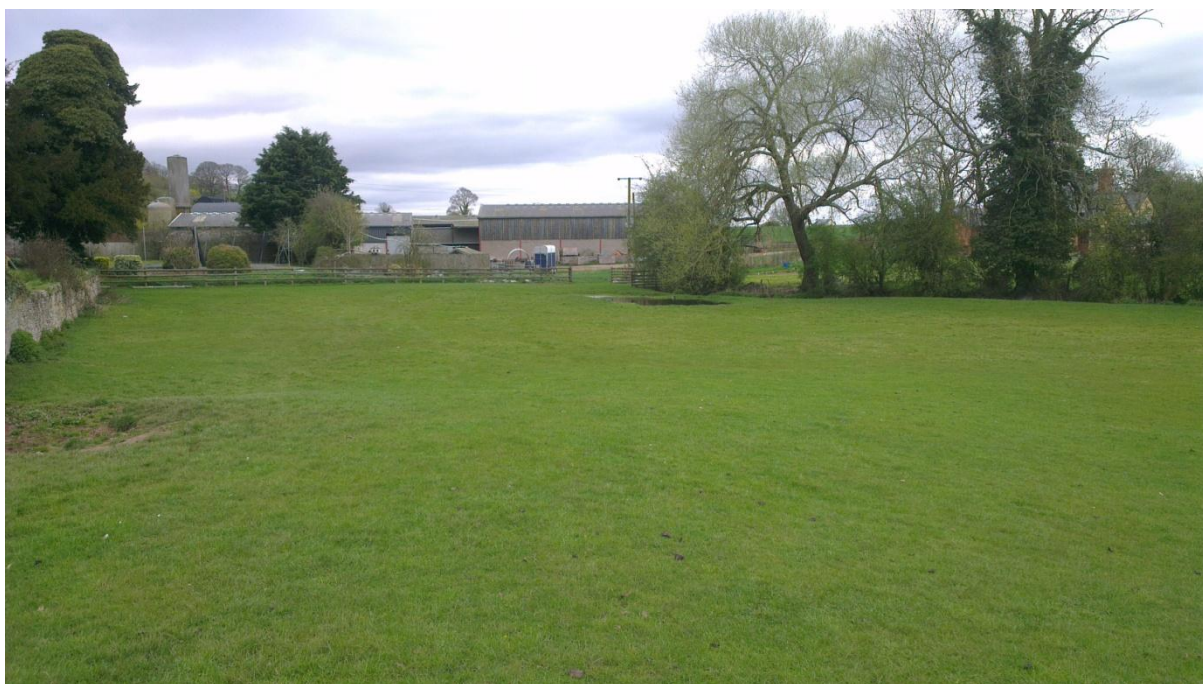
Within the northeast corner of the site adjacent to the main watercourse through the village of Dinedor the ground is clearly susceptible to waterlogging, as was the case at the time of this investigation. As a means of counteracting these ground conditions and alleviating land suitable for livestock grazing, an oval pond was excavated during the mid-20th century.

Plate 18: Pond and area susceptible to waterlogging within the northeast of the scheduled monument. © Herefordshire Archaeology

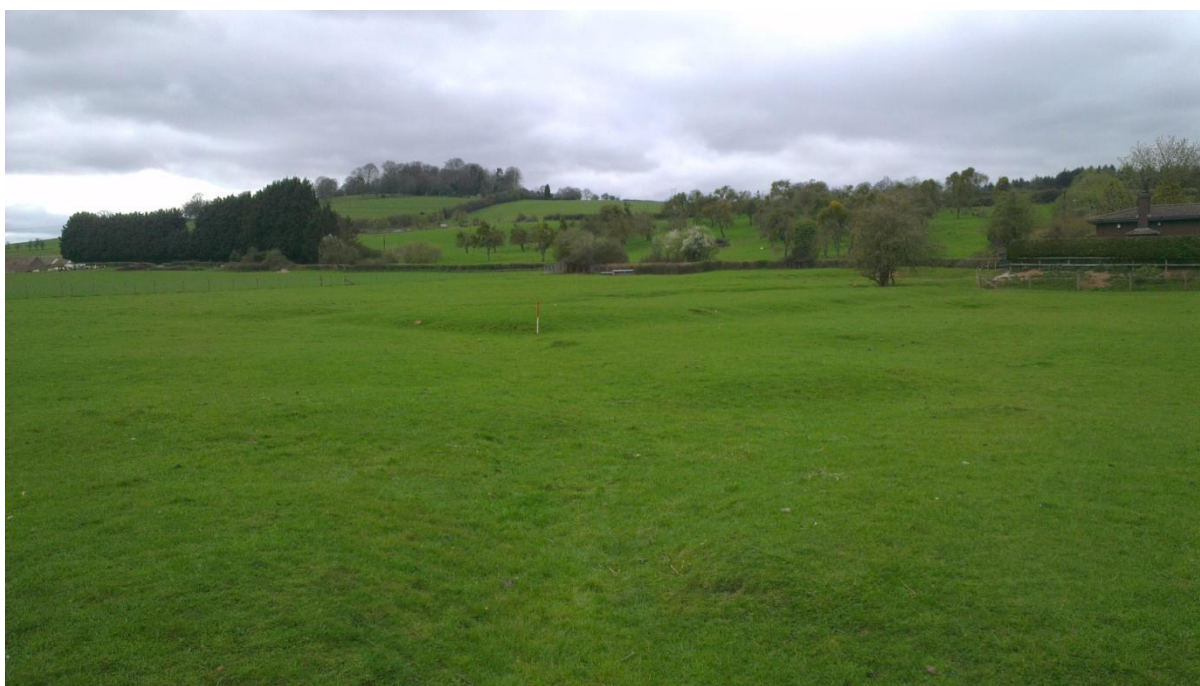
Plate 20: General view of the scheduled monument from the northeast looking towards Dinedor Camp to the southwest. © Herefordshire Archaeology
